Pipeline Accident Report

Natural Gas Pipeline Rupture and Fire Near Carlsbad, New Mexico August 19, 2000

**National
Transportation
Safety Board**
Washington, D.C.

**NTSB/PAR-03/01
PB2003-916501
Notation 7310B
Adopted February 11, 2003**

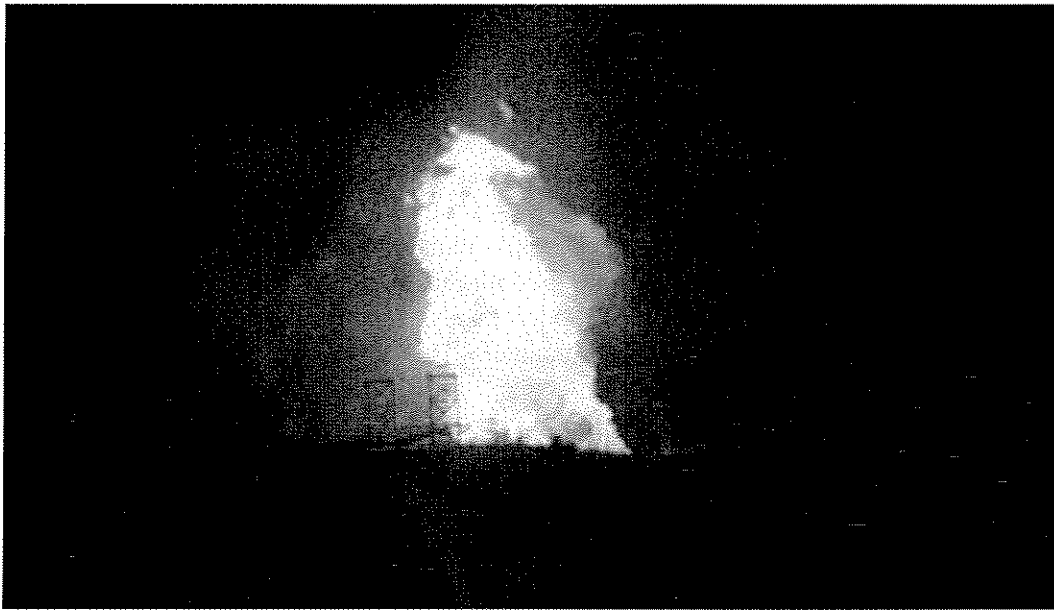
Figure 5. Post-rupture fire. At lower left of fireball can be seen the 85-foot-tall support structures for the pipeline suspension bridges.

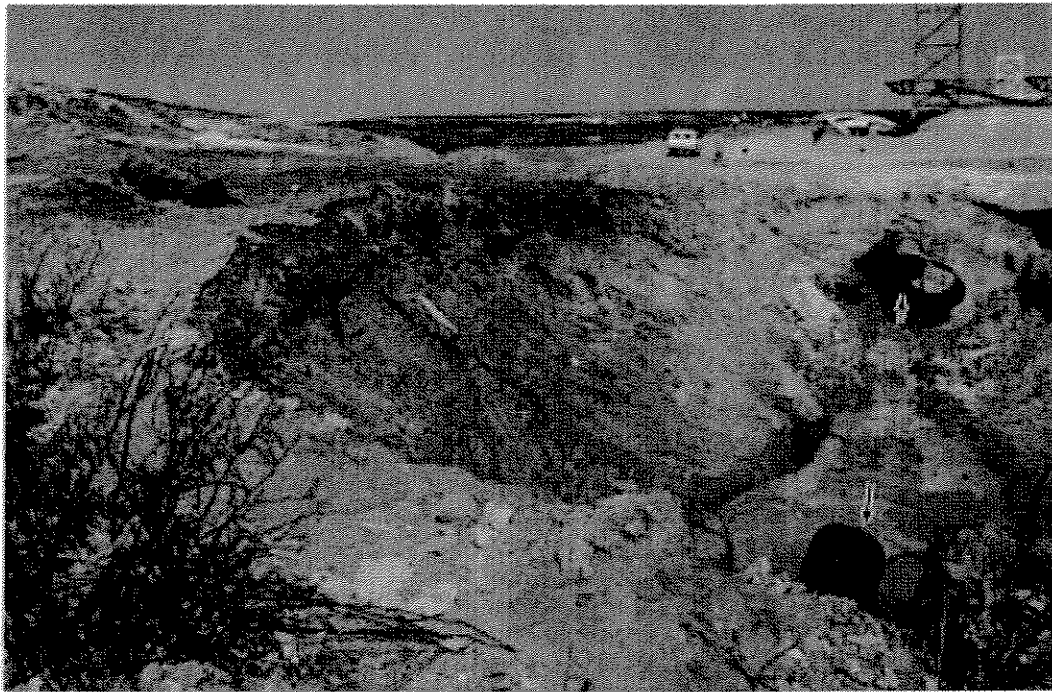
The force of the rupture and the violent ignition of the escaping gas created a 51-foot-wide crater about 113 feet along the pipe. A 49-foot section of the pipe was ejected from the crater in three pieces measuring approximately 3 feet, 20 feet, and 26 feet in length. (See figure 6.) The largest piece was found about 287 feet northwest of the crater in the direction of the suspension bridges. Investigators visually examined the pipeline that remained in the crater as well as the three ejected pieces. All three ejected pieces showed evidence of internal corrosion damage, but one of the pieces showed significantly more corrosion damage than the other two. Pits were visible on the inside surface of this piece, and at various locations, the pipe wall evidenced significant thinning. At one location, a through-wall perforation was visible. No significant corrosion damage was visible on the outside surfaces of the three pieces or on the two ends of the pipeline remaining in the crater. Pieces were cut from the ruptured pipeline segments and shipped to the Safety Board’s Materials Laboratory in Washington, D.C., for further evaluation. (That evaluation is discussed in the “Tests and Research” section of this report.)

Figure 6. Looking west at a portion of the crater created by the rupture. The missing section of pipe between the arrows was ejected from the crater.

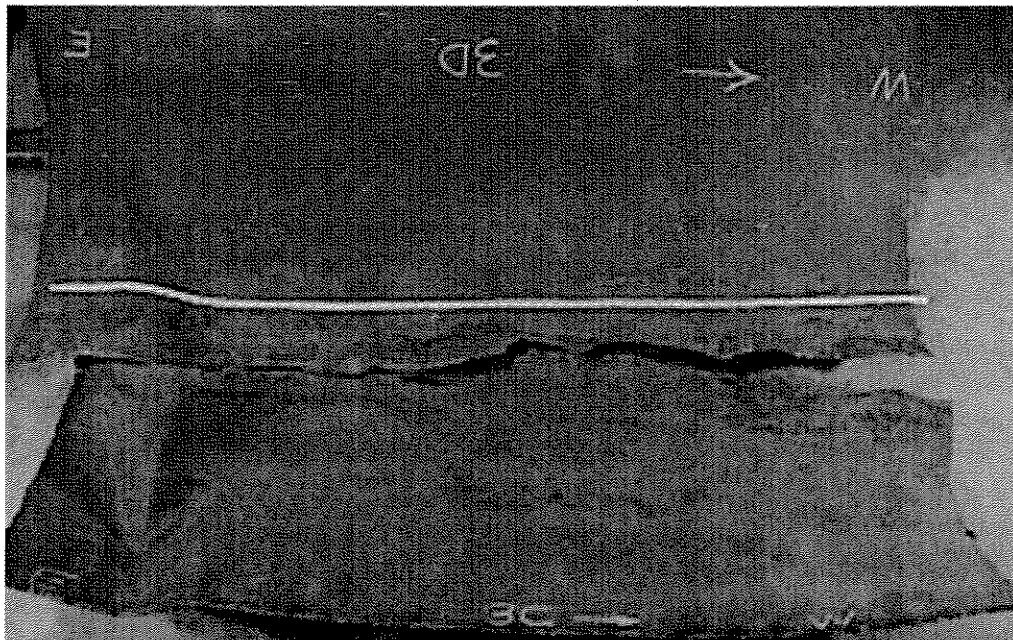
On-site examination of the three pieces of pipe that were ejected from the crater at the rupture site identified severe internal corrosion along the interior bottom of the pipe. (See figure 7.) From these three segments, eight pieces were excised and transported to the Safety Board's Materials Laboratory in Washington, D.C., for further examination. The examination of these pieces revealed no evidence of corrosion on the outside of the pipe or the internal surface across the top half of the pipe (between the 9 and 3 o'clock positions looking downstream/west). Severe wall loss due to corrosion was observed on the inside of the pipe at the bottom.

Figure 7. Fractured section of line 1103.

The area of corrosion damage extended 21 feet 5 inches. Sections of the girth (circumferential) and seam (longitudinal) welds that were in the bottom half of the pipe exhibited damage from internal corrosion similar to that found on the bottom pipe wall. The extent of corrosion damage (metal loss and number of pits) was most severe along the bottom of the pipe; the most severely corroded area reduced the original pipe wall thickness by 72 percent. (See figure 8.) The wall of many of the corrosion pits contained striations that extended around the pit. (See figure 9.) Within this length of corrosion damage were five circumferential wrinkles¹⁹ in the pipe wall on the top of the pipe.

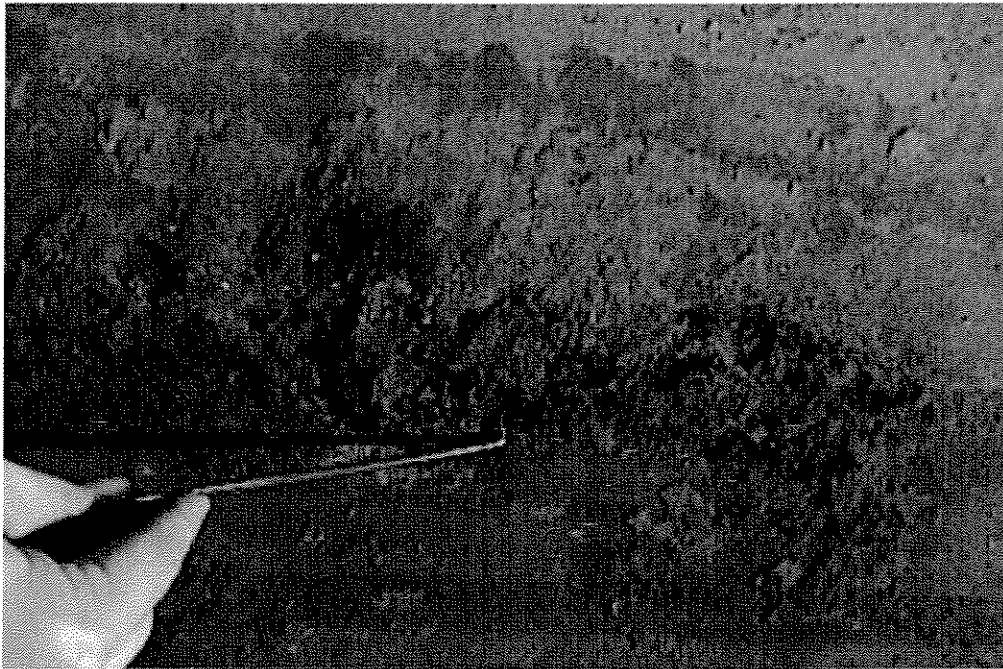
Figure 8. Corrosion pitting on inside of pipe near rupture site.

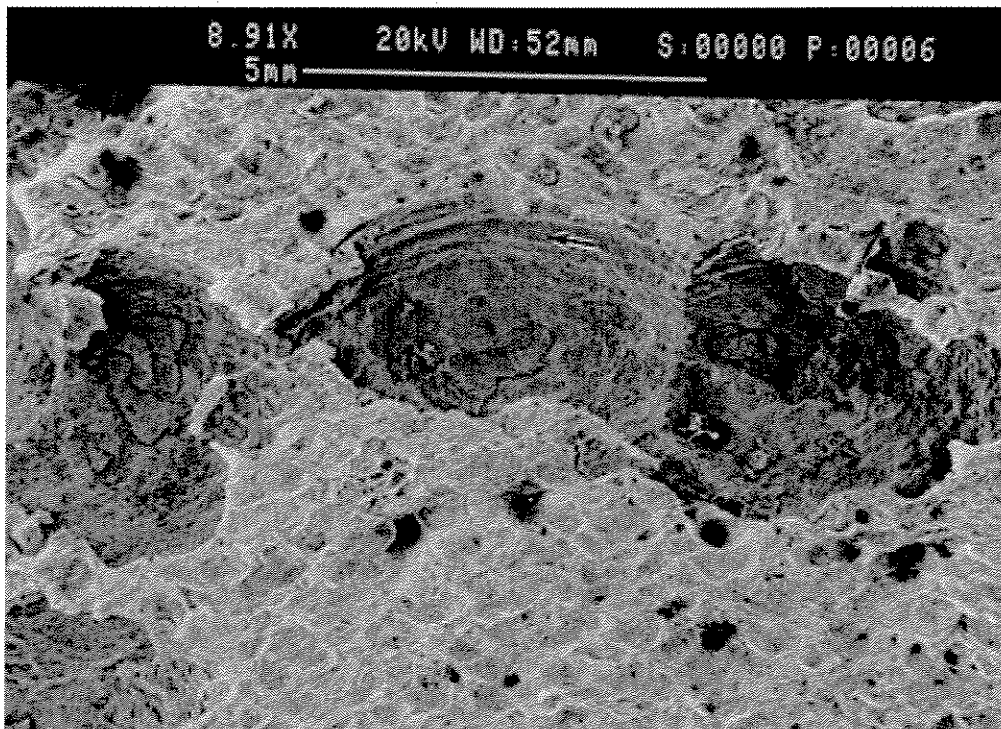
Figure 9. Microscopic view of corrosion pit showing striations

Examination of the fractures showed that a fracture face extended between the internal corrosion areas and the external wall of the pipe. The fracture faces resulted from overstress separation with no evidence of fatigue cracking or corrosion degradation, indicating that corrosion had not penetrated the wall of the pipe at the rupture point.

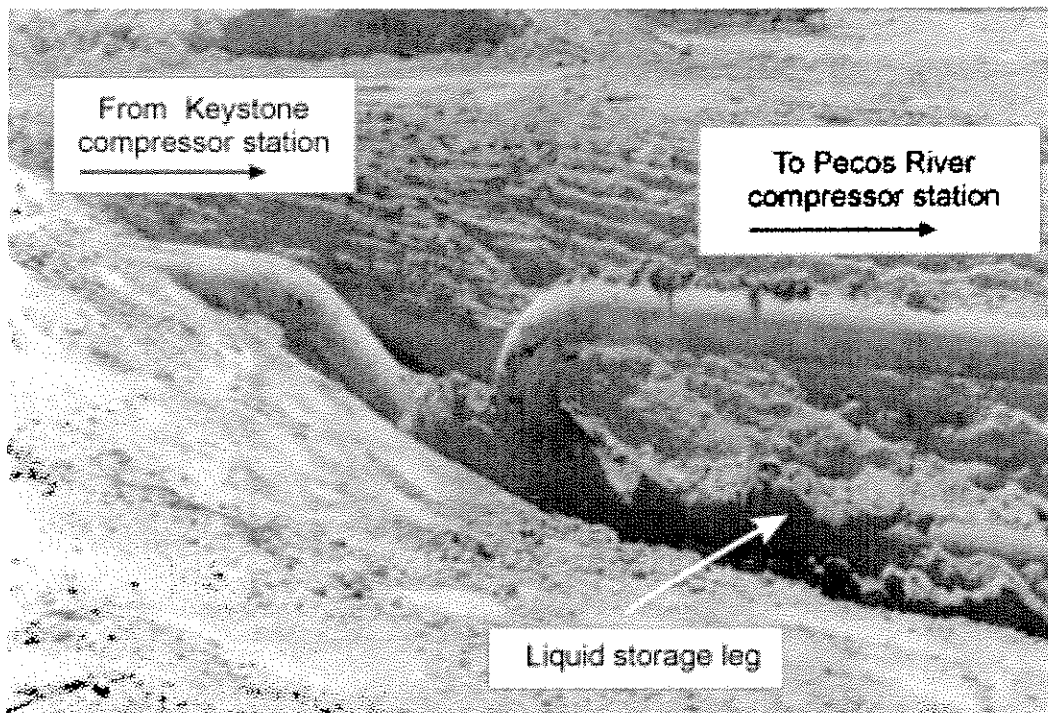
The drip¹⁷ between block valve No. 6 and the rupture site was removed from the pipeline and visually examined. The drip was found to contain a blackish oily-powdery/grainy material. At the area of its heaviest concentration, about 13 feet from the drip opening, this material filled approximately 70 percent of the cross-sectional area of the drip. No significant material was observed in the area just underneath and several inches away from the siphon drain at the closed end of the drip. No significant internal corrosion was observed in the drip.

Figure 10. Line 1103 drip after excavation.
