**APPENDIX 2**

**SITE PHOTOS**

## Phase 1 – Cacouna Energy, Gros Cacouna, Quebec

S-05-1743, Oct. 2005

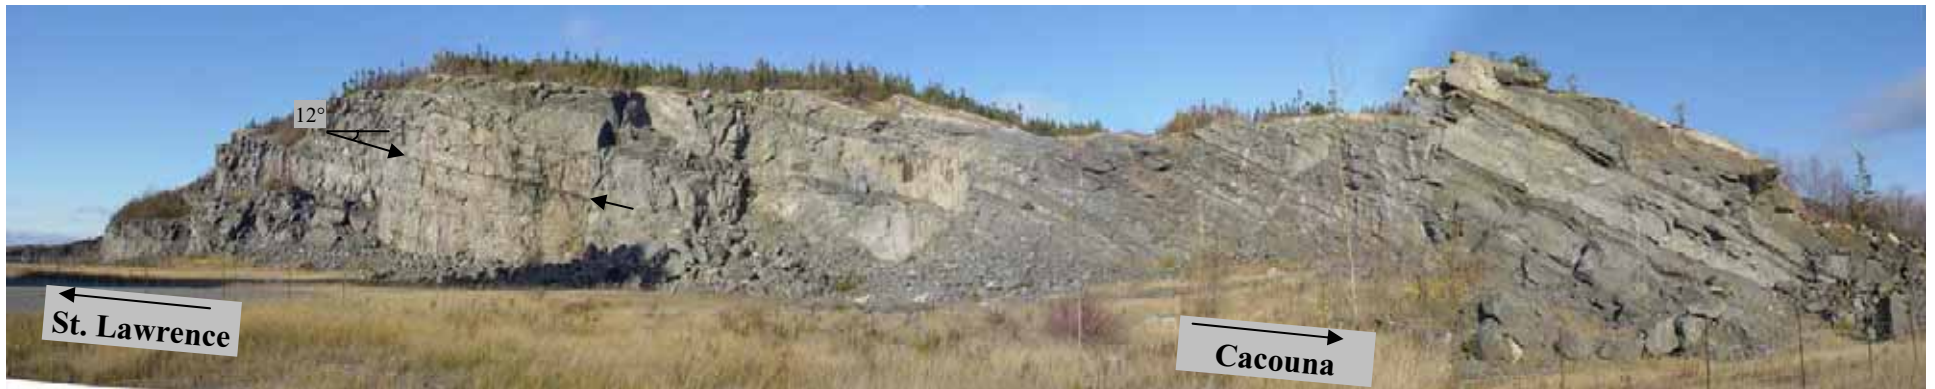
Photo 1. View of rock face on south side of quarry showing typical massive sandstone rock beds dipping at low angle (12 degrees) to the southeast

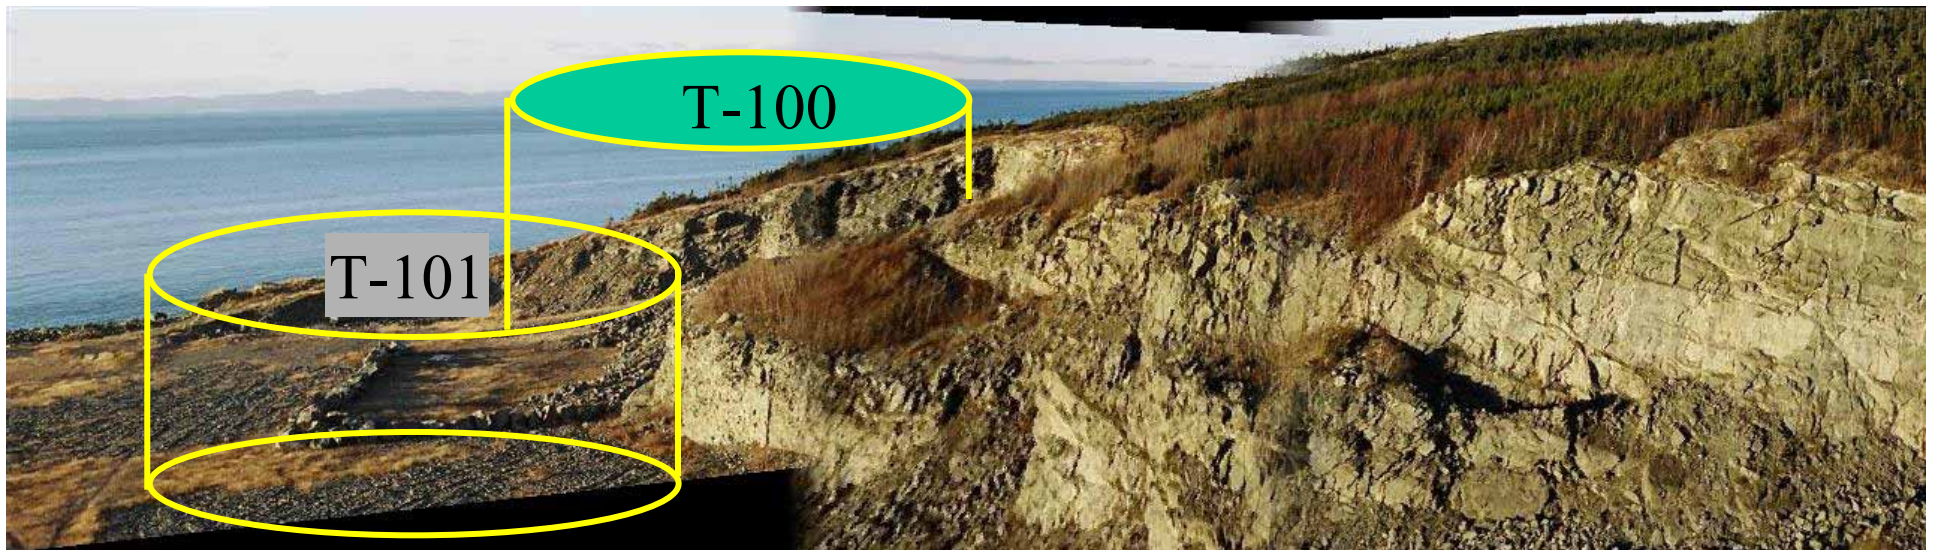
Photo 2. View looking across tank T-101 and T-100 sites towards the St. Lawrence (North).

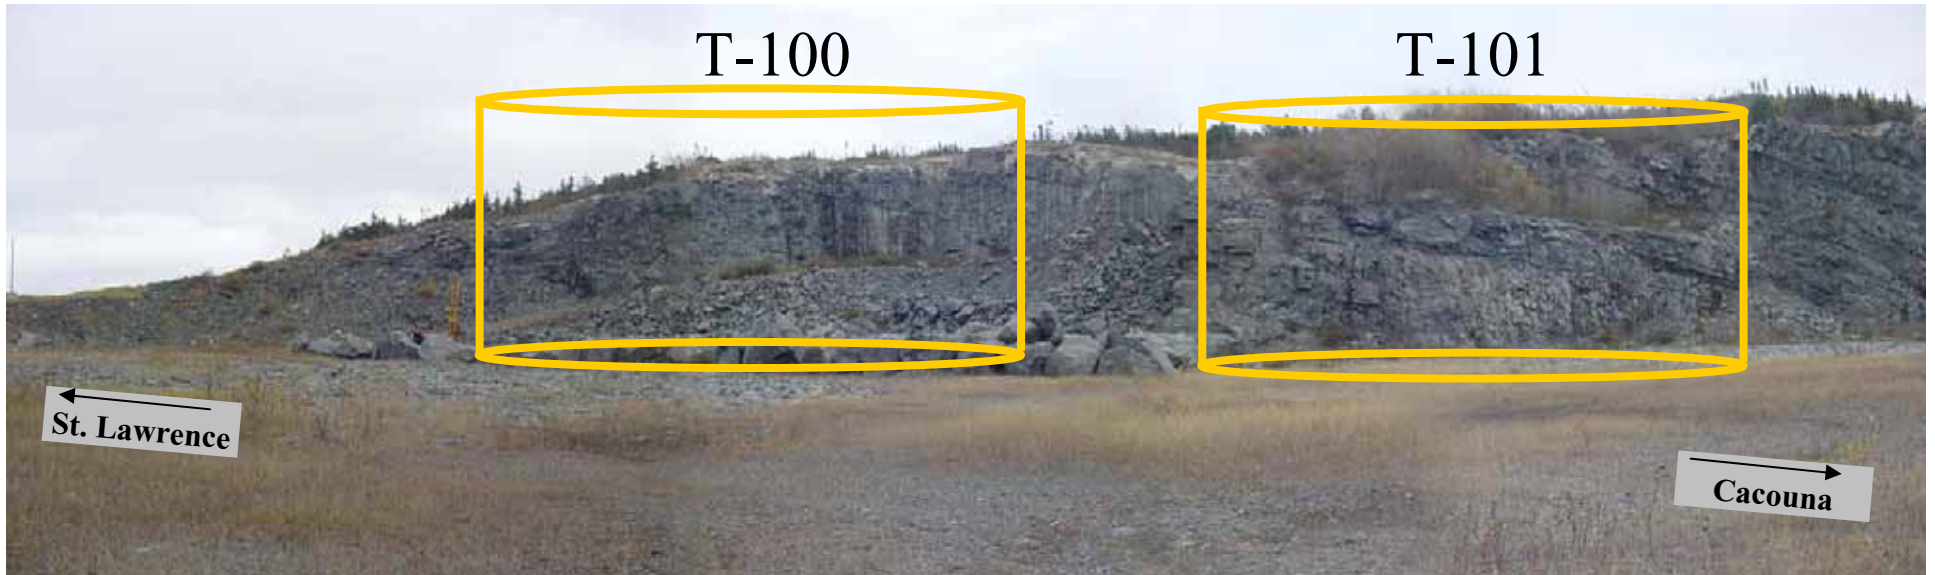
Photo 3. View of cliff face crossing tank T-100. Note rock layer formations sloping (dipping) at low angle of 12 degrees towards the south. These massive sandstone beds are the most prominent rock type in the area and will provide a solid foundation for the tanks.

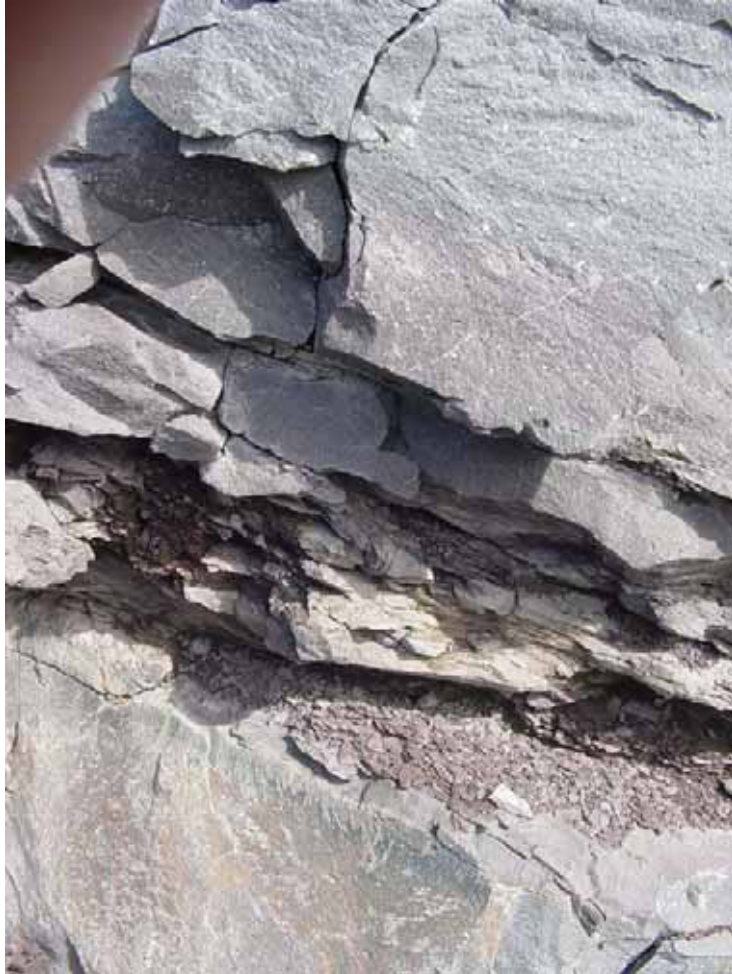
Photo 4. Green grey flaggy (thin layered) sandstone found on cliff face south of the tank locations. May be the same type of source material for ground up silt and sand found in borehole BH-2.

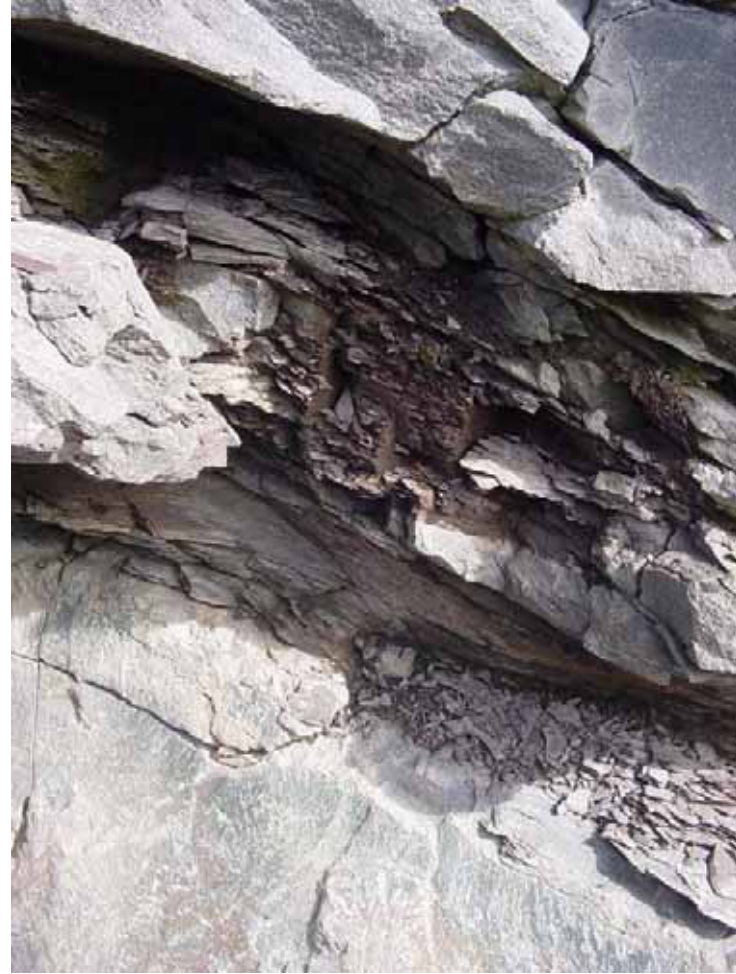
Photo 5. Brown fissile (very thin layered) sandstone. May be the same type of source material for the brown seam found near the surface in borehole BH-3.

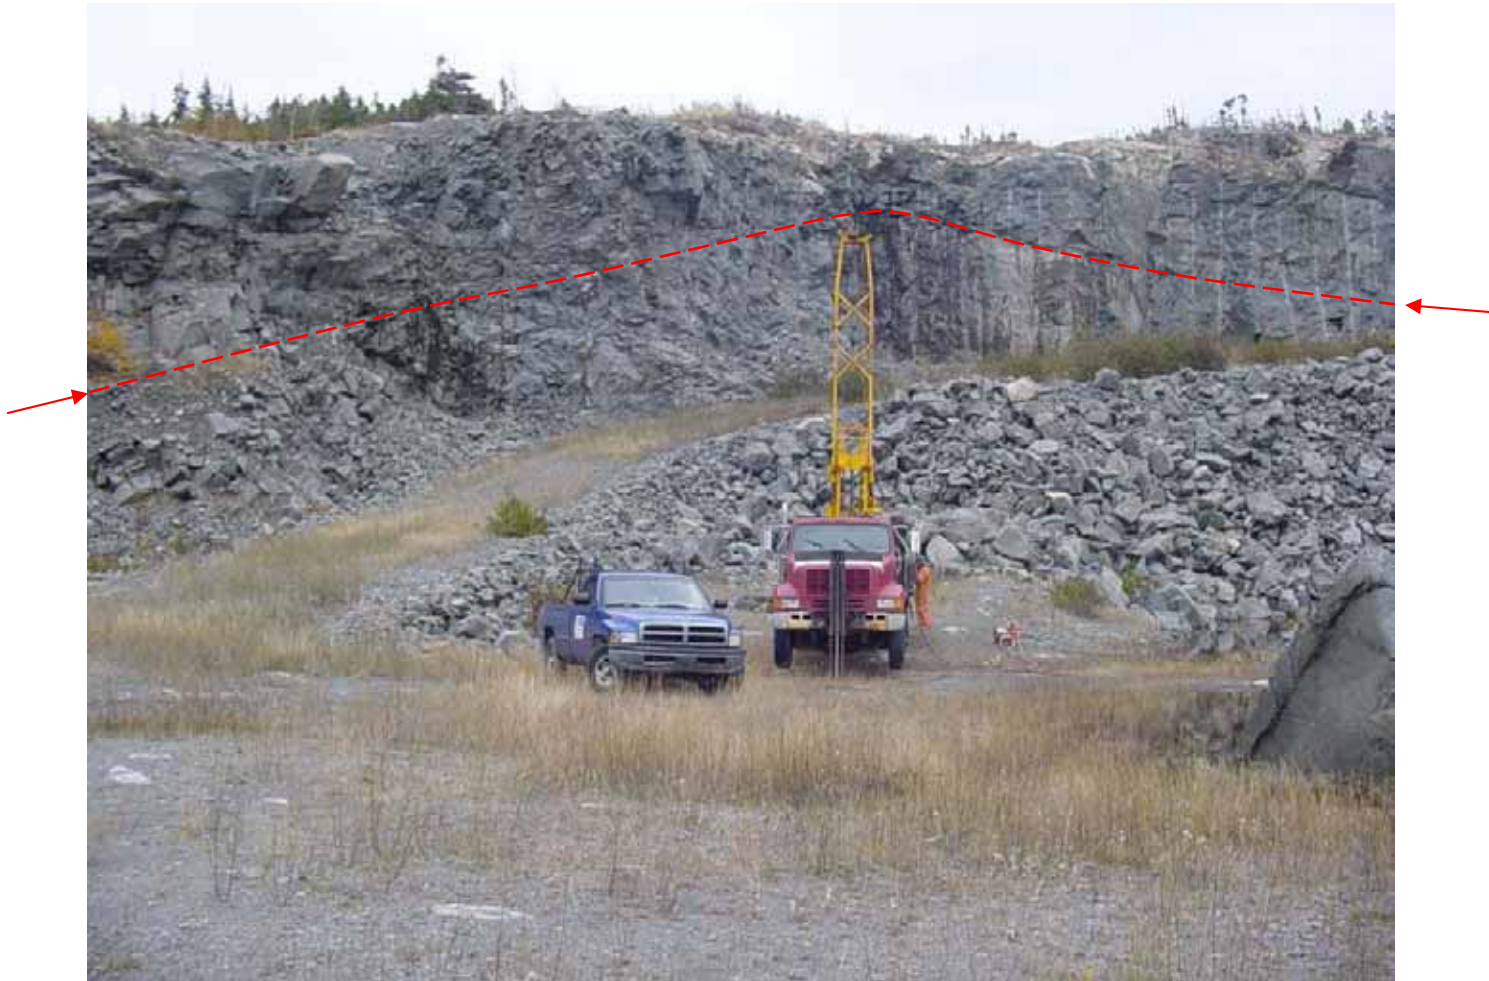
Photo 6. Rock face east of borehole BH-1 (near tank T-100). Note: No vertical offset of shale beds.

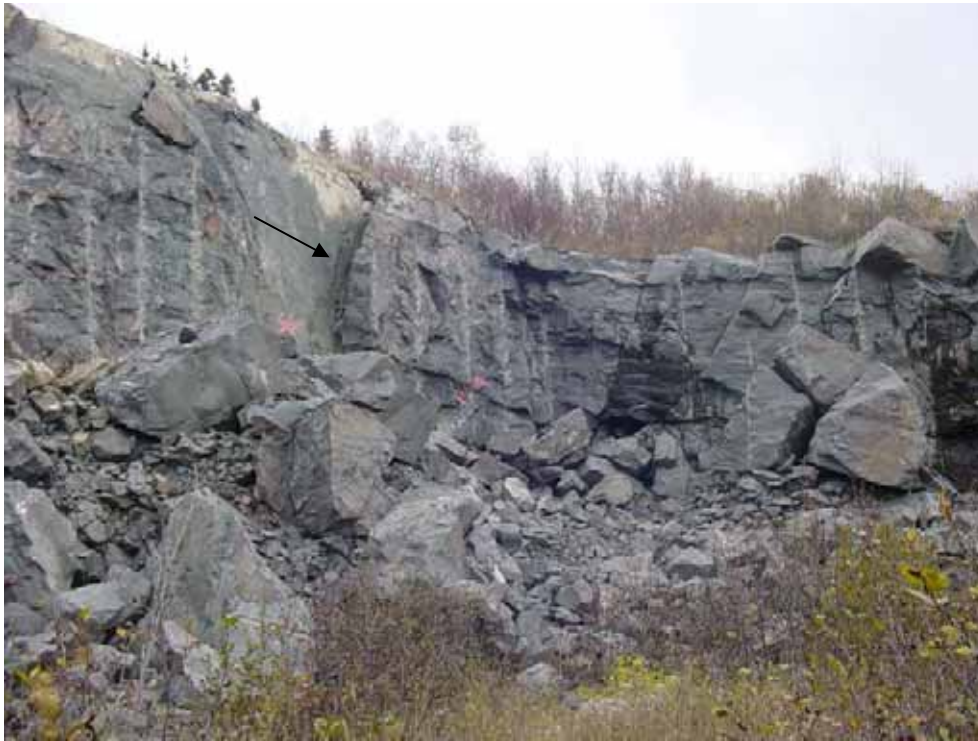
Photo 7. Area view of a sub-vertical fracture (photo looking south-east). The fracture plane separating the two massive sandstone beds continues through tank T-101.

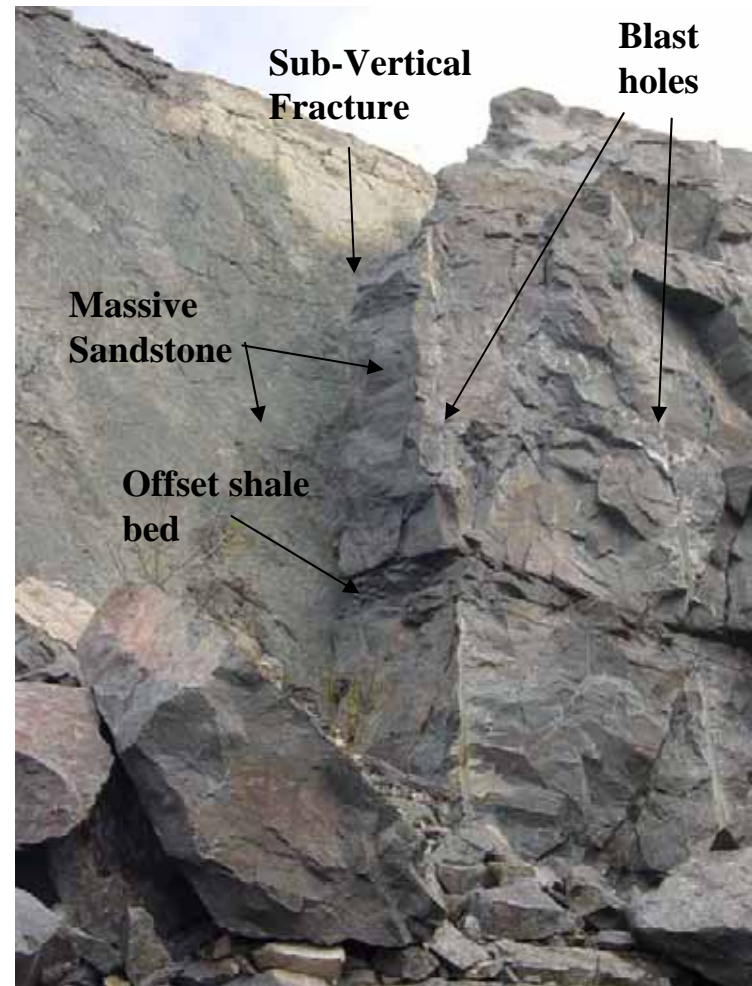
Photo 8. Close-up of sub-vertical fracture.

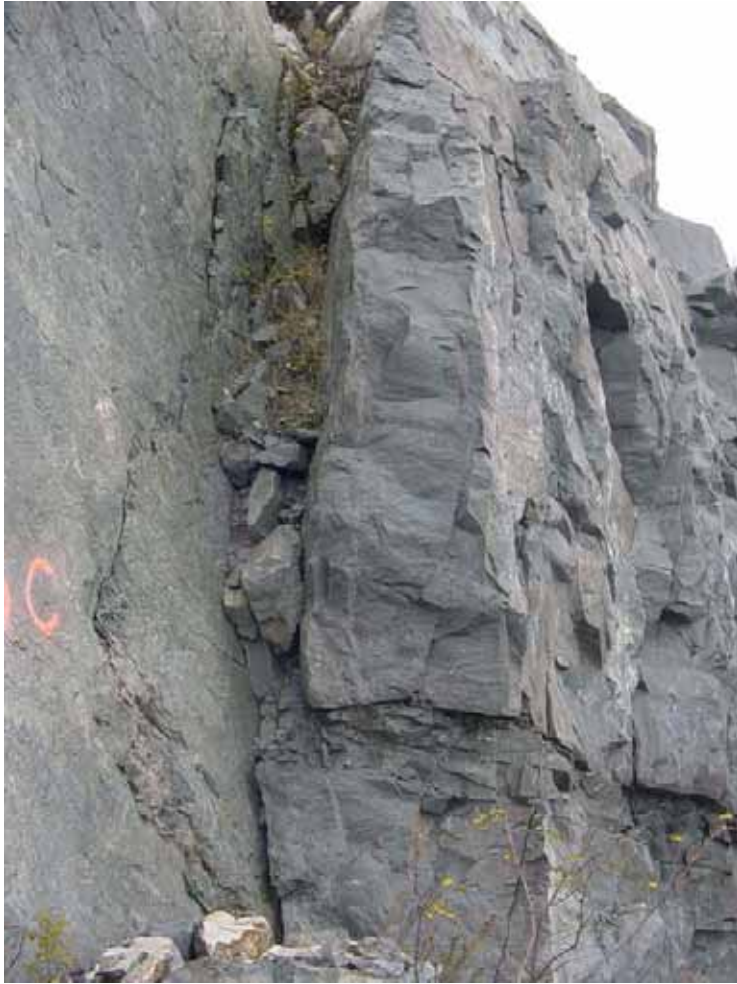
Photo 9. Close-up south cliff face of quarry. Note: sub-vertical fracture (looking south along east cliff face).

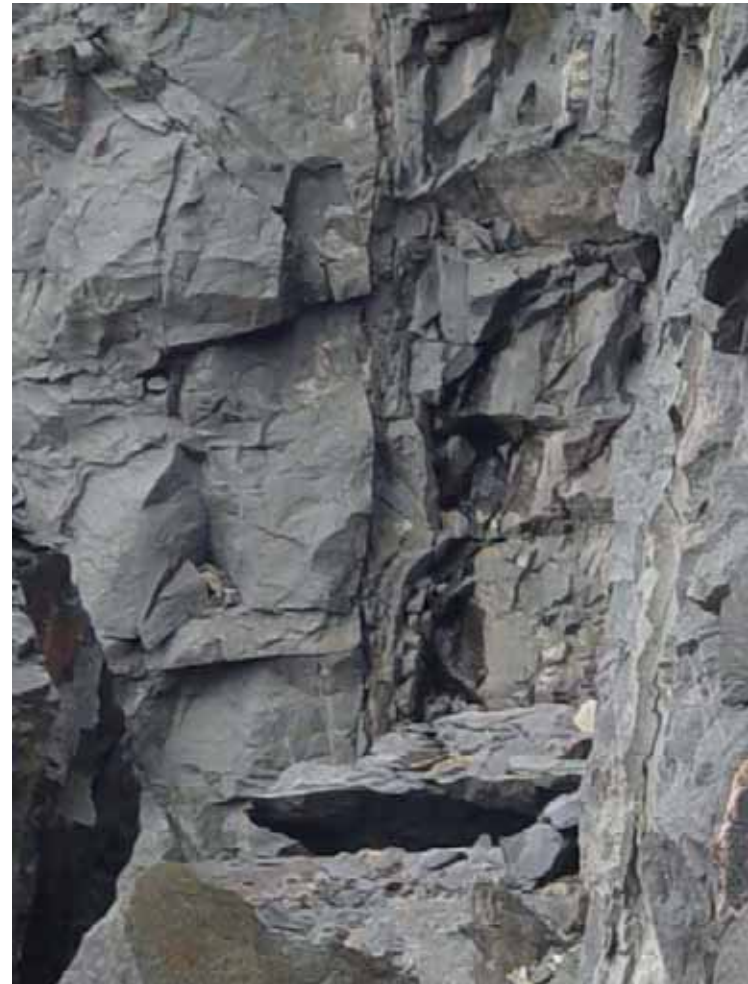
Photo 10. Opposite face of quarry (looking north towards future tank T-101). No visible faulting or movement observed.

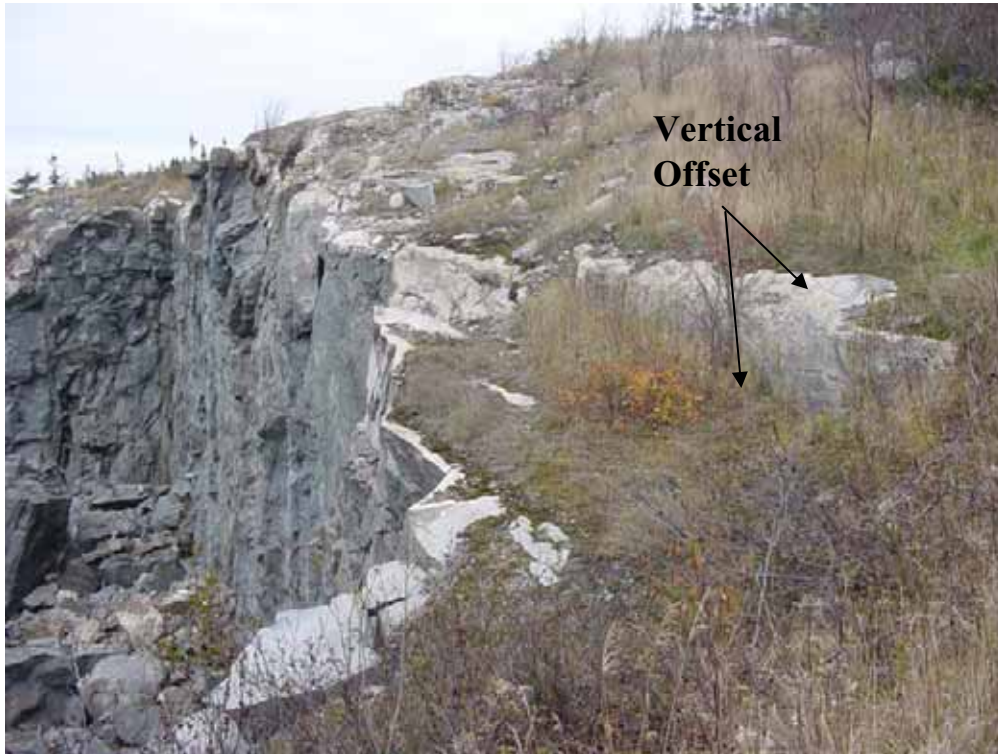
Photo 11. View from top of near vertical fracture looking to opposite (north side) of quarry towards future tank T-101 location. Note vertical offset in rock along fissure. No evidence of current fault movement was observed on the exposed rock face indicating that old faults near the tanks will not cause foundation problems.

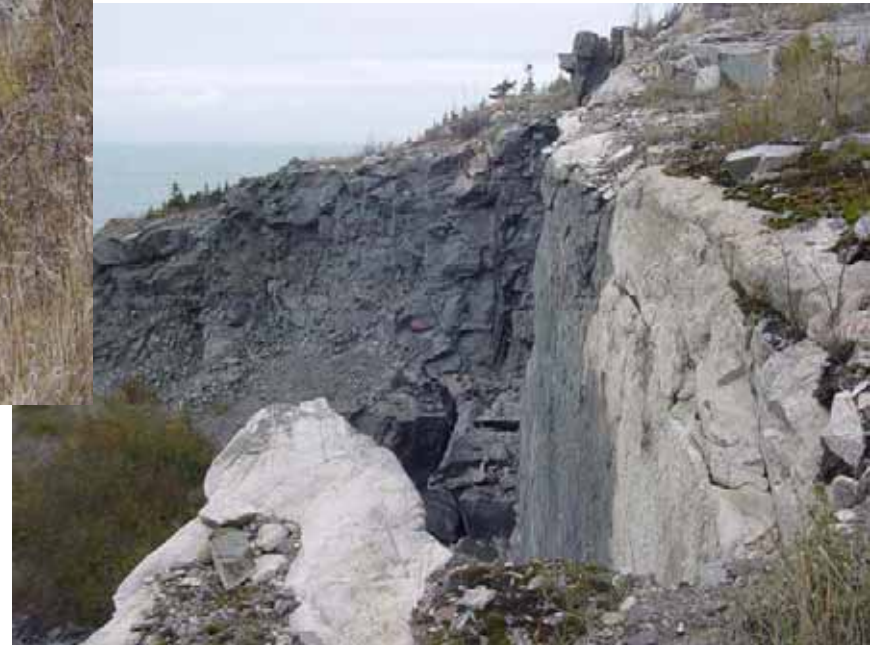
Photo 12. Close-up of rock face from top of near vertical fracture.

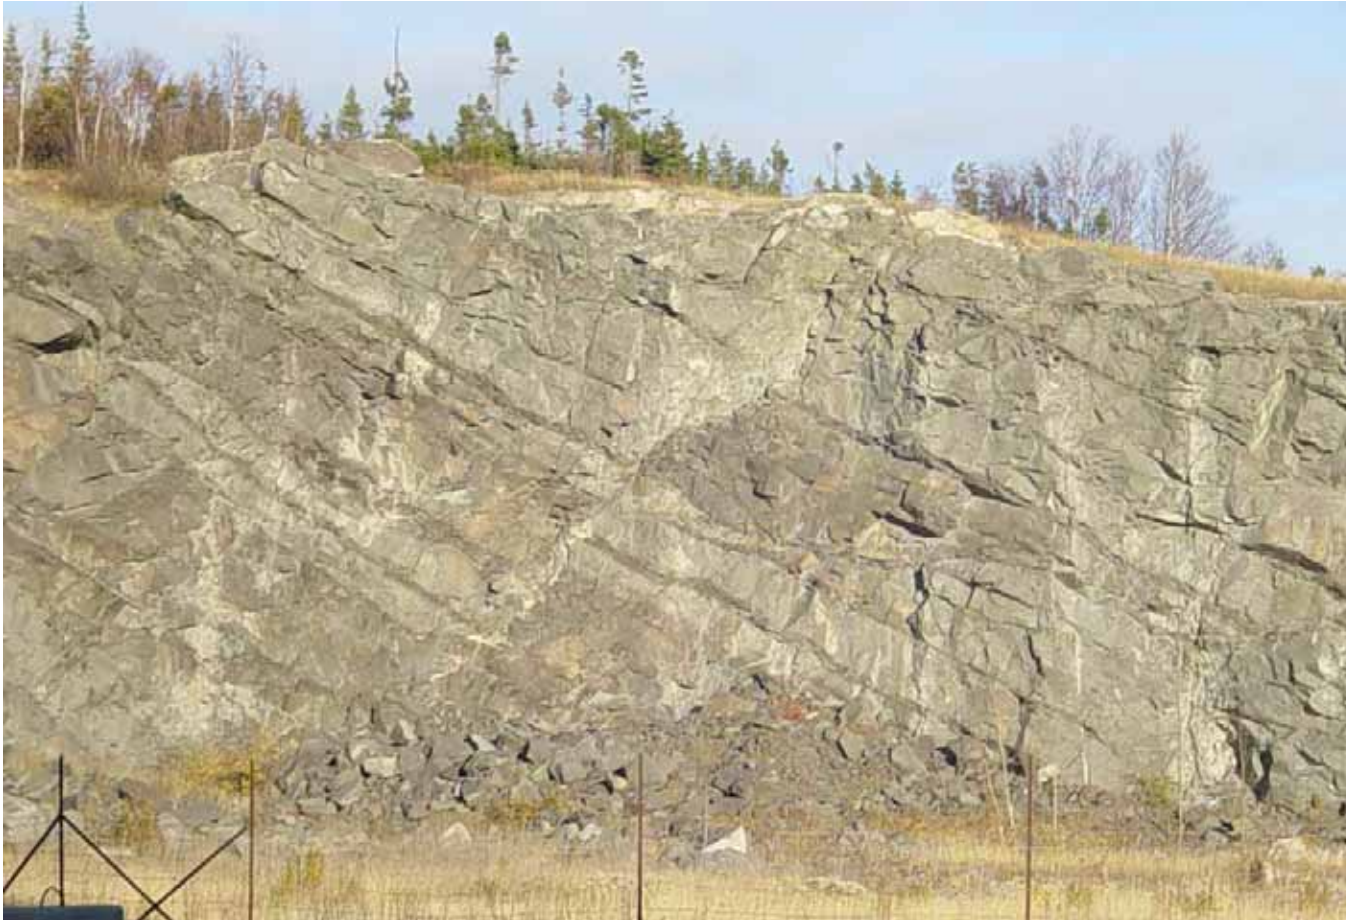
Photo 13. Clearly defined fault, with approximately 2.5m of vertical offset, south of future tank site (south west of cement silos). No indication of recent movement on fault plane. Fault plane passes approximately 200m east of and slopes away from future tanks and does not effect the tank foundations.

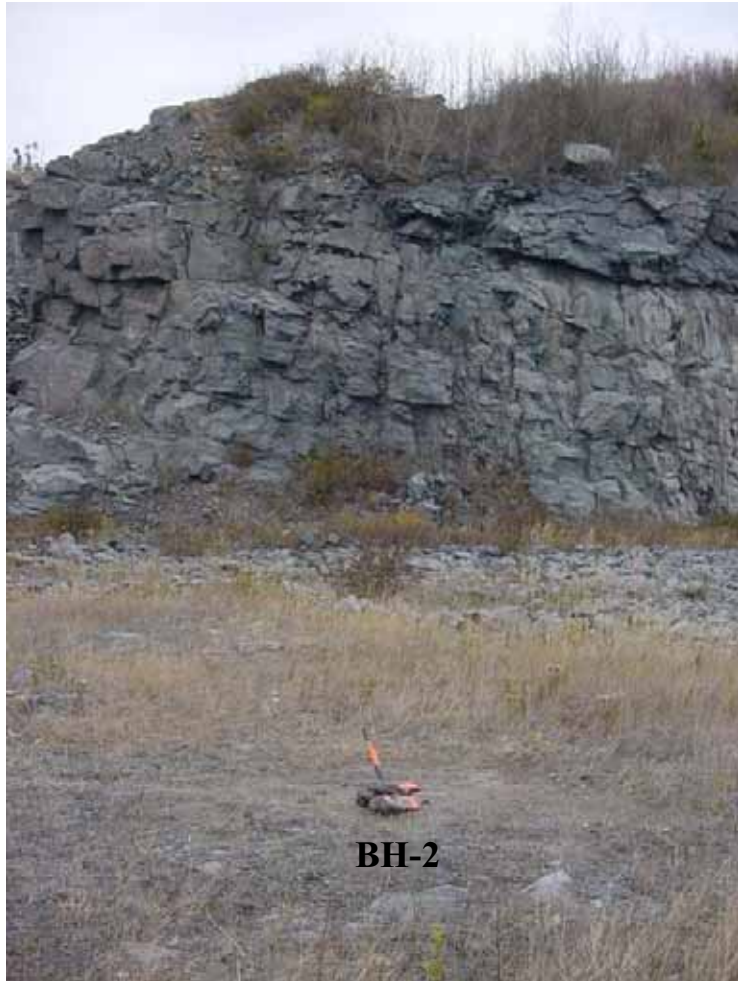
Photo 14. Solid grey sandstone showing stratification and southward 12 degree slope of rock beds.

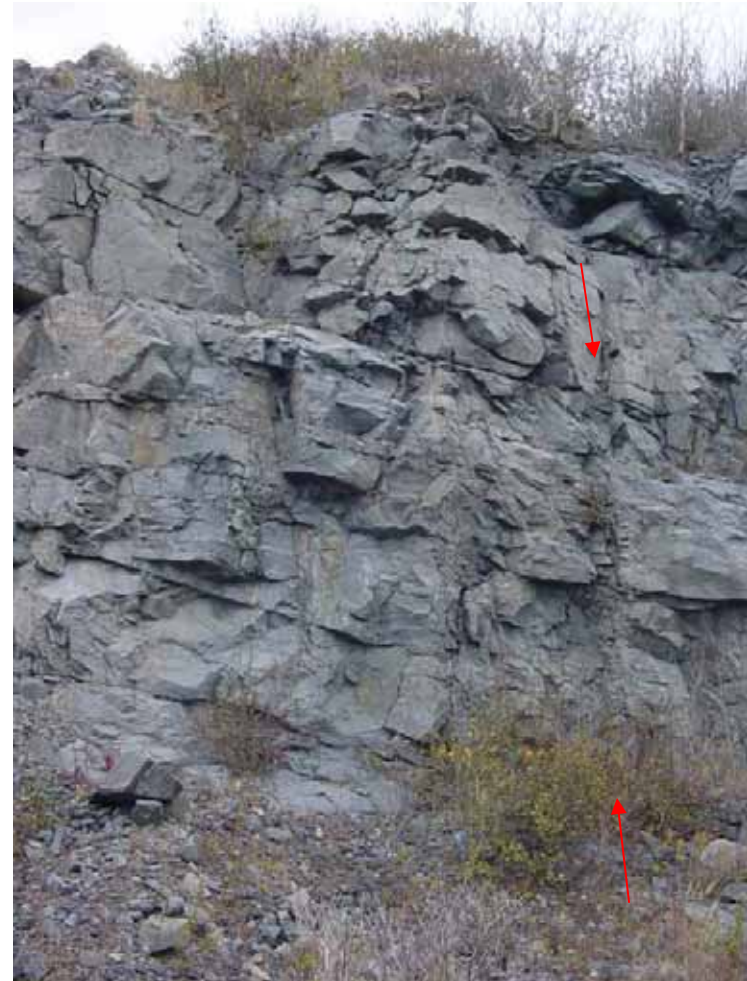
Photo 15. Close-up of formation showing jointing along bedding planes and running near perpendicular to beds. No vertical offset was observed indicating rock near tank T-101 is stable.

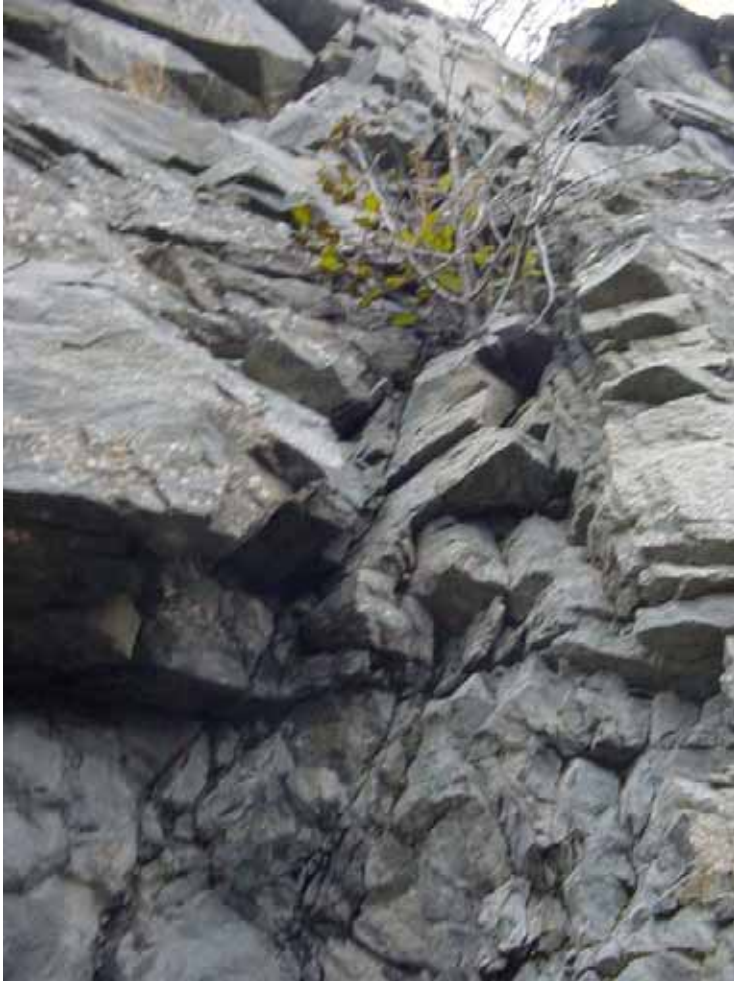
Photo 16. Close up of tight vertical jointing passing through conglomerate and sandstone layers near BH-2 (Tank T-101). Note: no vertical displacement indicating rock has not been subject to fault movement.

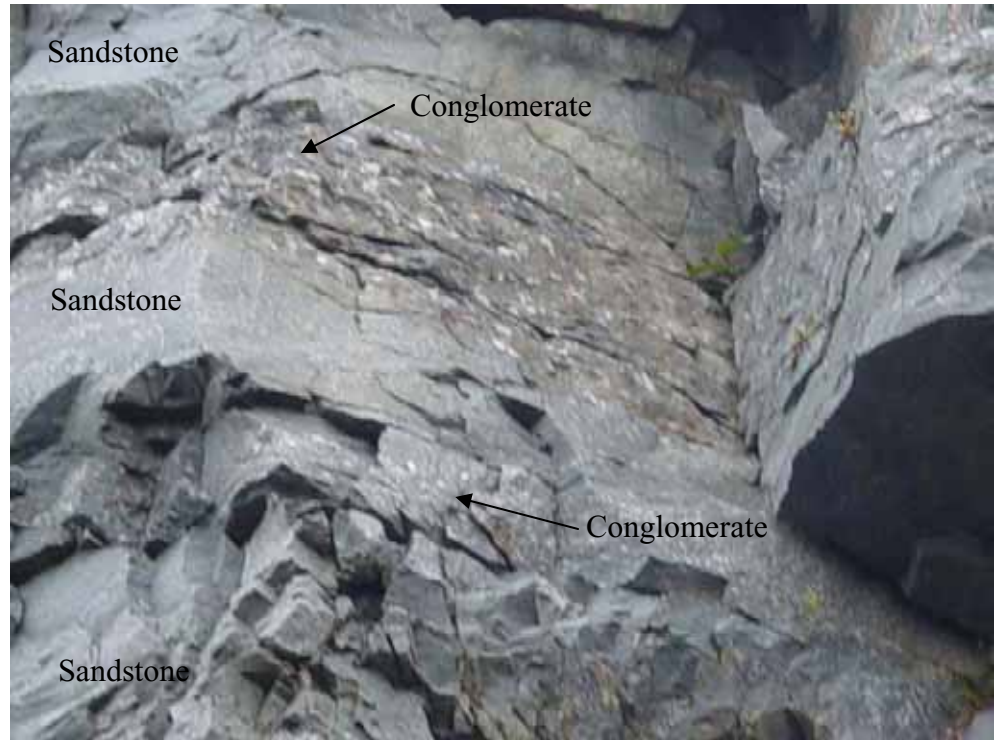
Photo 17. Formation grading from sandstone to conglomerate, returning to sandstone and then grading back into a thinner conglomerate layer. Rock is of the same massive rock type and solid quality for foundations as observed in boreholes BH-2 and BH-3.

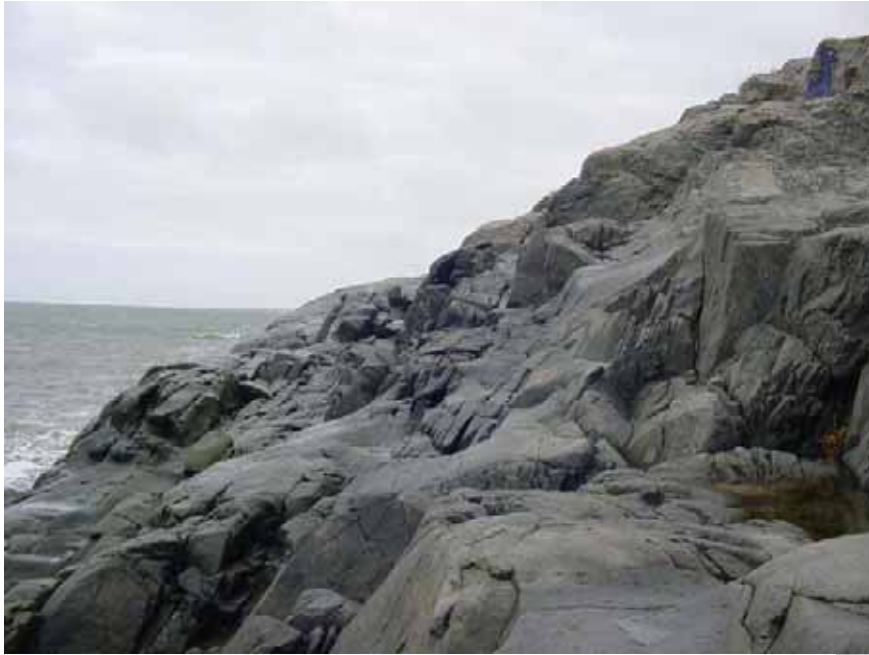
Photo 18. Looking east. Vertical and sub-vertical jointing striking parallel and perpendicular to shoreline. No low dipping beds or seams were observed on the upper portion of the beach above the high tide line that may interfere with the foundation further to the south.

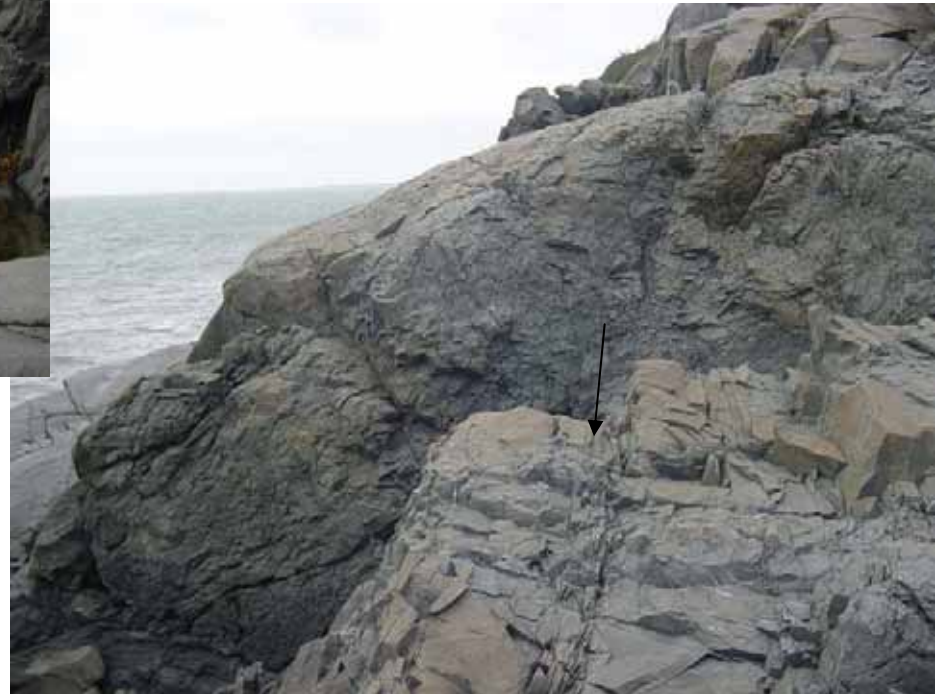
Photo 19. Close of of sub-vertical shaly sandstone running parallel to the shoreline. This feature is commonly associated with folded/highly deformed/faulted rocks. This feature was not observed near the proposed tanks.

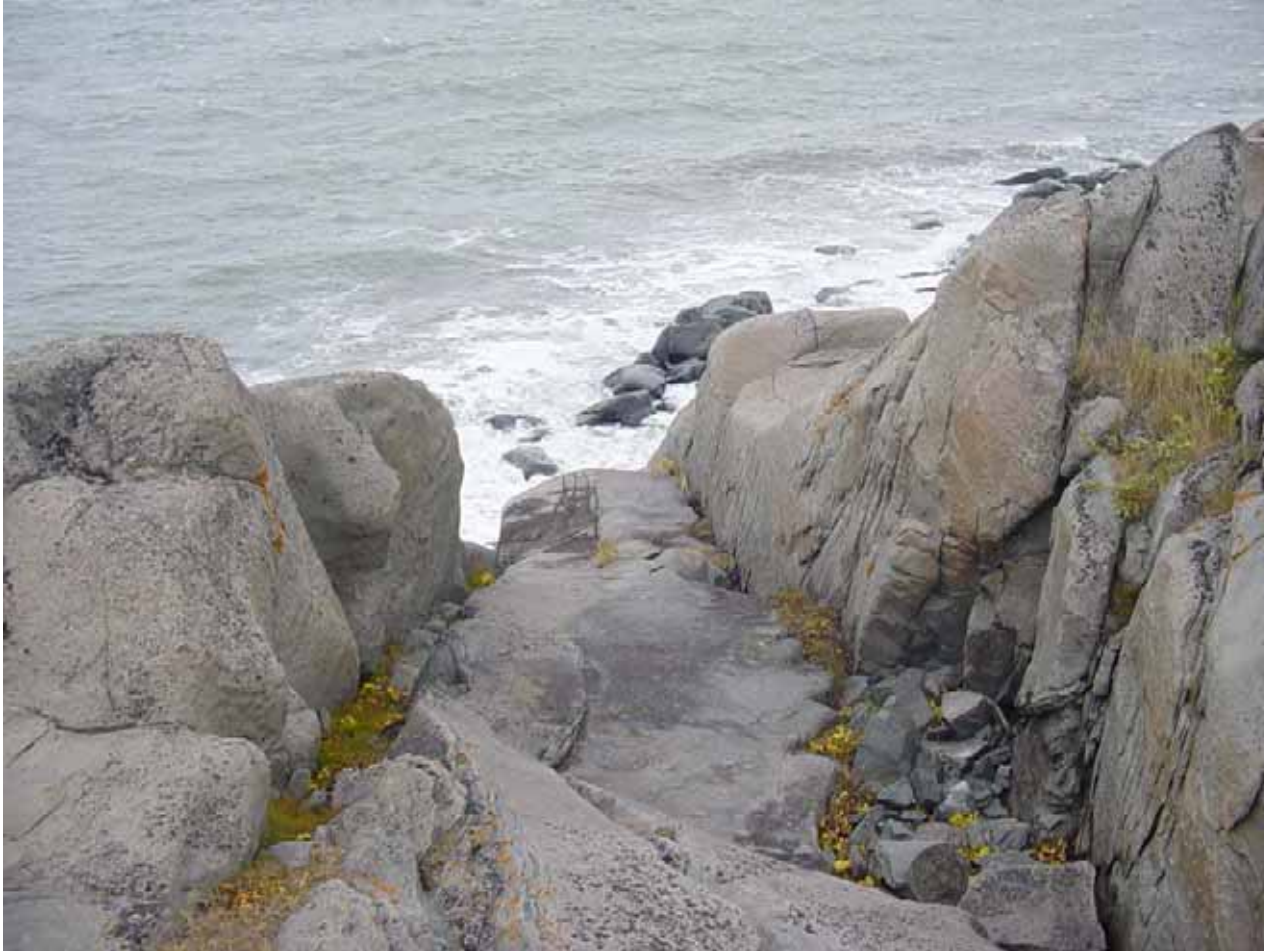
Photo 20. Near vertical series of joint planes orientated NE-SW. Note vertical grooves in northern rock face (right). Features are likely caused by wave erosion but the underground extension of feature should be observed during future works or excavations to confirm that it does not effect the foundation for tank 2-future.
