**APPENDIX 3B**

**CLOSE-UPS OF ROCKCORES**

# Phase 3 – Cacouna Energy, Gros Cacouna, Quebec

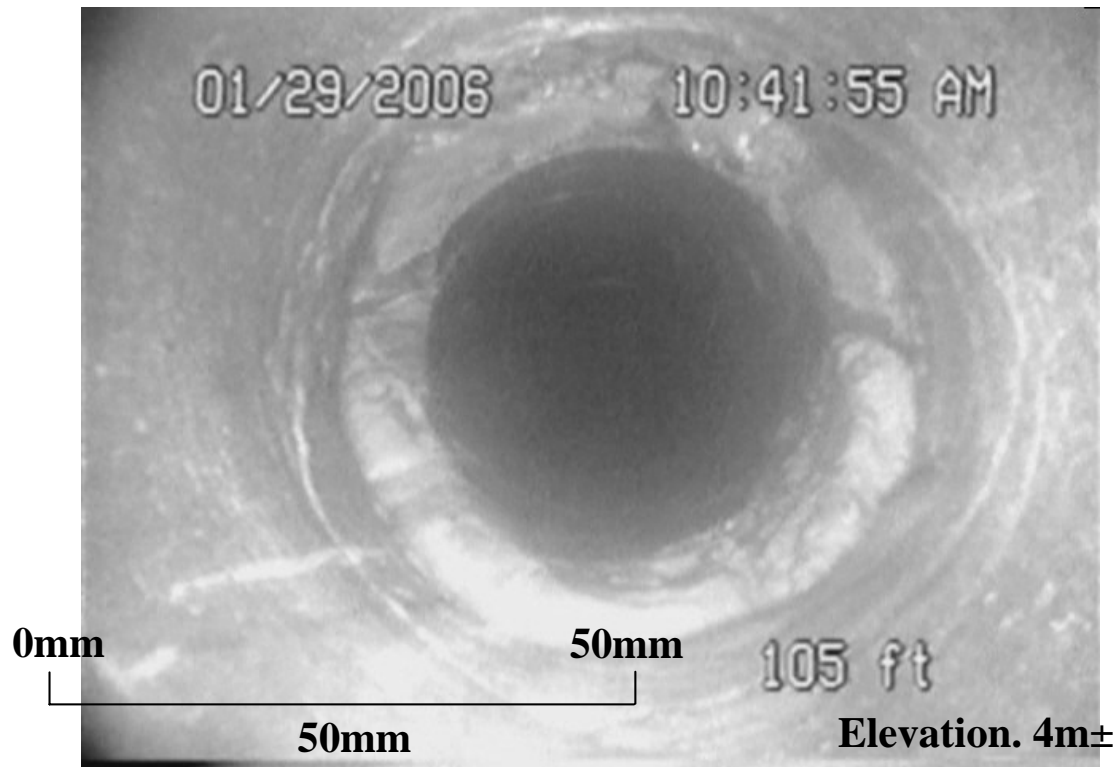
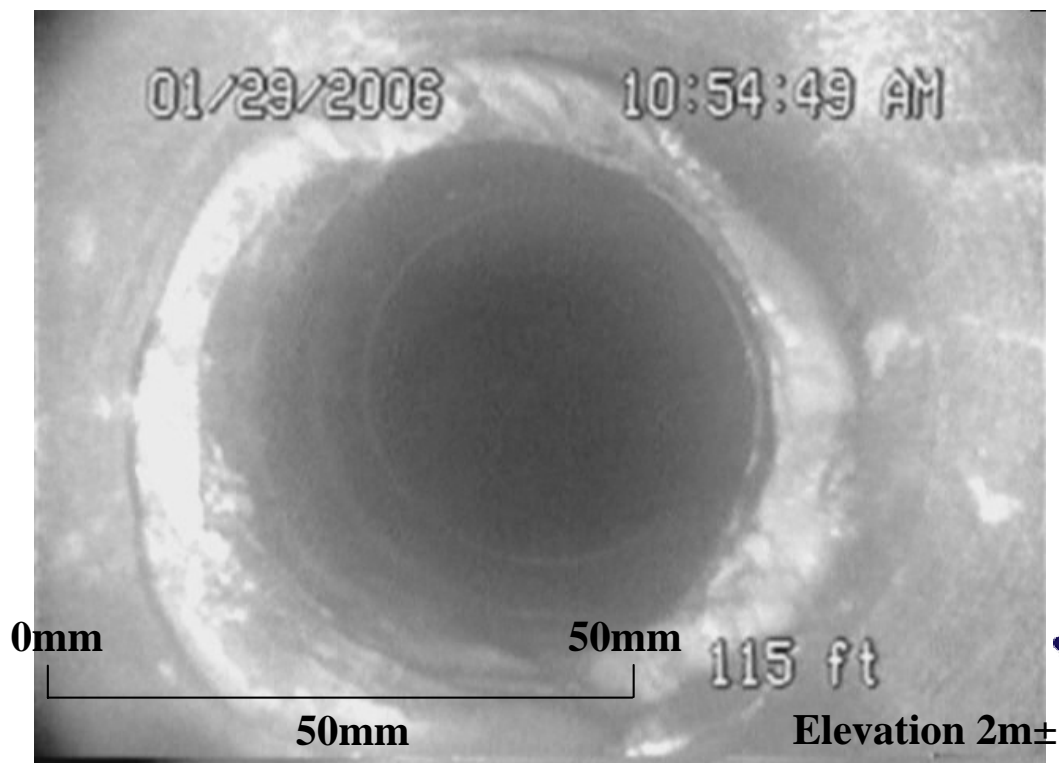
## BH-4

Photo 1. Down hole camera shot of borehole BH-4. Note the small 5mm fractures at approximate elevations 4m and 2m. These elevations correspond to changes in rock type and the fractures are the normal result of the small separation or movements between the beds caused by the slow folding that is known to have occurred in this region.

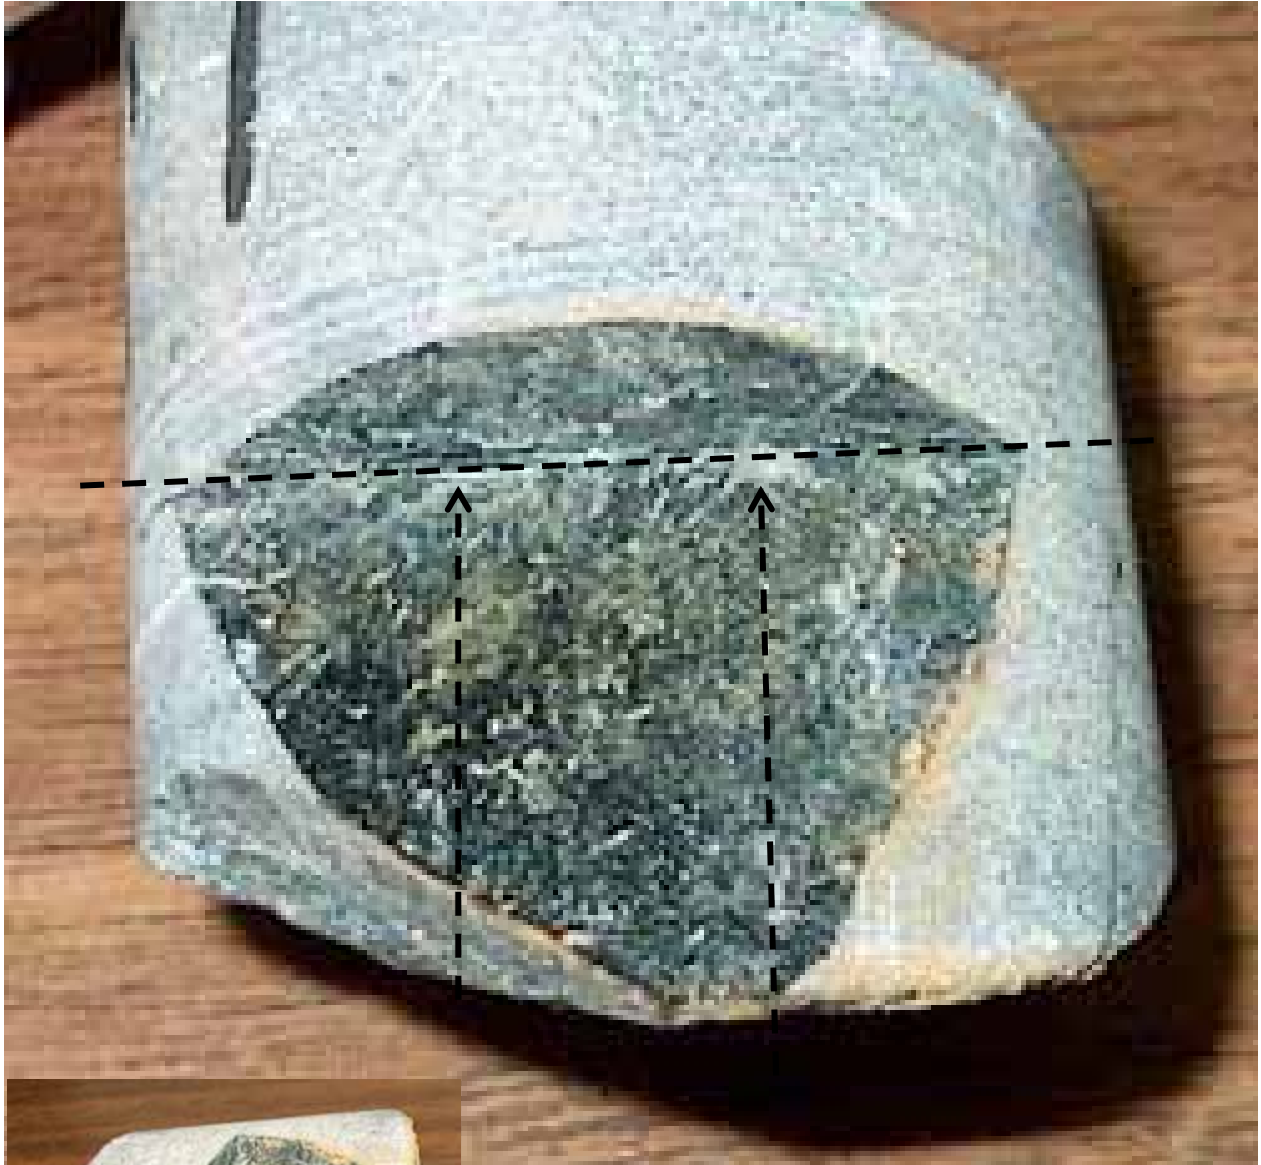
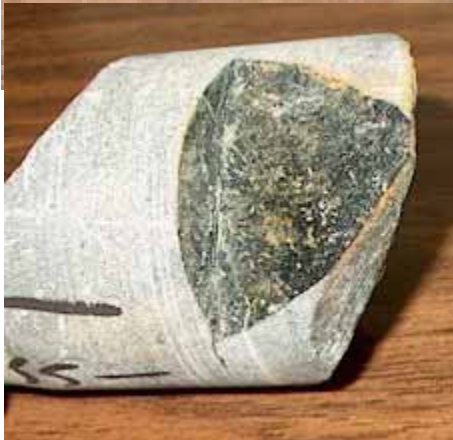
BH-4 : 31.7 m

Photo 2. Close up of core from borehole BH-4. Slickensides (polished surface with striations) are truncated at the horizontal section of thin fracture in the core indicating these features are a result of small adjustments of the rock over time. These observations, along with the lack of fault gouge in the core show that the large fracture in the area does not pass below tank T-100.

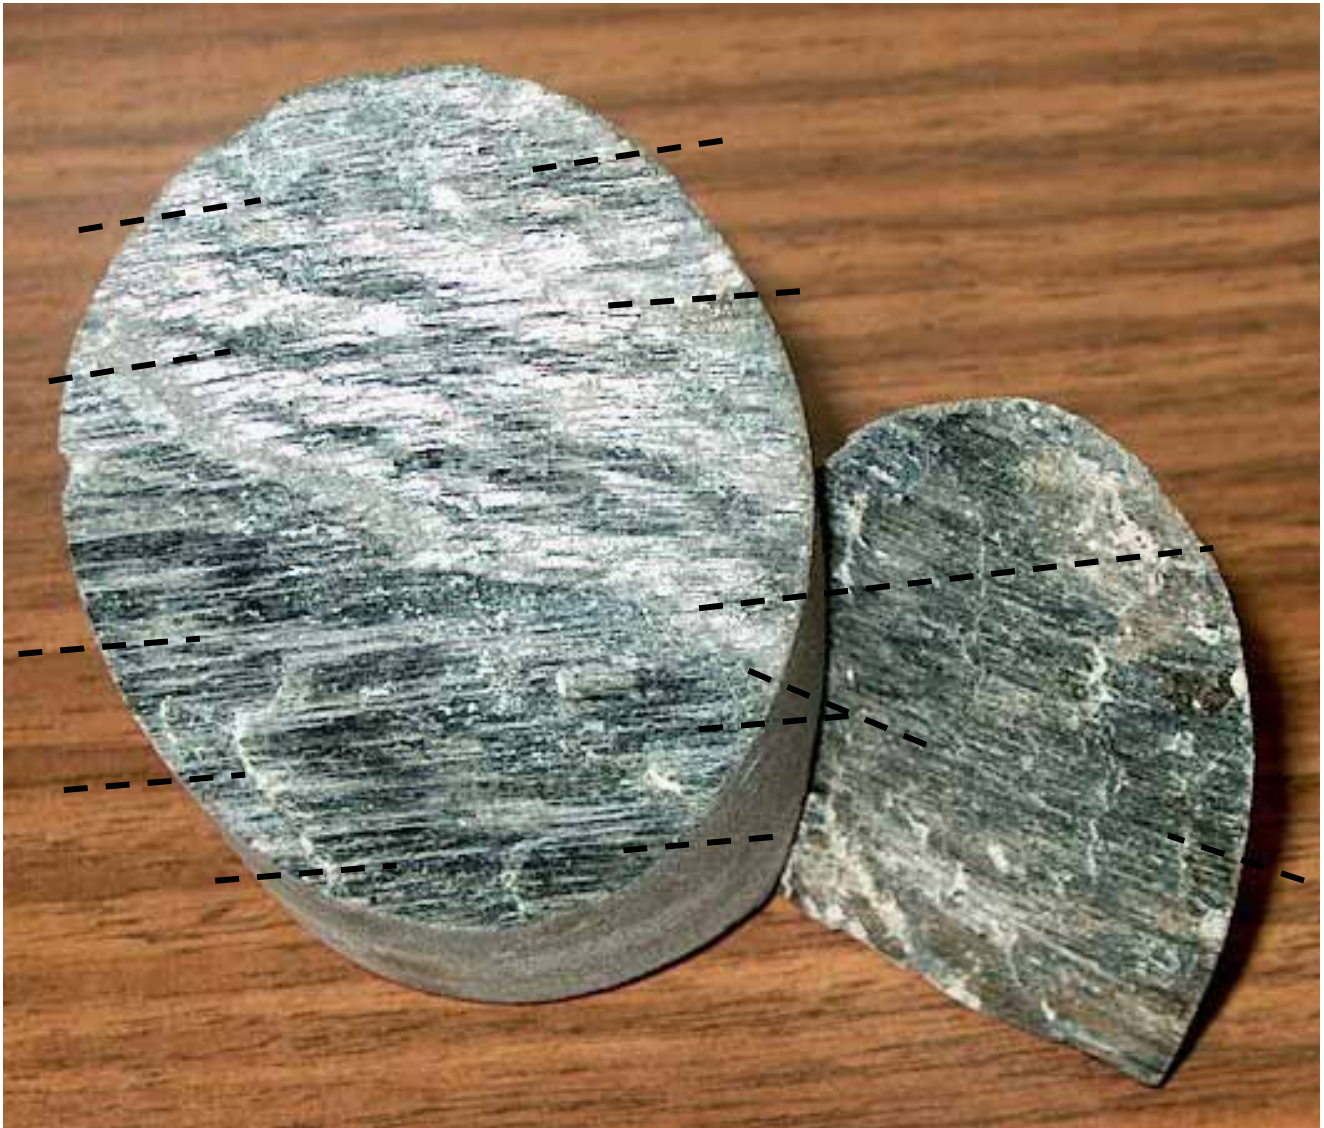
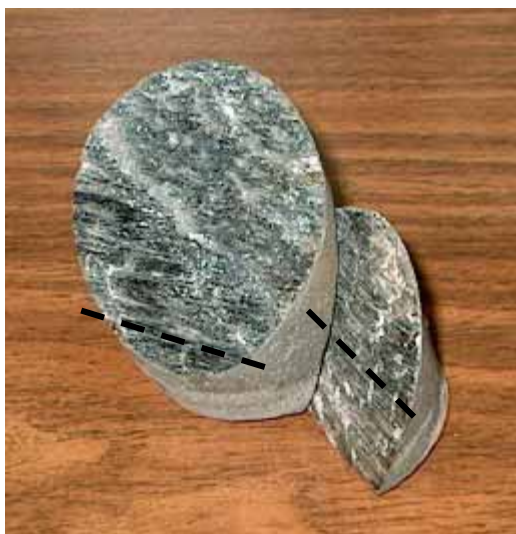
BH-7 : 4.0 m

Photo 2. Close up of core from borehole BH-7 (below Tank T-101) showing well defined polished surface and striations (slickensides). Note the multiple orientations of the striations that suggest movements are due to small adjustments of the rock as a result of the general folding events in the geological history of the region. The presence of these features below tank T-101 where geophysics have shown a lack of large fractures indicates that they are ubiquitous in the regions and not a result of single large faults.
