**VEGETATION ON EMBANKMENT DAMS
A GROWING CONCERN FOR HYDRO-QUÉBEC**

Richard Gervais, ing., M. Sc. A., Hydro-Québec, Sécurité des barrages, Montréal, Québec, Canada
François Gauthier, ing. f., M. Sc., Hydro-Québec, TransÉnergie, Montréal, Québec, Canada
Nadine Adm, B.Sc., LL.L., LL.B., Hydro-Québec, Environnement, Montréal, Québec, Canada
Jean-Philippe Gilbert, B.Sc., Hydro-Québec, Environnement, Montréal, Québec, Canada

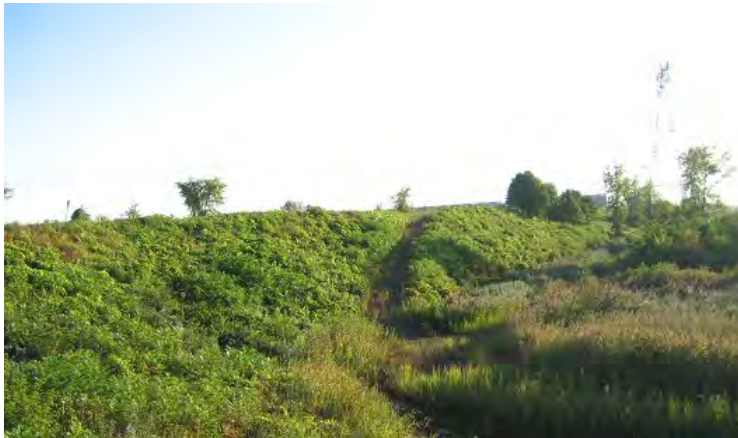
Figure 2: Downstream slope before vegetation control

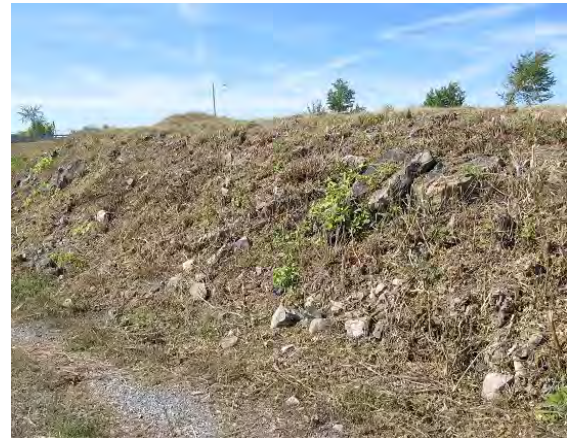
Figure 3: Slope after vegetation control

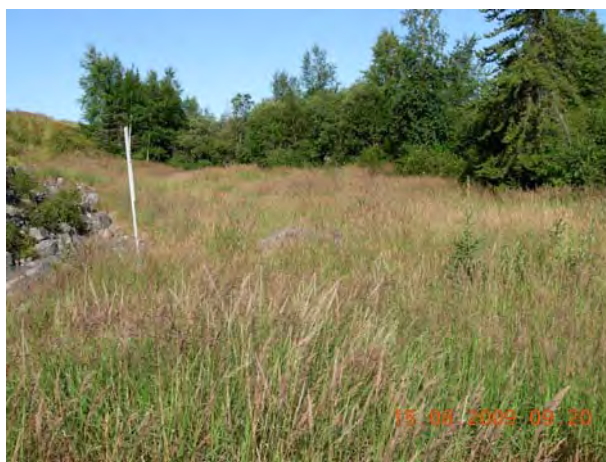
In 2006 and 2007, Garlon 4 (Triclopyr) was used at LG-2 and LG-3. After chemical treatment, herbaceous plants invaded the cleared areas as can be seen in Figure 8. At the left of the photograph, the nearly vertical line is a distance marker seen sideways. It is more than 2 m tall, and it is more than halfway submerged in tall grasses. In 2008, VisionMax (Glyphosate) was used at LG-2, but vegetation growth was intense the next year. In 2009, VisionMax (Glyphosate) and Arsenal (Imazapyr) were used, and results are to be assessed in 2010.

Figure 8: Downstream toe area after vegetation control

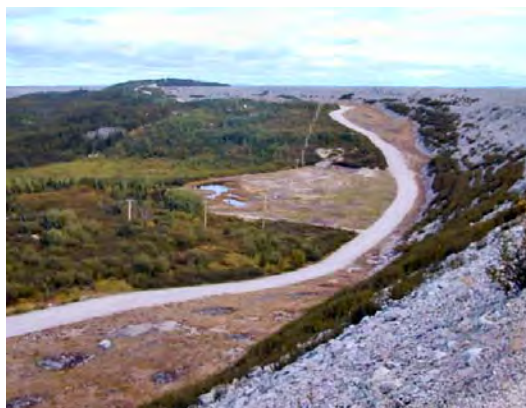
Figure 9: Selective vegetation limitation

Figure 9 shows the appearance of a dam after the application of the selective vegetation limitation. It can be seen that shrubs are encroaching on the downstream slope beyond the 5 m cleared area, in spite of the ground being constituted only of rockfill with no organic soil. Even with the slow growth associated with a Northern climate, this 31-year old dam shows invasive vegetation from alders. Such an artificial mass built by man will eventually look like the nearby hills, visible at the left of the photograph, with mature birch, aspen, and spruce. It is fairly obvious that dam inspection is hindered to a certain degree by invasive vegetative cover.

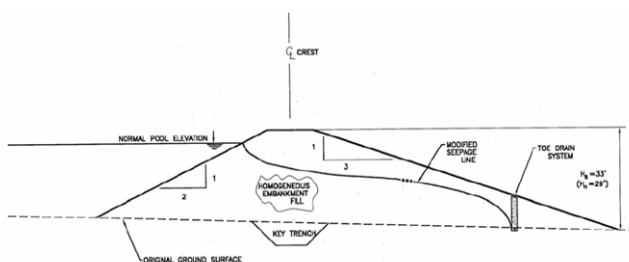
Figure 10: Homogeneous section with toe drain

Figure 10 shows an homogeneous cross section that has vertical drainage at the toe. If ever this drain fails to work, the phreatic surface will raise up to the downstream surface like shown on Figure 11. This could lead to potential instability for the dam. If vegetation is permitted to colonize the downstream slope and the downstream toe area, it becomes quite impossible to assess with confidence the efficiency of the drainage and the stability of the dam.

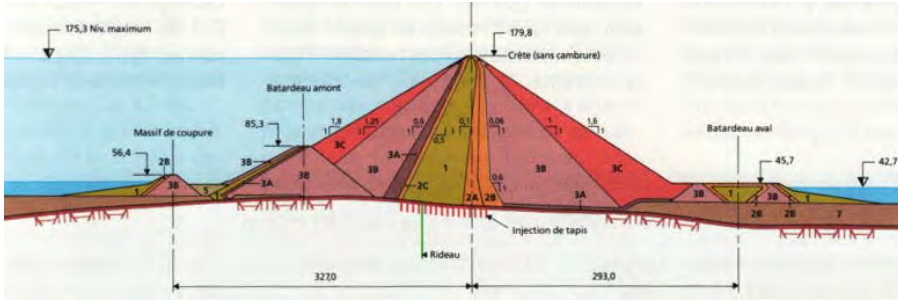
Figure 12 shows a slightly inclined central core with rockfill shells. From a theoretical point of view, no seepage water can exit on the downstream slope. However, the ongoing vegetation colonization shown on Figure 13 is impeding visual observation. While not an engineering problem like the homogeneous case presented in the previous paragraph, it could eventually become an ethical problem for the engineer in charge. Cracks and deformations might become impossible to observe.

Figure 12: Rockfill cross section

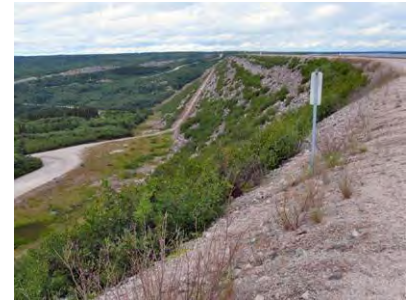
Figure 13: Downstream slope

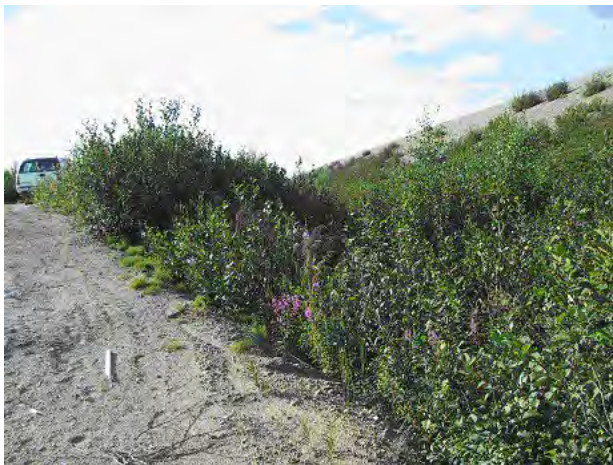
Another issue to consider is worker safety. When people are expected to perform inspection in situations shown on Figures 14 and 15, it is obvious that great care must be taken in order not to trip on obstacles or to fall in a depression or a ditch. Sending people in such work conditions provides poor inspection quality, and might lead to serious worker injury. Past cases of refusal to perform inspections have been documented.

Figure 14: Downstream slope and toe area

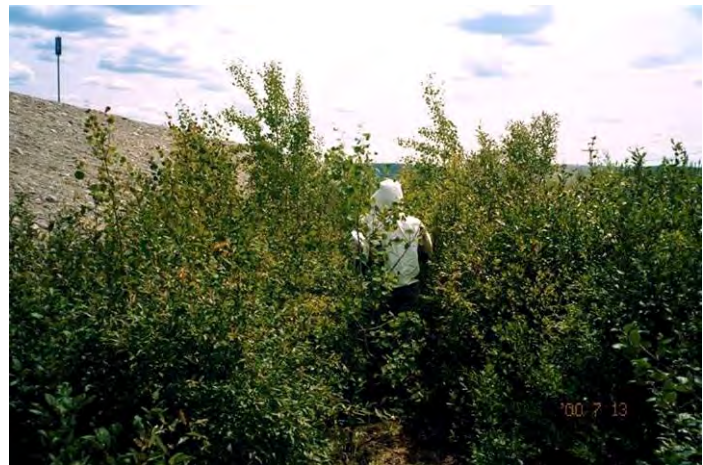
Figure 15: Downstream toe area

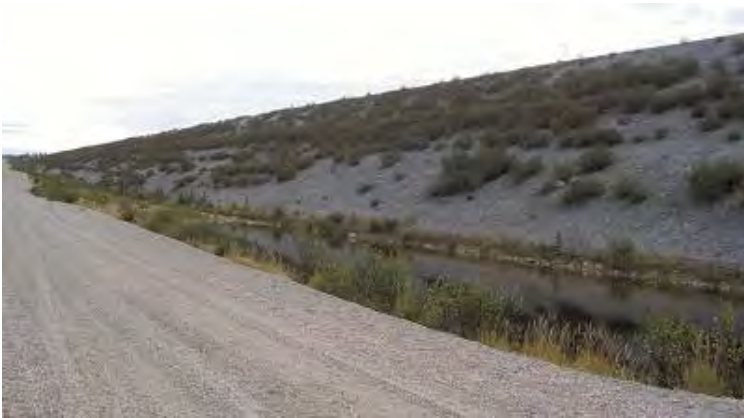
Figure 16: Downstream slope of a 30-year old embankment

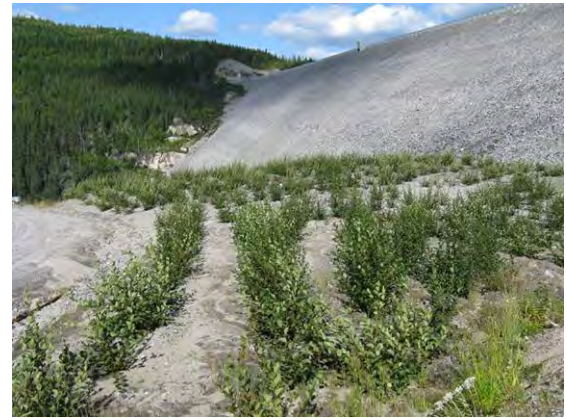
The practice of using alders continues to this day since it is very successful from a vegetation point of view. Figure 17 shows post-construction site naturalization. In the background, the downstream slope of the concrete faced dam is made of fine rockfill that is sloped at 38 degrees up to a 76 m height. The

picture was taken three years after dam construction, but it can be predicted that alders will likely try to colonize the vacant space in the future. Considering the type of dam shell and the very steep inclination of the downstream slope, vegetation control will soon be quite a challenge at this location.

Figure 17: Alder plantation near a new dam

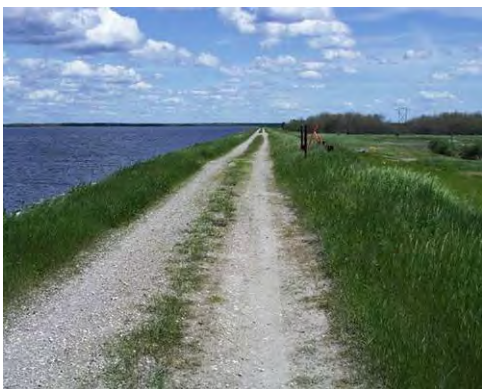
Figure 19: Crest of the embankment

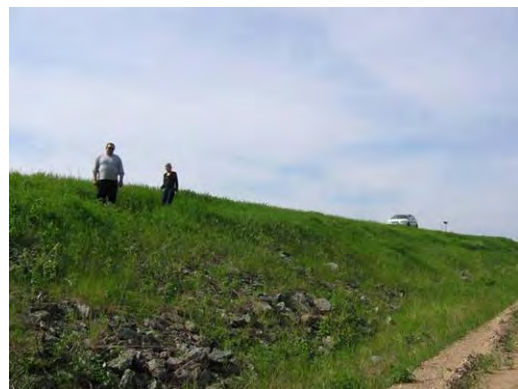
Figure 20 Downstream slope of the embankment
