Projet minier aurifère Canadian Malartic

**Addendum  
au plan de restauration du  
site minier Est-Malartic**

**Février 1999**

ADDENDUM 1.0  
Plan de restauration – Division Est-Malartic

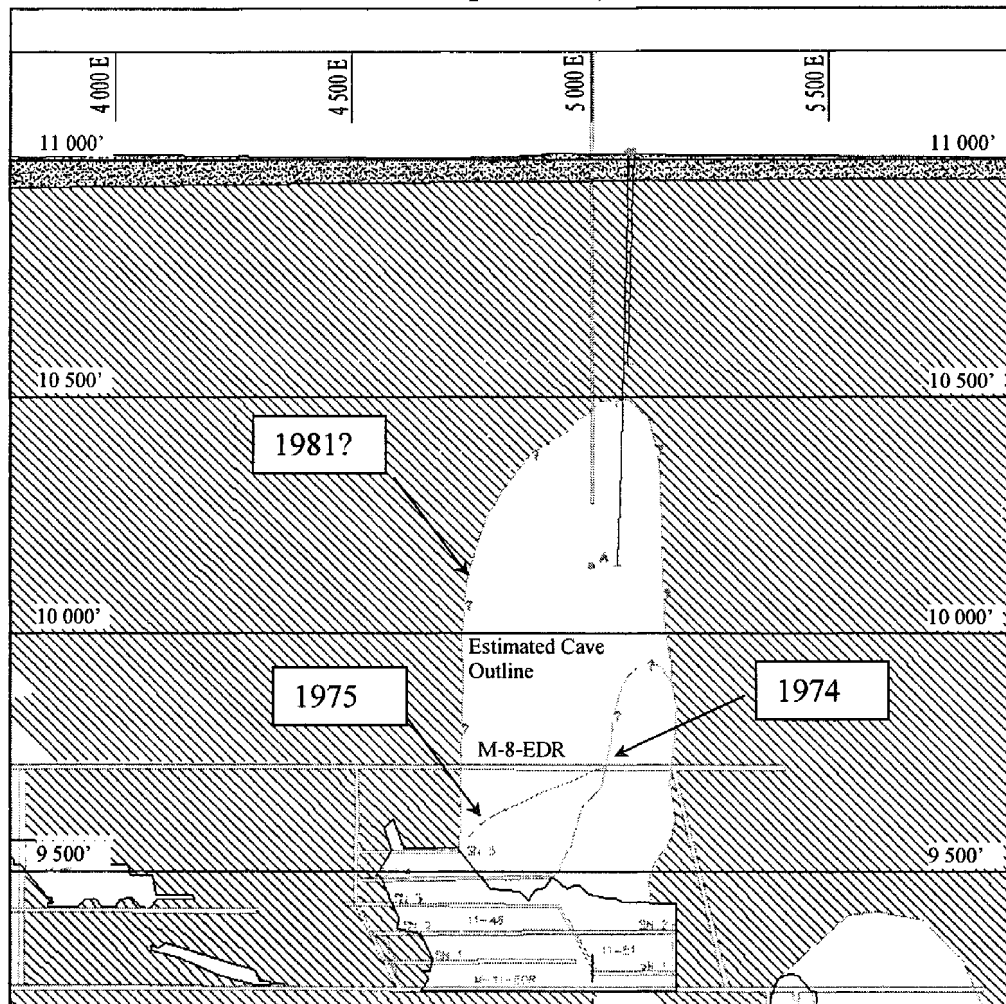
**Figure 3.1: 11-48 Limits in 1974 and “Estimated Cave Outline” Indicated in 1981 (after Geospex, 1997)**

In 1975, the cave on the M-8-EDR level had extended laterally by approximately 23 meters. It is important to note that no further caving on level M-8-EDR was recorded on any plan section. In

1981, a longitudinal section showing the 11-48 stope, the cave limit from 1974 and an “Estimated Cave Outline” was constructed by mine personnel. It will be shown later, that the estimated cave outline was not observed but was most likely an estimated choking limit for the stope. A choking limit represents the outline of the volume of rock which would be required to fill the stope to a stable state. It is noted that the lateral limit of the estimated cave outline was not indicated on the M-8-EDR plan section of 1981, suggesting that no caving of that magnitude was ever observed.

The conclusions from the field investigations and the historical review of drilling records suggest that the cave limit identified on the 1981 longitudinal section does not indicate a stope outline and by association, a crown pillar thickness which would represent an unstable system. The following section describes a more likely estimate of post-mining stope limits which will provide insight on how the "Estimated Cave Outline" limit drawn on the 1981 section was likely constructed.

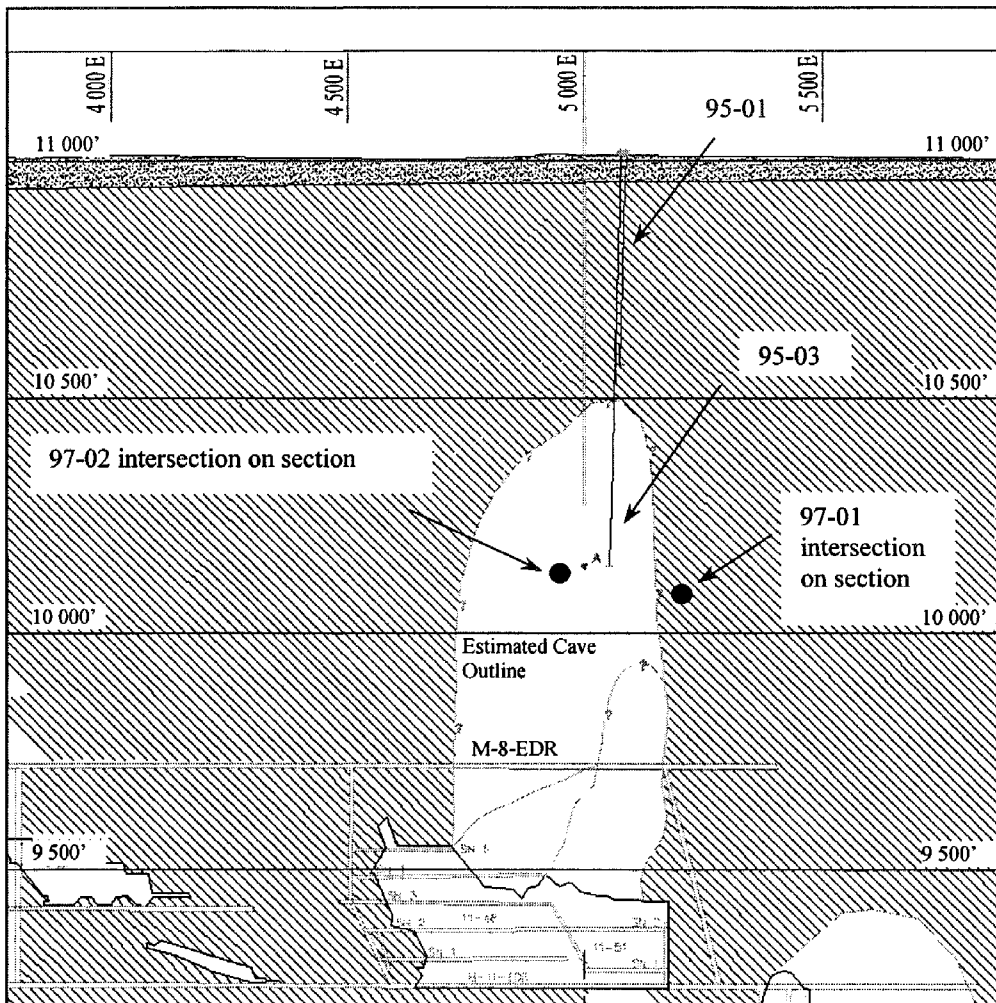
**Figure 4.1: Investigative Drilling to Determine the Location of the 11-48 Stope.**

drilled for long term monitoring purposes. The conclusion of that drilling program was that even though the 95-03 hole was drilled to a depth of 244 meters, no indication of potential caving limit was observed. The program did however, provide insight on the quality of the rock mass in the crown pillar.

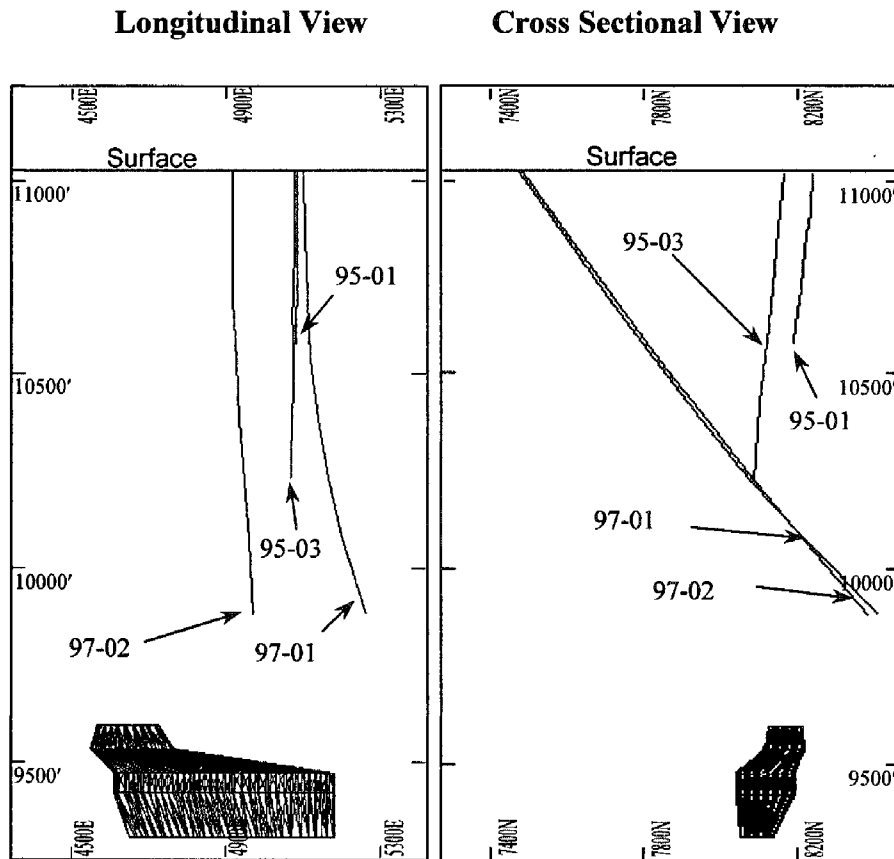
**Figure 4.2: Location of Drill Holes Relative to Planned Stope Limits**

The second drilling program consisted of two holes (97-01 and 97-02), oriented to cross cut the potential caved stope at a depth of 245 meters. The borehole logs for those holes as well as geological sections have been included in Appendix 2. The intersection location of the holes on the view are plotted on Figure 4.1. Figure 4.2 a) shows the diamond drill holes in longitudinal view with respect to the planned stope limits and Figure 4.2 b) shows a cross section of those holes. Although neither of the holes ever intersected a void, both holes intersected zones of low RQD or fractured core ( 1.2 m and 2.8 m for holes 97-01 and 97-02 respectively). The fractured zones were identified as a potential thickness of caved material.

It was concluded that if the fractured run of core was indeed the stope cave, the stope thickness was now reduced to a maximum of 2.8 m and the stope was filled at a depth of 245 meters. Alternatively, if the fractured run of core was not the caved stope, then the crown pillar thickness was the required stable thickness of 245 meters. Indeed, inspection of the fractured length of core did not provide any confidence that the material was caved material. Also, while typical values of RQD for crown pillars of the East-Malartic property ranged from 10% to 50%, the 97-02 hole directly above the planned stope limits demonstrated RQD values between 9% and 93%. Additionally, unconfined compressive strength (U.C.S.) data used in the stability assessment performed by GAL, ranged from 10 to 100 MPa while U.C.S. data of core from diamond drill hole 97-02 ranged from 143 – 320 MPa. These values should be re-considered when determining the crown pillar stability.

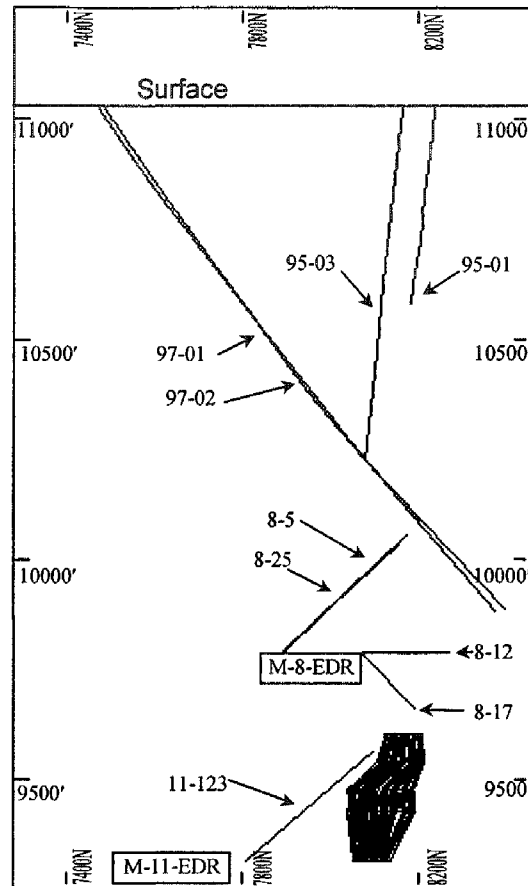
**Figure 5.1: Exploration Diamond Drill Holes Relative to Planned Stope Limits**

Diamond drill records for the period 1958 to 1974 relevant to the 11-48 and 11-51 stope were reviewed. At the time, the diamond drill holes were used as exploration probes to establish reserve limits for ore-bearing zones. In as many as five independent holes drilled from 1970 to 1973, difficulty in drilling was noted on the records. Since the dates indicate that the geology cross-cut by those holes was not influenced by mining activity, it is necessary to conclude that the results represent *in situ* conditions. The difficulties observed ranged from the detection of a water seam to the loss of drill rods at noted depths. The comments made for those holes as well as the noted depths are summarized in Table 5.1.

The similar depths of each of the water seam and the fracture location indicated in the drill records hinted that they might all be related. Indeed, using drafting programs, a three dimensional plane relating each of the depths can be constructed. The plane as well as the planned stope limits are illustrated in Figure 5.2A. Now, the plane constructed can be

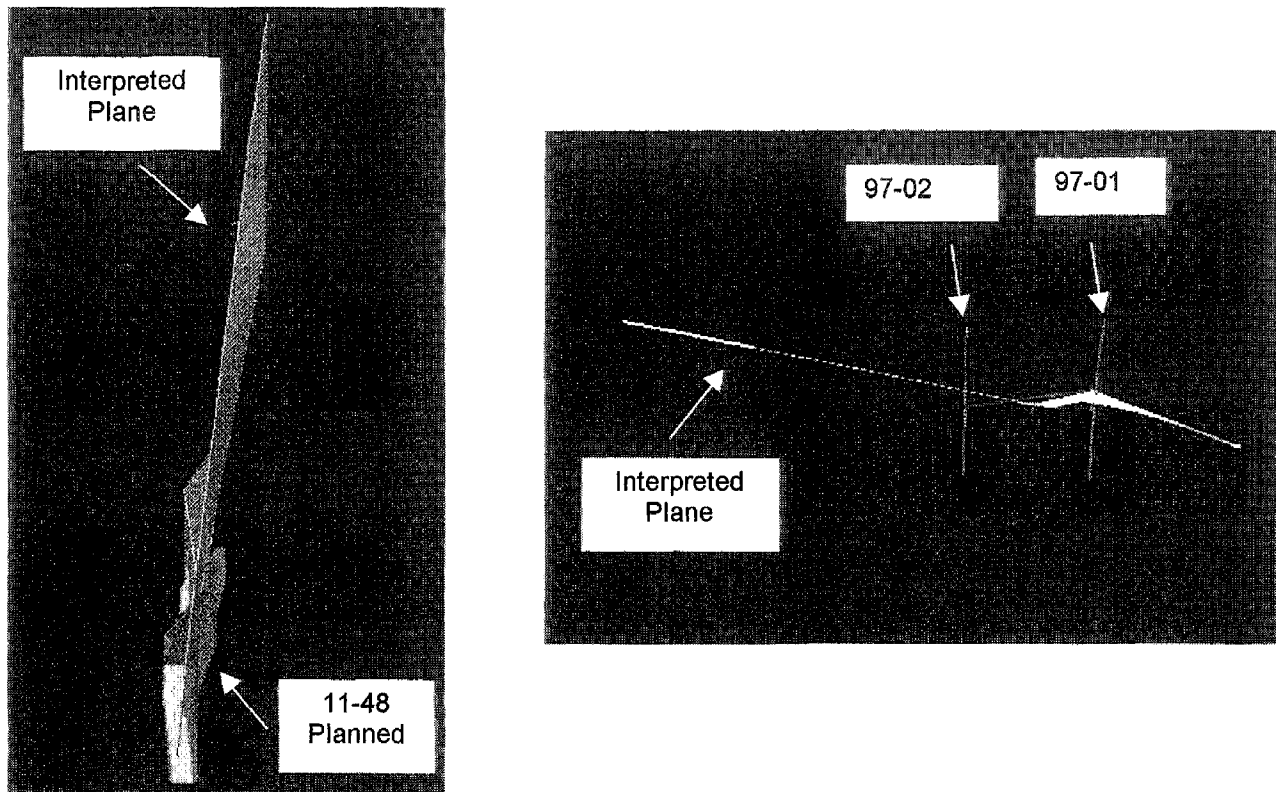
**Figure 5.2: A) Cross Section of Planned Stope and Interpreted Plane; B) Plan View of Plane and Diamond Drill Holes 97-01 and 97-02.**

Remembering that similar fractured core was observed in both holes 97-01 and 97-02, the intersection of the constructed plane with the drill holes is worth noting. Figure 5.2B shows a plan view of the plane (appears in plan as a white line), diamond drill holes 97-01 and 97-02 and a line linking the location of the observed fractured lengths of core (red). From the figure, it is clear that the extrapolated plane cross-cuts the diamond drill holes at approximately the same location and the same orientation as the fractured core observed in those holes. It can now be concluded that the fractured length of core obtained from the diamond drill holes in 1997 was the continuation of the discontinuity noted in 1970, 1972 and 1973, not a filled volume of the 11-48 stope.

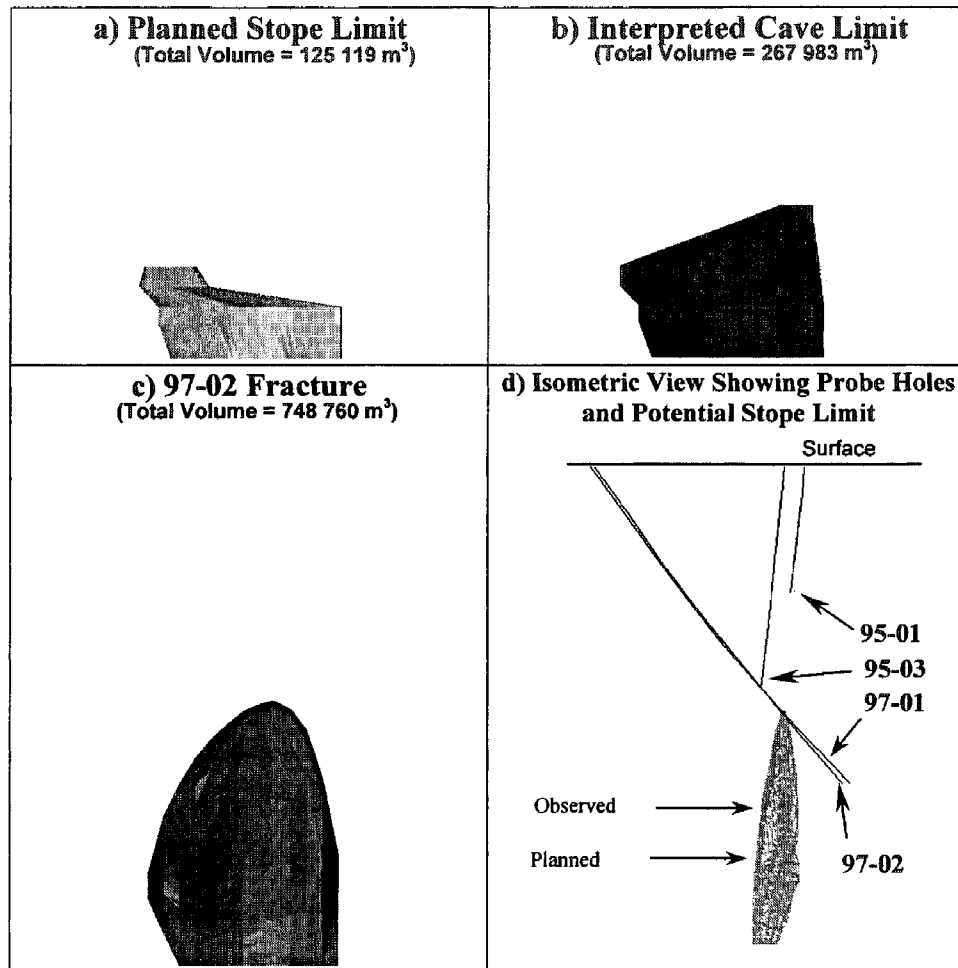
**Figure 6.1: Possible Scenarios for the Cave Outline of the 11-48 Stope**

Figure 6.1 a), b), c) and d) below are three-dimensional re-constructions of the 11-48 stope (11-51 included) using available sub-level plans for the stope. By interpolating between the sub-levels, a three-dimensional volume can be created and the magnitudes for the scenarios compiled. Scenario a) represents the planned stope limits based on the level plans. Scenario b) represents a possible cave outline constructed by joining the planned limits with the cave limit observed in 1974. Scenario c) is constructed by assuming that the 2.8 m fractured length of core obtained from hole 97-02 is the maximum vertical stope extent. The volumes for each scenario are included in the figure. Clearly, scenario c) does not represent a realistic estimation of the stope

limits. Scenario b) represents a very conservative estimate of the 1978 stope limit. Scaled drawings of the figures below can be found in Appendix 3.

The site investigation already discussed demonstrated that there is no void of significant proportions as was indicated on the longitudinal section from 1981. The discussion above suggests that the volume of rock mined does not approach the volume indicated on that section. Remember also, that the outline was placed in doubt since it was not indicated on the plan section included with the longitudinal view. Based on these observations, one is required to ask how the 1981 outline was constructed. A common rule of thumb estimation of choking limit height (as previously defined) based on an initial stope outline can be obtained by multiplying the initial stope height by 2.5 (GAL, 1993). If the stope limit from scenario b) is assumed to represent the final stope geometry and its height is multiplied by 2.5, a choking limit similar to the “Estimated

Cave Outline” can be obtained. It can now be concluded that the outline indicated on the 1981 longitudinal section is merely an estimate of the choked stope limits. For the purpose of crown pillar stability analysis, a more realistically conservative representation of the actual stope outline is the one indicated by scenario b).

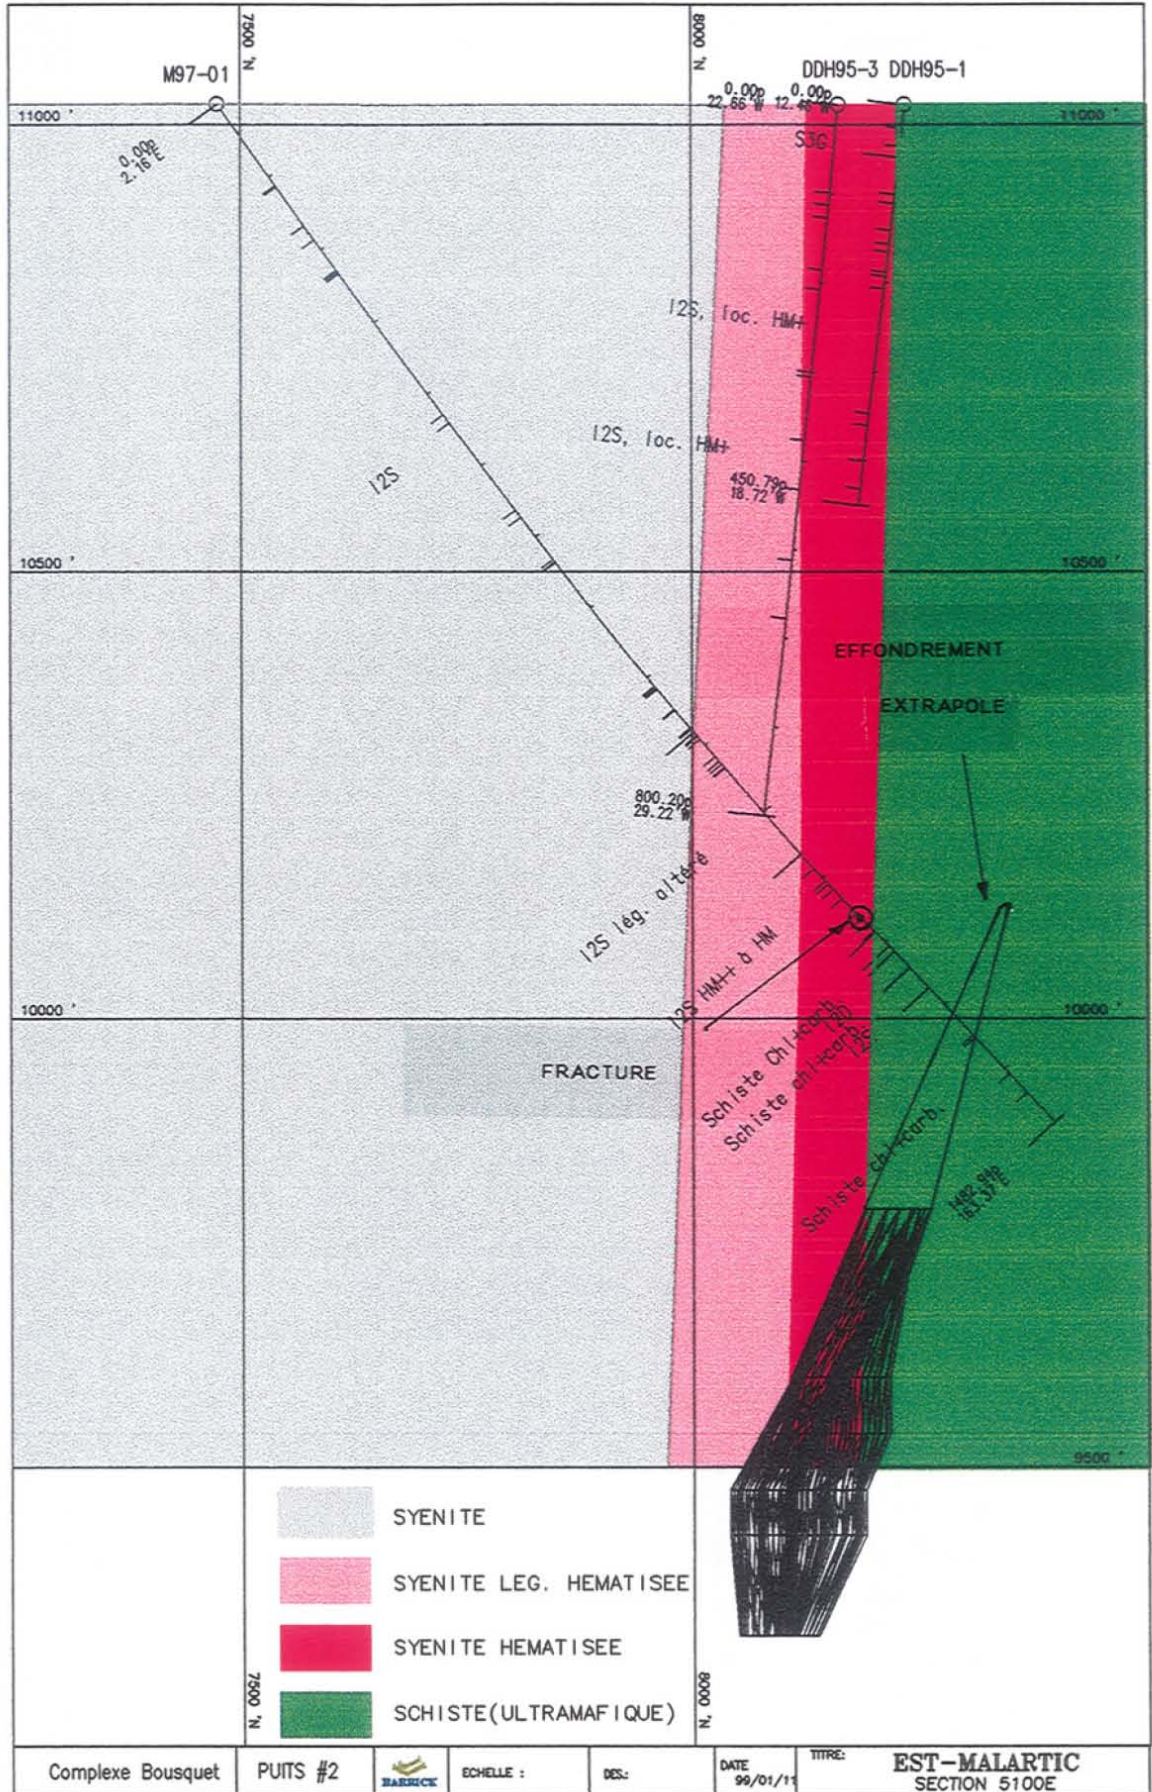
It is useful to construct a trend line on both sections which identifies a possible caving direction based on the observed cave of level M-8-EDR (Section 5100E and 4920E). In both sections, it is clear that if the trend is extrapolated to the same elevation as the fractured core, the line does not intersect the diamond drill hole at that location. Furthermore, referring to the borehole logs and in particular the RQD values for the core between the fractured length of core and the extrapolated caving trend, the quality of the rock indicates that there is no association between the expected cave trend, the fractured length of core and the rock in between. Simply stated: if the cave observed in 1974 were to continue in the same direction, it would not come close to the location of the fractured core identified in holes 97-01 and 97-02. Perhaps more importantly, if the cave progression changed orientation, which would be required to cause the fractures observed in holes 97-01 and 97-02, the rock quality between the theoretical trend and the fracture would necessarily be compromised. This was not observed in the core obtained from either hole (see Appendix 2, borehole log 97-01 p.7, log 97-02 p.7).

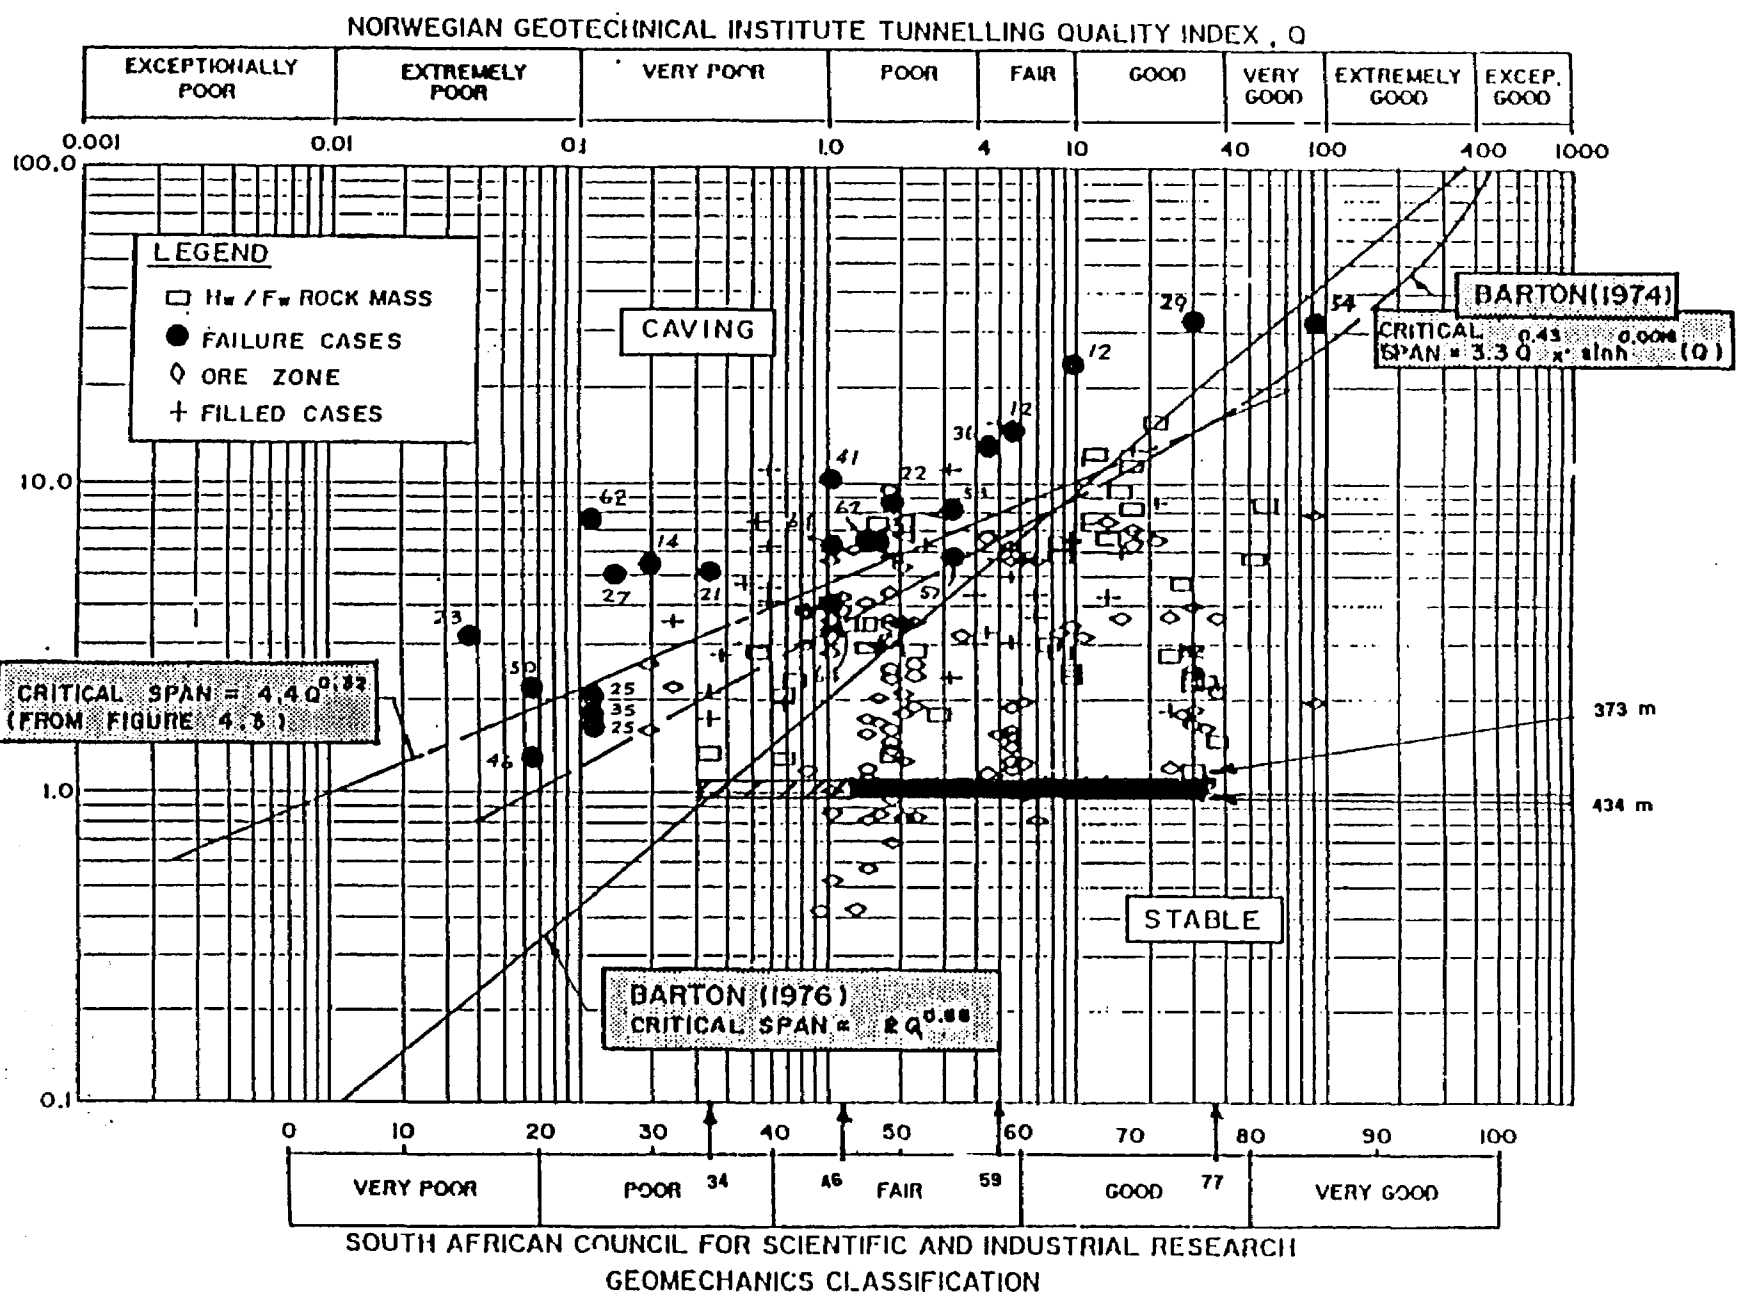
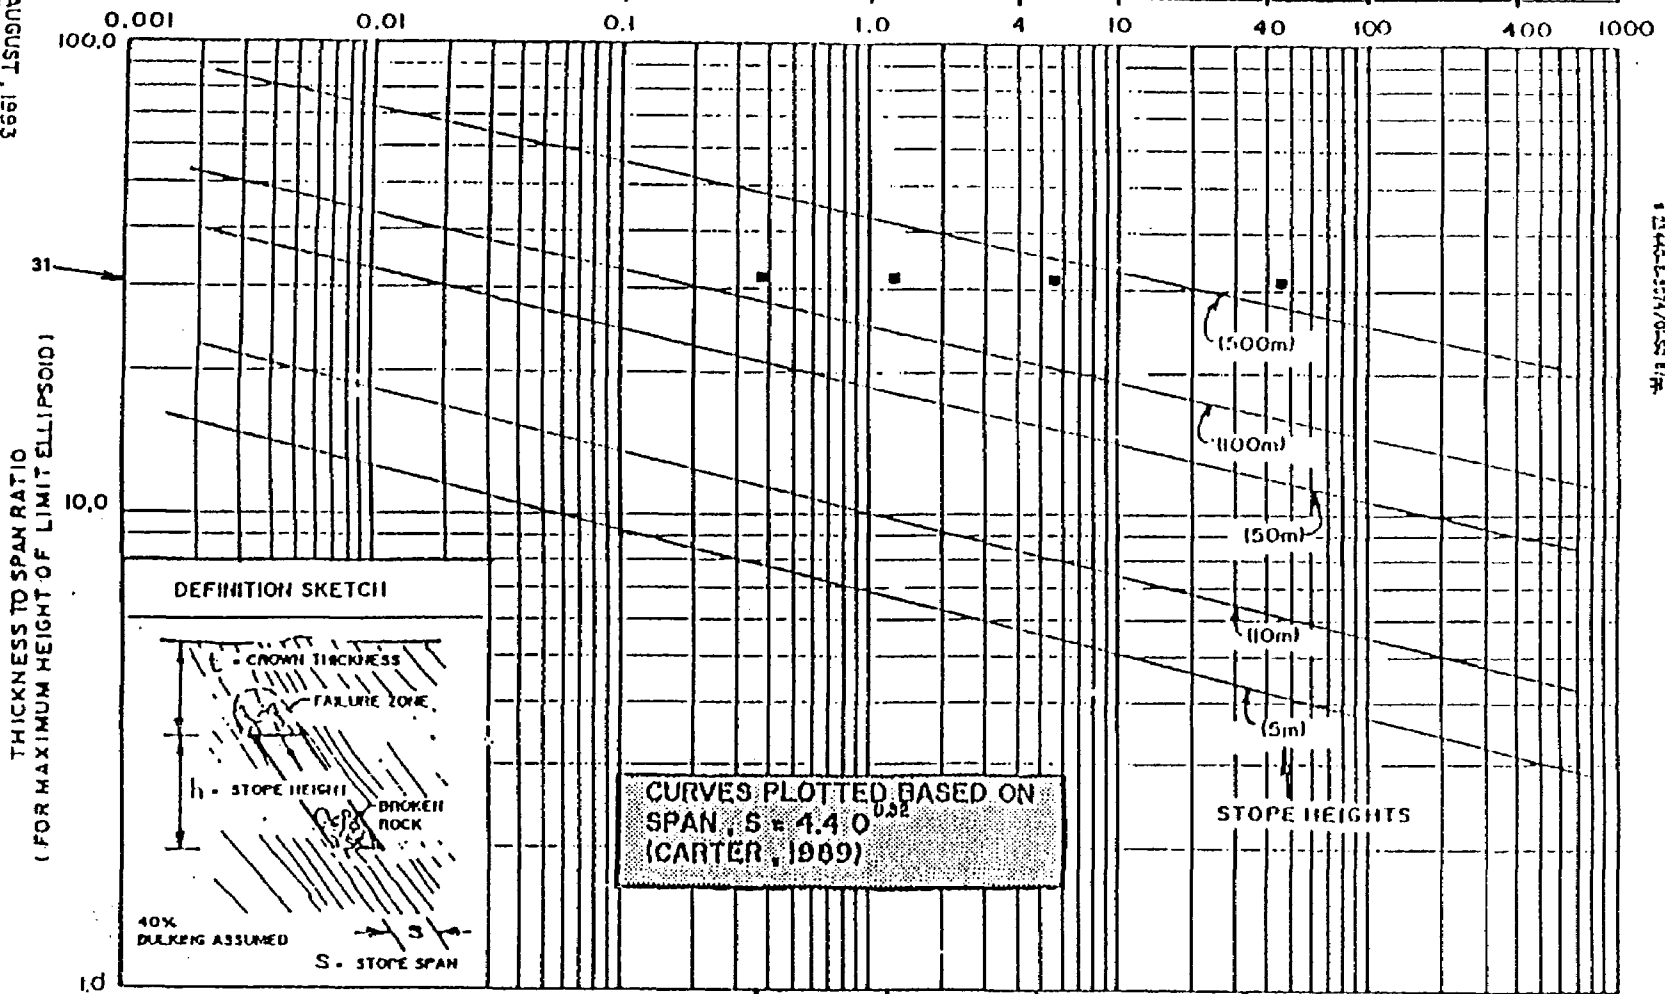
The scaled crown span is plotted with respect to the rock mass quality of the crown pillar (Figure A.6 in Appendix 4). For the purpose of this report, the rock mass quality is presented in terms of the Rock Mass Rating (RMR) classification system. The core obtained from diamond drill holes 97-01 and 97-02 was used to classify the crown pillar rock mass. Four lithologies were observed in core obtained from diamond drill holes 97-01 and 97-02. These were a syenite, a hematized syenite, a diorite (dyke), and an ultramafic chlorite schist. It is known that the altered hematized syenite hosts the ore and therefore was primarily used in crown pillar stability assessment. The rock mass characterization for the hematized syenite is summarized in Table 7.1. Upper and lower bounds have been included so that a sensitivity analysis can be conducted.

Referring to Figure A.6 in Appendix 4, upper and lower bounds for the scaled span and the Rock Mass Rating are plotted. From the figure, it is clear that the conditions applicable to the crown pillar above the 11-48 stope plot in the stable zone of the graph.
