Projet d'exploitation du gisement de
graphite naturel du Lac-Guéret dans la MRC
de Manicouagan

Preliminary Geotechnical Investigation Report - Concentrator site – Plant (Qualitas, 2015)

Preliminary Geotechnical Investigation Report Concentrator site - Plant

**Baie-Comeau
Quebec, Canada**

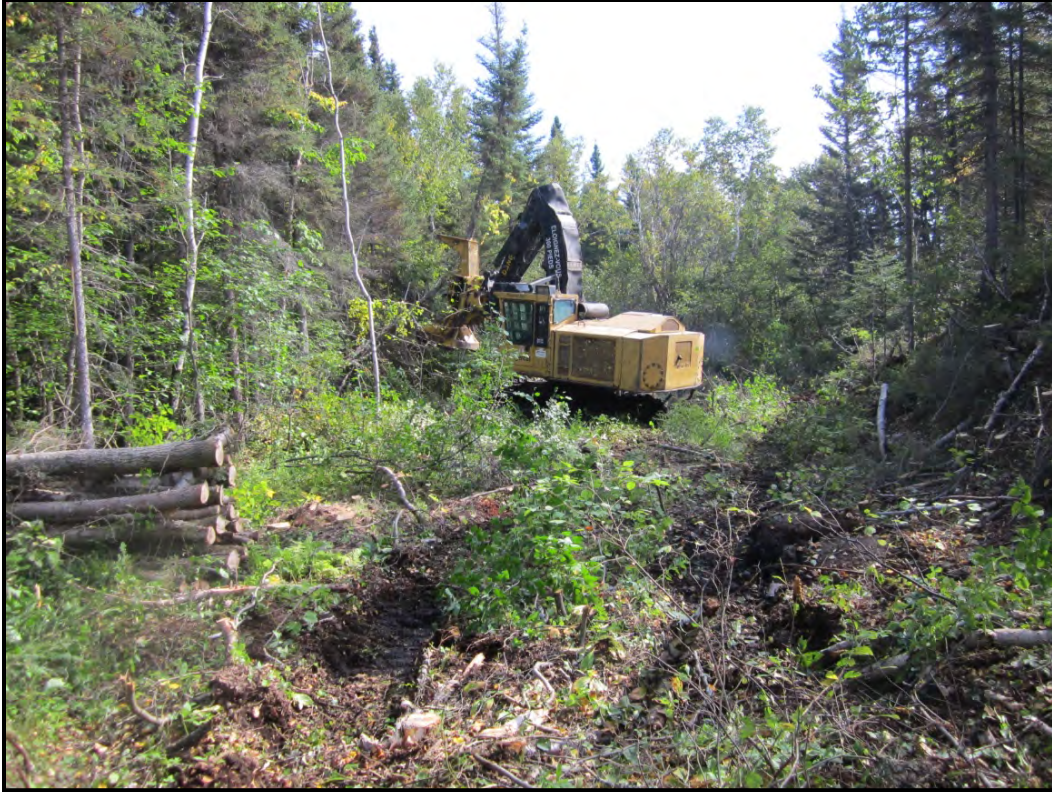
Figure 2 - General view of the wood-clearing work

The following figures show general view of the land-clearing work.

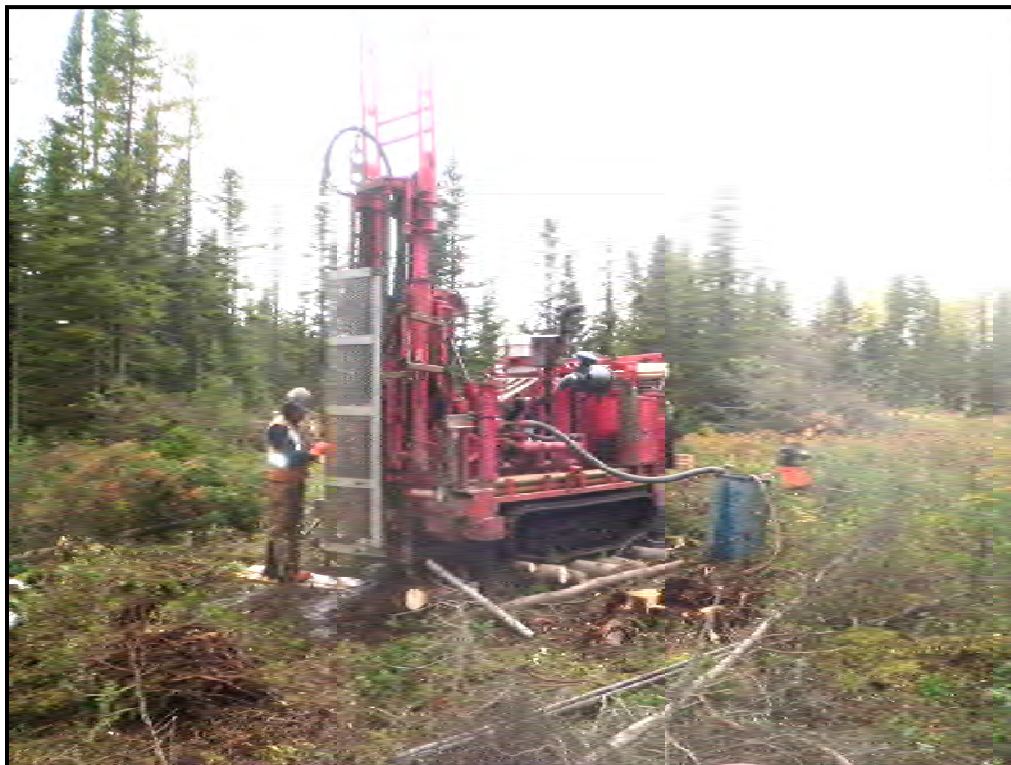
Figure 4 - CME-55 drill in operation

All the boreholes were drilled using a CME-55 drill, mounted on a CME-300 tracked carrier (Figure 4) using the cased wash boring method. The drilling and other equipments mentioned above were owned and operated by Forage André Roy Inc., subcontracted by Qualitas. A total of 8 boreholes were drilled under mandate 632622.1 in the plant area. The drilling length of the 8 boreholes ranged from 9.28 to 25.92 m. The boreholes were drilled under the constant supervision of our geotechnical field supervisors, either Mr. Kevin Simoneau or Mr. Alex Tremblay. Borehole locations are shown on drawing 632622.1-01 in Appendix 3.

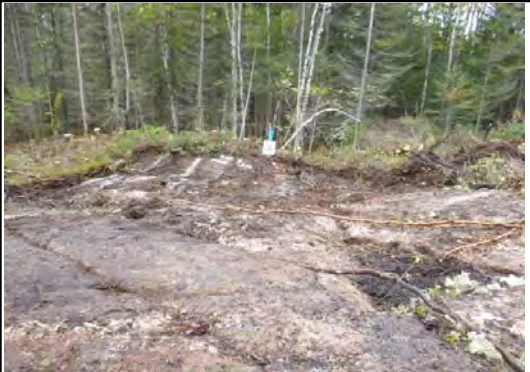
COMMENTS:
 Step-like bedrock dip approximately 20° in the North direction. See the following drawing for further details.

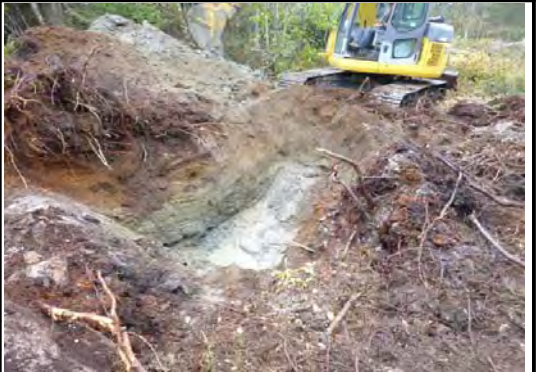
COMMENTS:
 Step-like bedrock dipping approximately 34° in the South direction. See the following drawing for further details. Seepage from 1.50 to 1.75 m on the West wall of the trench.

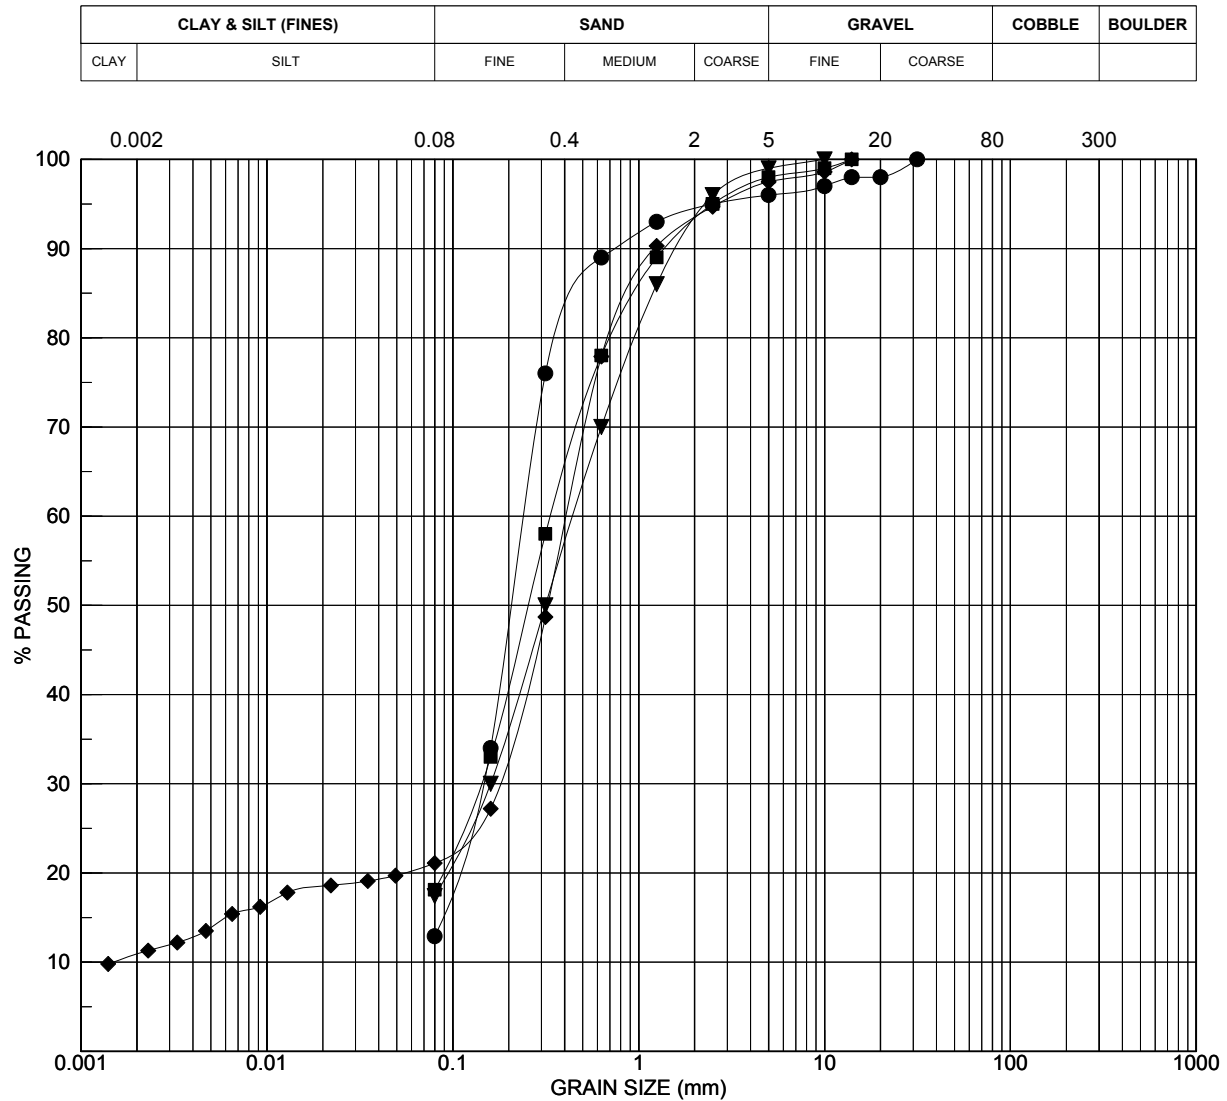
FIGURE 2.1

Borehole	Sample	Depth (m)	Description	Gravel (%)	Sand (%)	Silt (%)	Clay (%)
●	TP-15-17	MA-2	0,30 - 0,80	Sand, some silt, traces of gravel.	4	83	13	-
■	TP-15-18	MA-2	0,30 - 0,80	Sand, some silt, traces of gravel.	2	80	18	-
▼	TP-15-28	MA-2	0,30 - 0,80	Sand, some silt, traces of gravel.	1	82	17	-
◆	TP-15-31	MA-3	0,90 - 1,40	Sand, some clay and silt, traces of gravel.	3	76	10	11

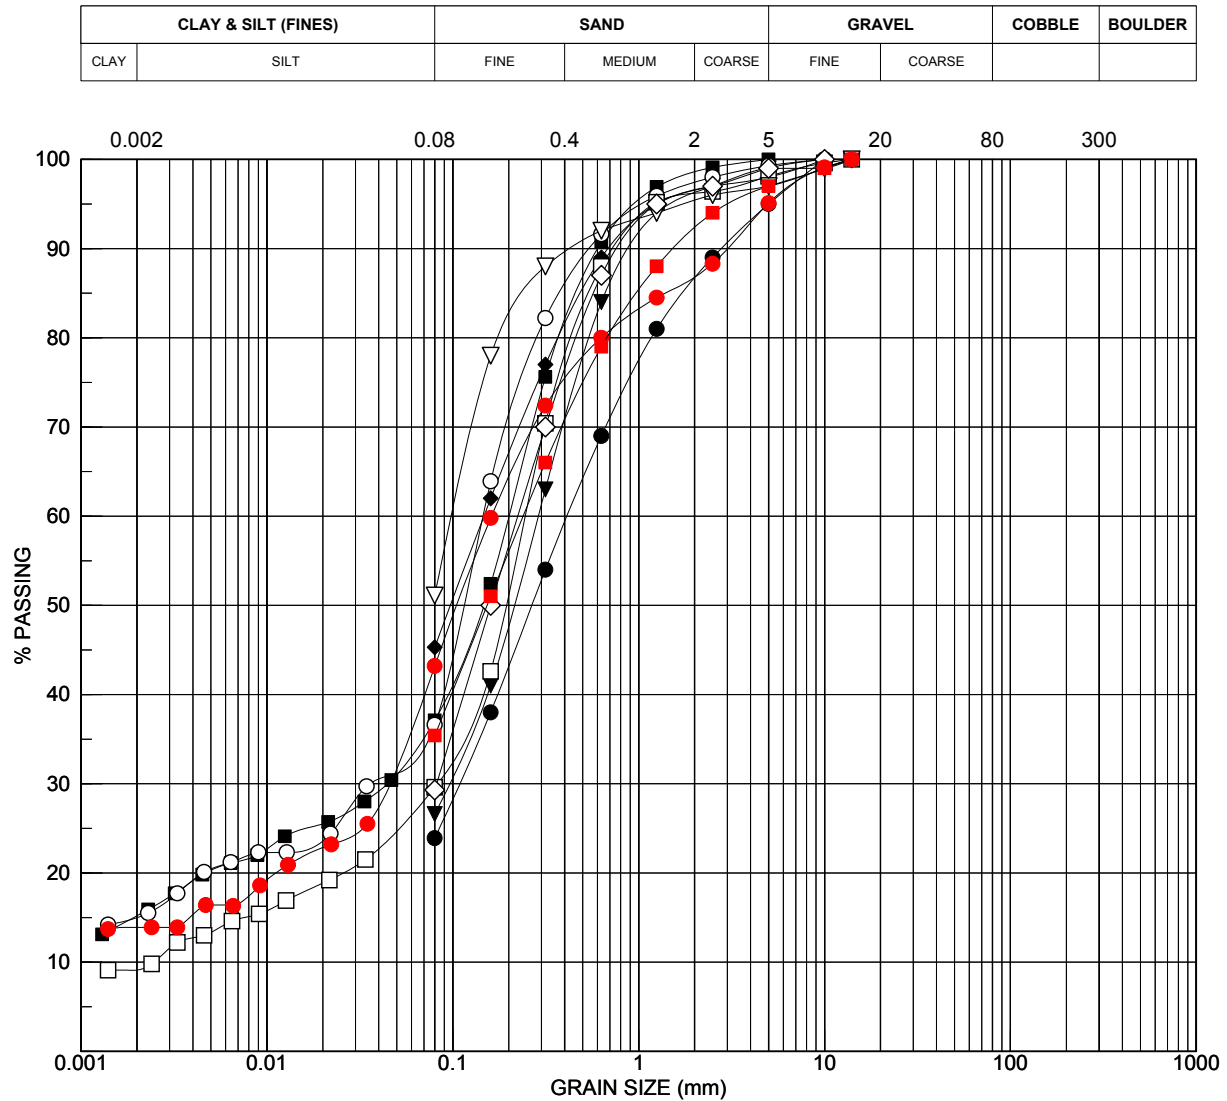
FIGURE 2.2

Borehole	Sample	Depth (m)	Description	Gravel (%)	Sand (%)	Silt (%)	Clay (%)
●	TP-15-01	MA-3	0,70 - 1,20	Silty sand, traces of gravel.	5	71	24	-
■	TP-15-03	MA-3	0,50 - 1,00	Silty sand, some clay.	0	63	22	15
▼	TP-15-05	MA-3	0,60 - 1,10	Silty sand, traces of gravel.	1	72	27	-
◆	TP-15-08	MA-3	1,00 - 1,50	Sand and silt, traces of gravel.	2	53	45	-
○	TP-15-17	MA-7	2,80 - 3,30	Silty sand, some clay, traces of gravel.	1	63	22	15
□	TP-15-21	MA-2	0,30 - 0,80	Silty sand, traces of clay and gravel.	2	68	21	9
▽	TP-15-25	MA-2	0,50 - 1,00	Silt and sand, traces of gravel.	3	46	51	-
◇	TP-15-26	MA-2	0,30 - 0,80	Silty sand, traces of gravel.	1	70	29	-
●	TP-15-26	MA-4	1,30 - 1,80	Silty sand, some clay, traces of gravel.	5	52	29	14
■	TP-15-32	MA-3	0,70 - 1,20	Sand and silt, traces of gravel.	3	62	35	-

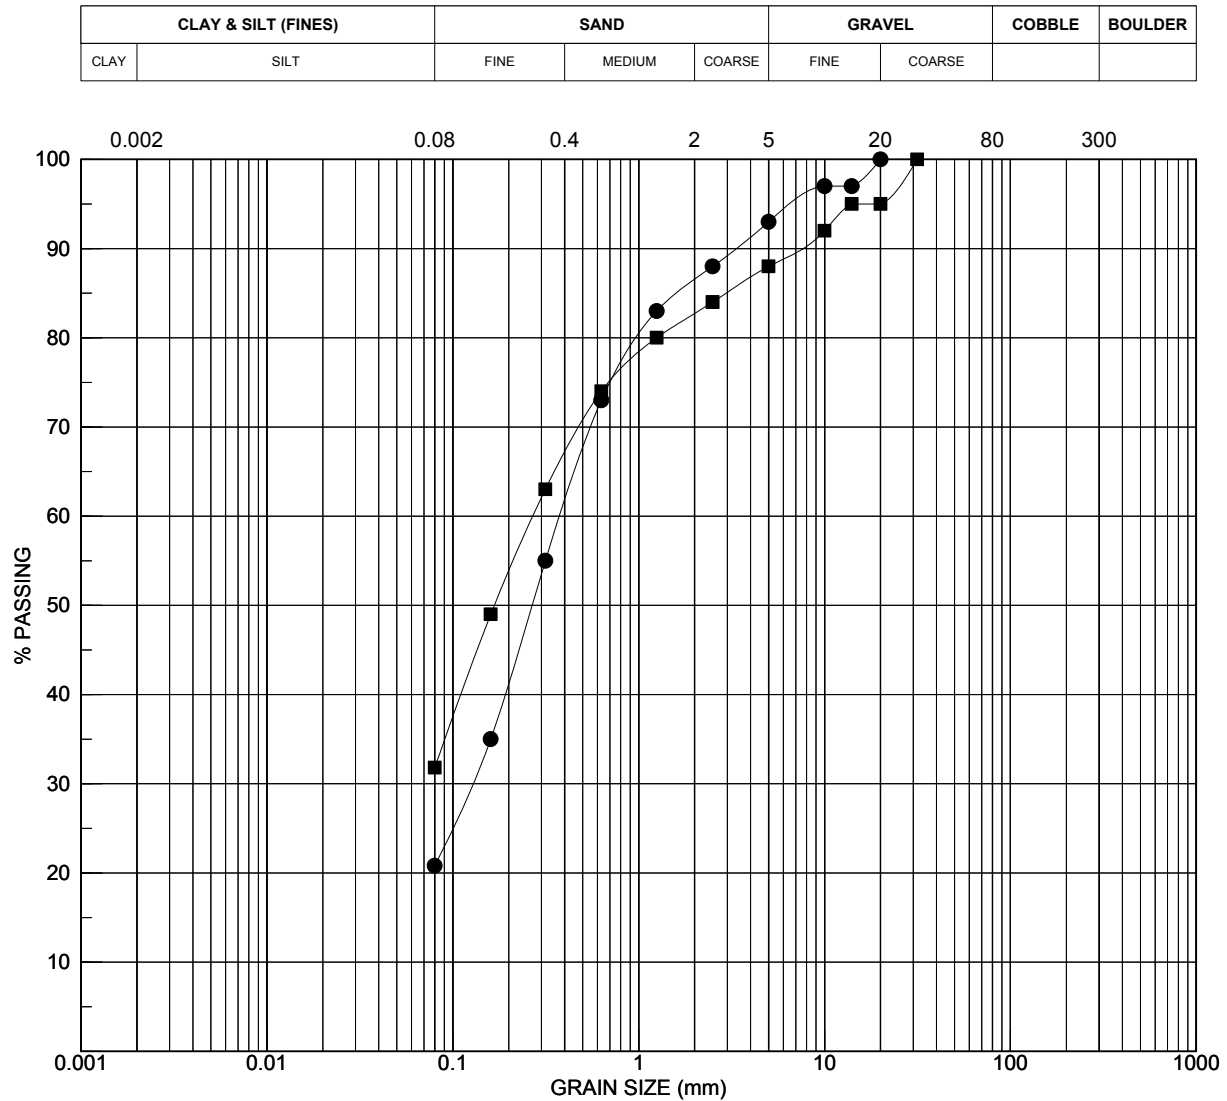
FIGURE 2.4

Borehole	Sample	Depth (m)	Description	Gravel (%)	Sand (%)	Silt (%)	Clay (%)
●	BH-15-05	CF-8	4,27 - 4,88	Silty sand, traces of gravel.	7	72	21	-
■	BH-15-14	CF-17	12,09 - 12,70	Silty sand, some gravel.	12	56	32	-

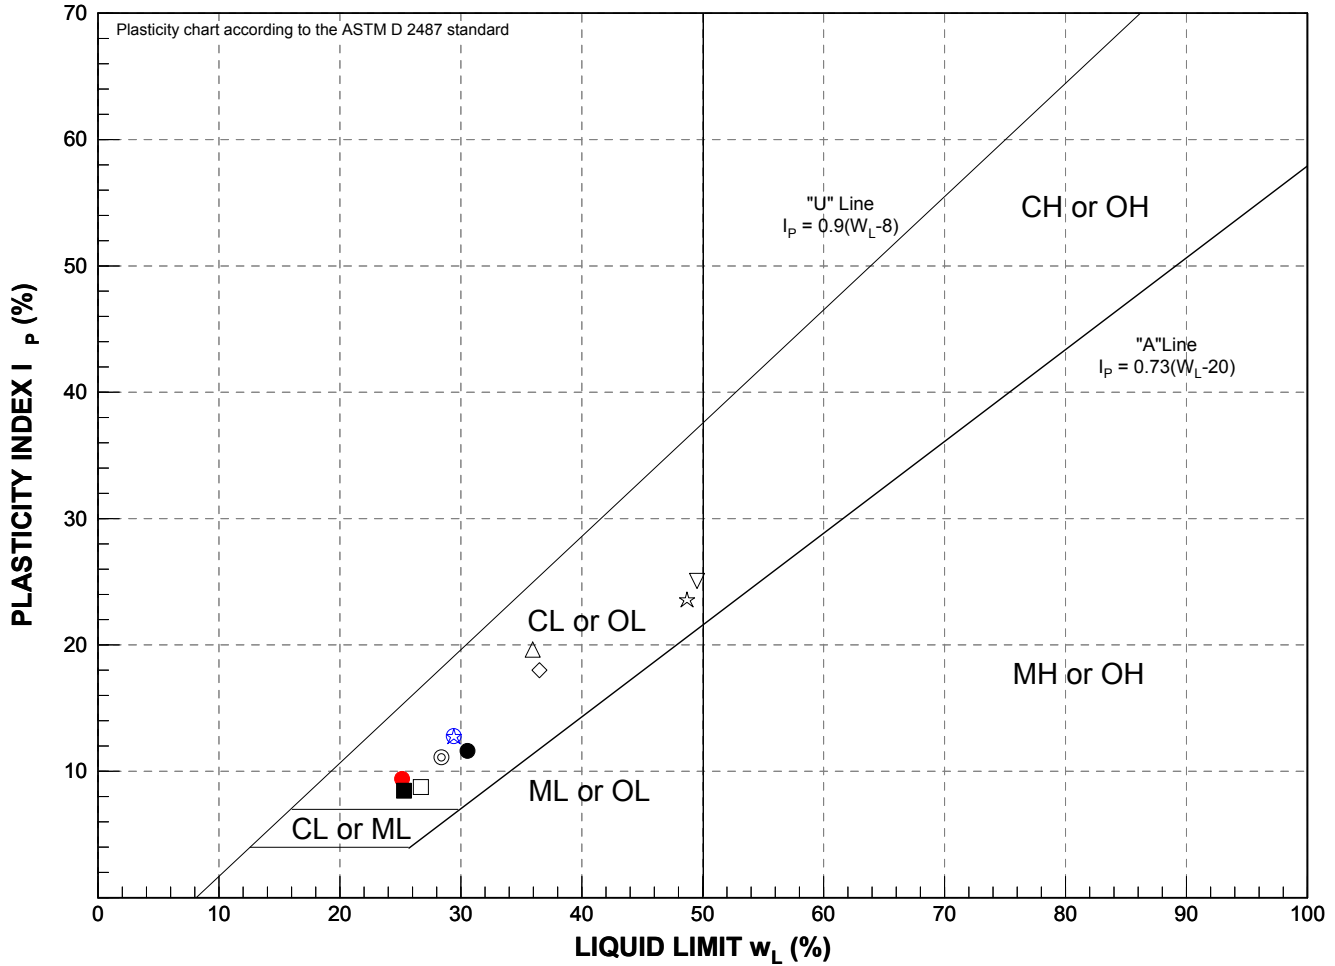
Figure 2.5

Symbol	Borehole	Type	Sample	Depth		w	w _L	w _p	I _L	I _p	USCS	Description
				from	to							
●	BH-15-03	CF	13	8.38	8.99	33	25	16	1.9	9	CL	-
□	BH-15-03	CF	16	10.67	11.28	51	27	18	3.8	9	CL	-
▽	BH-15-03	CF	8	4.57	5.18	58	50	24	1.4	25	CL	-
☆	BH-15-03B	TM	7	3.05	3.76	64	49	25	1.6	24	CL	-
⊙	BH-15-06	TM	14	1.22	1.83	39	28	17	2.0	11	CL	-
◇	BH-15-08	TM	15	3.45	4.16	39	37	19	1.1	18	CL	-
△	BH-15-08	CF	3	1.22	1.83	32	36	16	0.8	20	CL	-
☆	BH-15-08	CF	6	3.05	3.66	39	29	17	1.7	13	CL	-
●	BH-15-14	CF	10	6.10	6.71	43	31	19	2.1	12	CL	-
■	BH-15-14	CF	13	8.38	8.99	37	25	17	2.4	9	CL	-

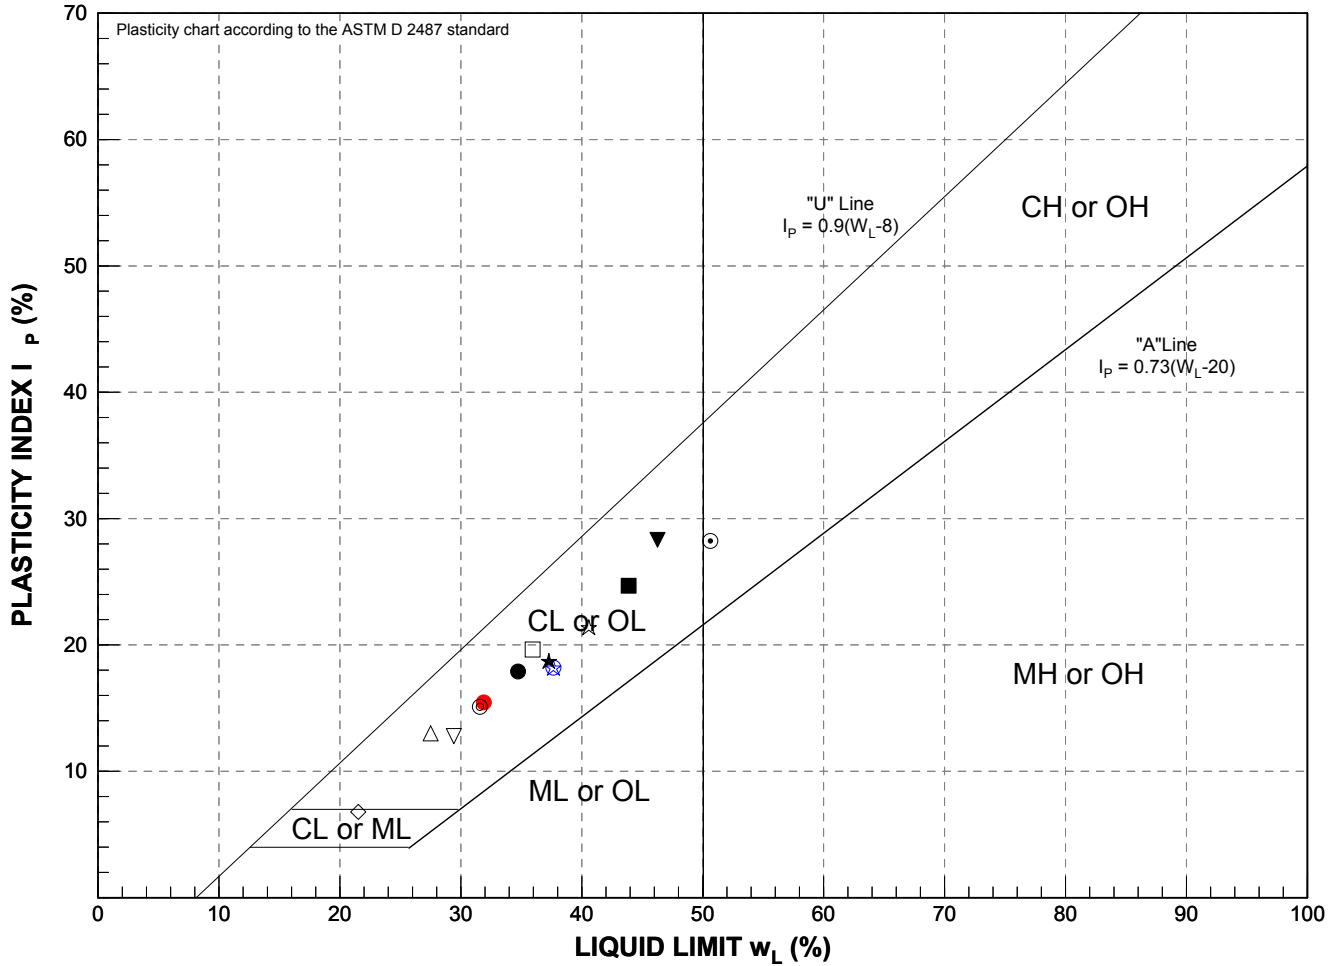
Figure 2.6

Symbol	Borehole	Type	Sample	Depth		w	w _L	w _p	I _L	I _p	USCS	Description
				from	to							
●	TP-15-05	MA	5	1.60	2.10	21	32	16	0.3	15	CL	-
□	TP-15-08	MA	3	1.00	1.50	32	36	16	0.8	20	CL	-
▽	TP-15-08	MA	6	2.50	3.00	39	29	17	1.7	13	CL	-
☆	TP-15-16	MA	2	0.20	0.70	37	41	19	0.8	21	CL	-
⊙	TP-15-16	MA	6	2.20	2.70	29	32	16	0.8	15	CL	-
◇	TP-15-17	MA	7	2.80	3.30	21	22	15	0.9	7	CL-ML	-
△	TP-15-20	MA	5	2.00	2.50	27	28	15	0.9	13	CL	-
☆	TP-15-21	MA	6	2.30	2.80	48	38	19	1.6	18	CL	-
●	TP-15-23	MA	4	1.30	1.80	33	35	17	0.9	18	CL	-
■	TP-15-23	MA	8	3.30	3.70	56	44	19	1.5	25	CL	-
▼	TP-15-26	MA	4	1.30	1.80	37	46	18	0.7	28	CL	-
★	TP-15-26	MA	8	3.20	3.50	39	37	19	1.1	19	CL	-
⊙	TP-15-31	MA	4	1.40	1.90	50	51	22	1.0	28	CH	-

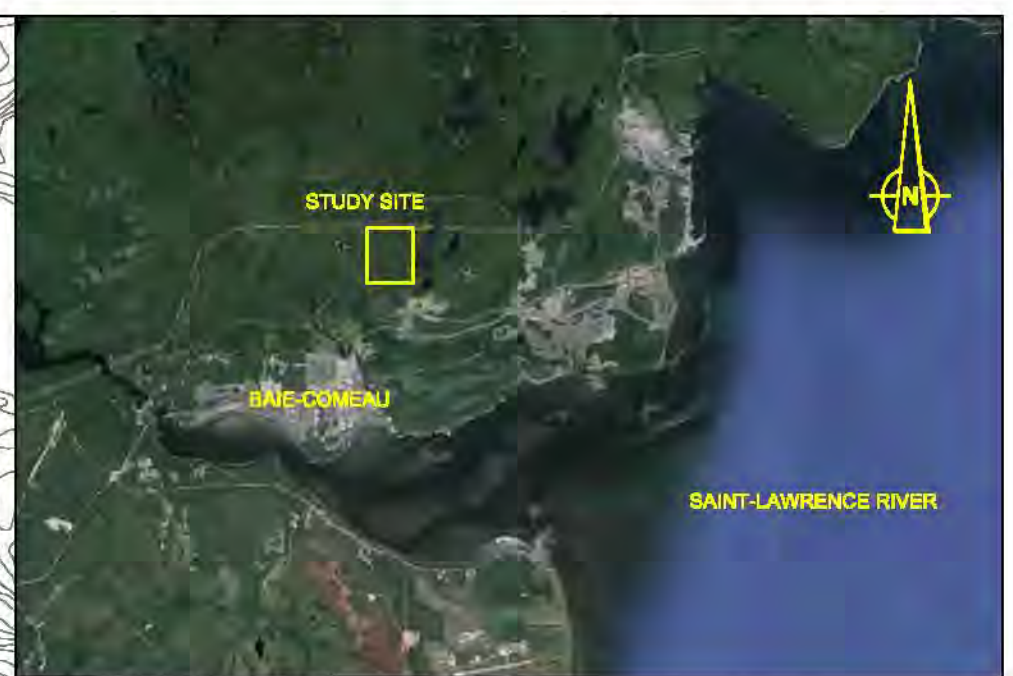
DRAWING 632622.1-01 – SOUNDING LOCATION PLAN

- Borehole 2015
Elevation of surface (m)
Bedrock elevation (m)
Water level elevation (m)
- Test Pit 2015
Elevation of surface (m)
Bedrock elevation (m)
- Projected TMF position
- Water line
- Intermittent stream
- Contour line (m)

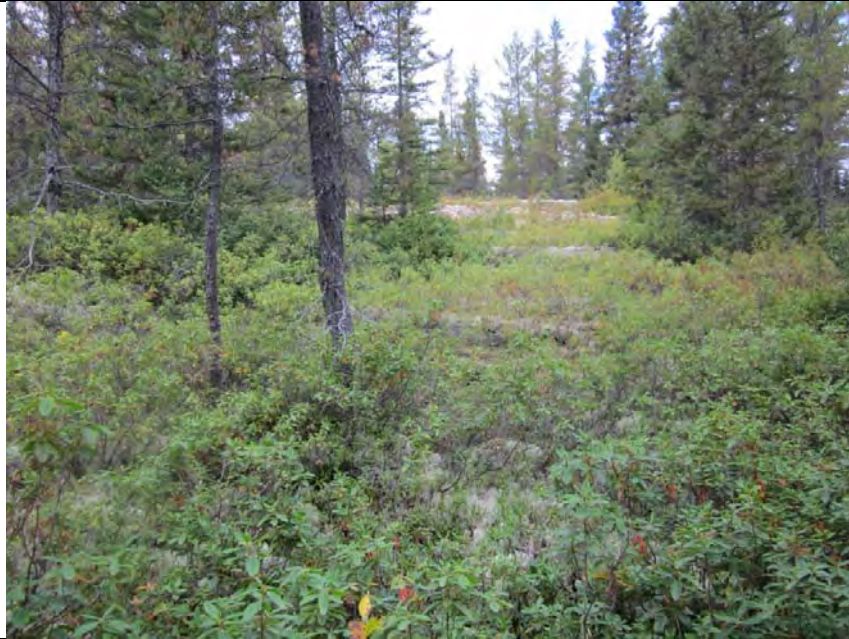
OB6_P01: View in the West direction.

Vast shallow rock and outcrop zone. No visible structures. Covered with a thin layer of peat. Photos taking on the North limit of the observed area. The general dip on the ground surface is towards the North. Observation made between test-pit TP-15-15 and TP-15-17.

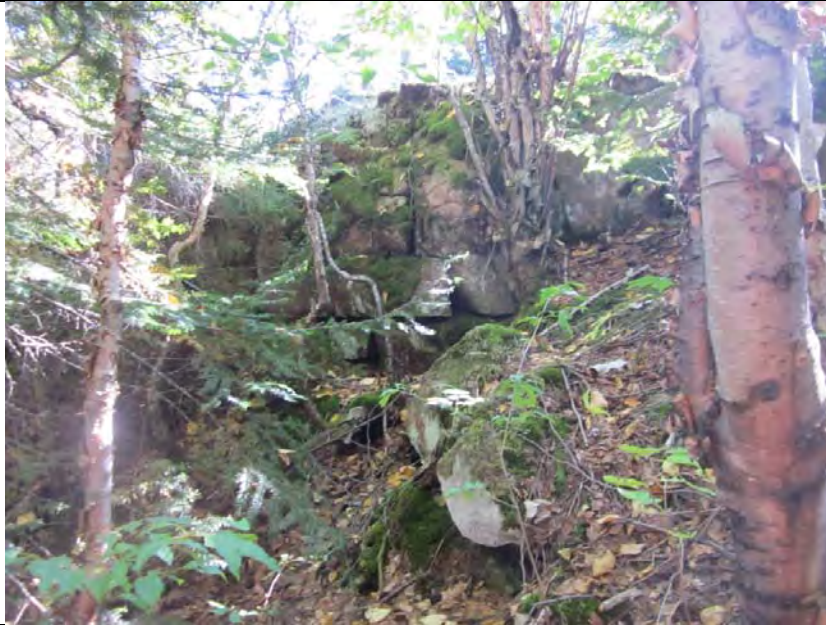
OB7_P03: View in the South direction. Rock wall from 4 to 5 metres high. Some fragments detached from the rock wall.

Vast shallow rock zone (granitic rock). No visible structures. Covered with a thin layer of peat. Extension to the West of the shallow rock zone observed in Observation 6. Photos were taken while walking in the North-West direction.

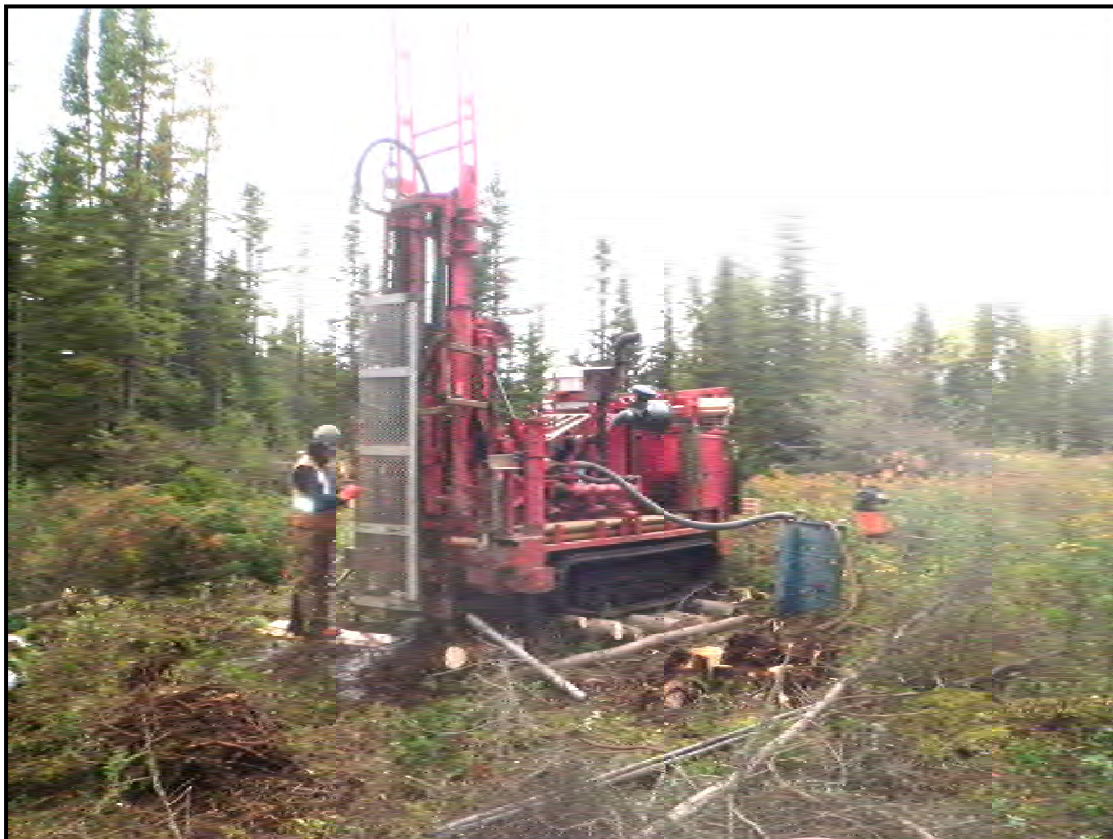
Figure 4 - CME-55 drill in operation

All the boreholes were drilled using a CME-55 drill, mounted on a CME-300 tracked carrier (Figure 4) using the cased wash boring method. The drilling and other equipments mentioned above were owned and operated by Forage André Roy Inc., subcontracted by Qualitas. A total of four (4) boreholes were drilled under mandate 632622.2 in the TMF area. Borehole locations are shown on drawing 632622.2-01 in Appendix 5.

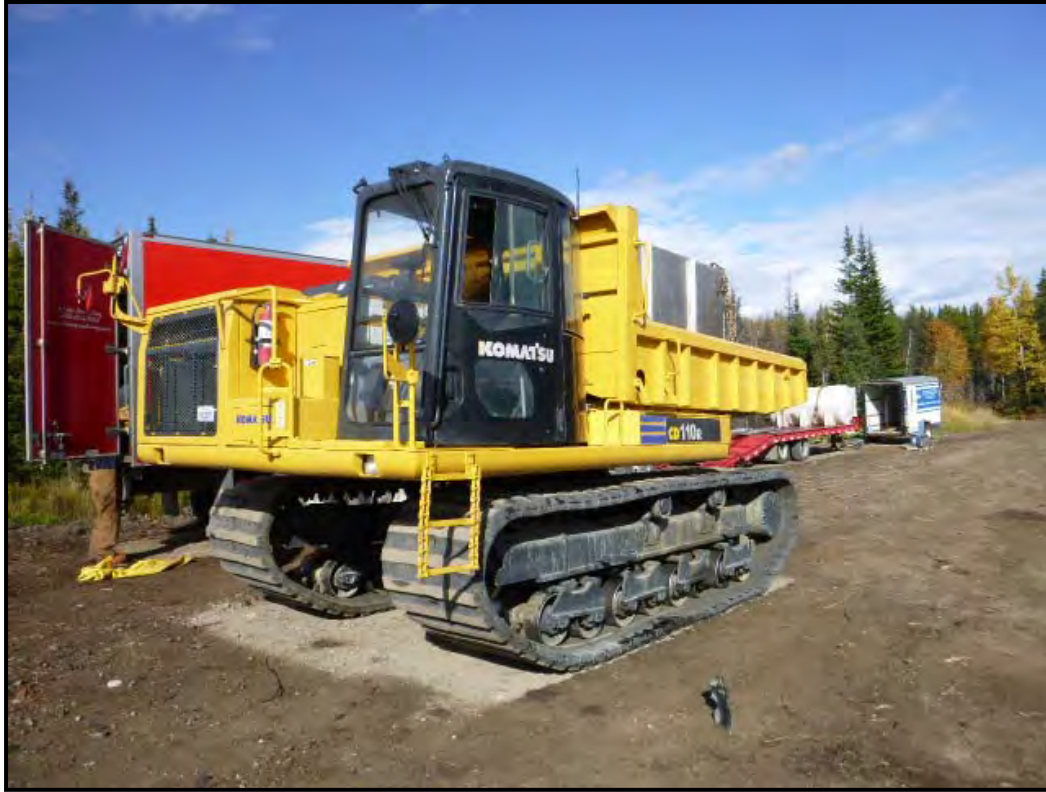
Figure 5 - Qualitas subcontractor's Komatsu CD 110R crawler

The field team, the material and the core boxes were transported using a track-mounted all-terrain vehicle. The drilling and test water supply was transported from Petit-Bras Lake to the sites in a reservoir, using a Komatsu's CD 110R crawler (Figure 5) provided by the contractor.

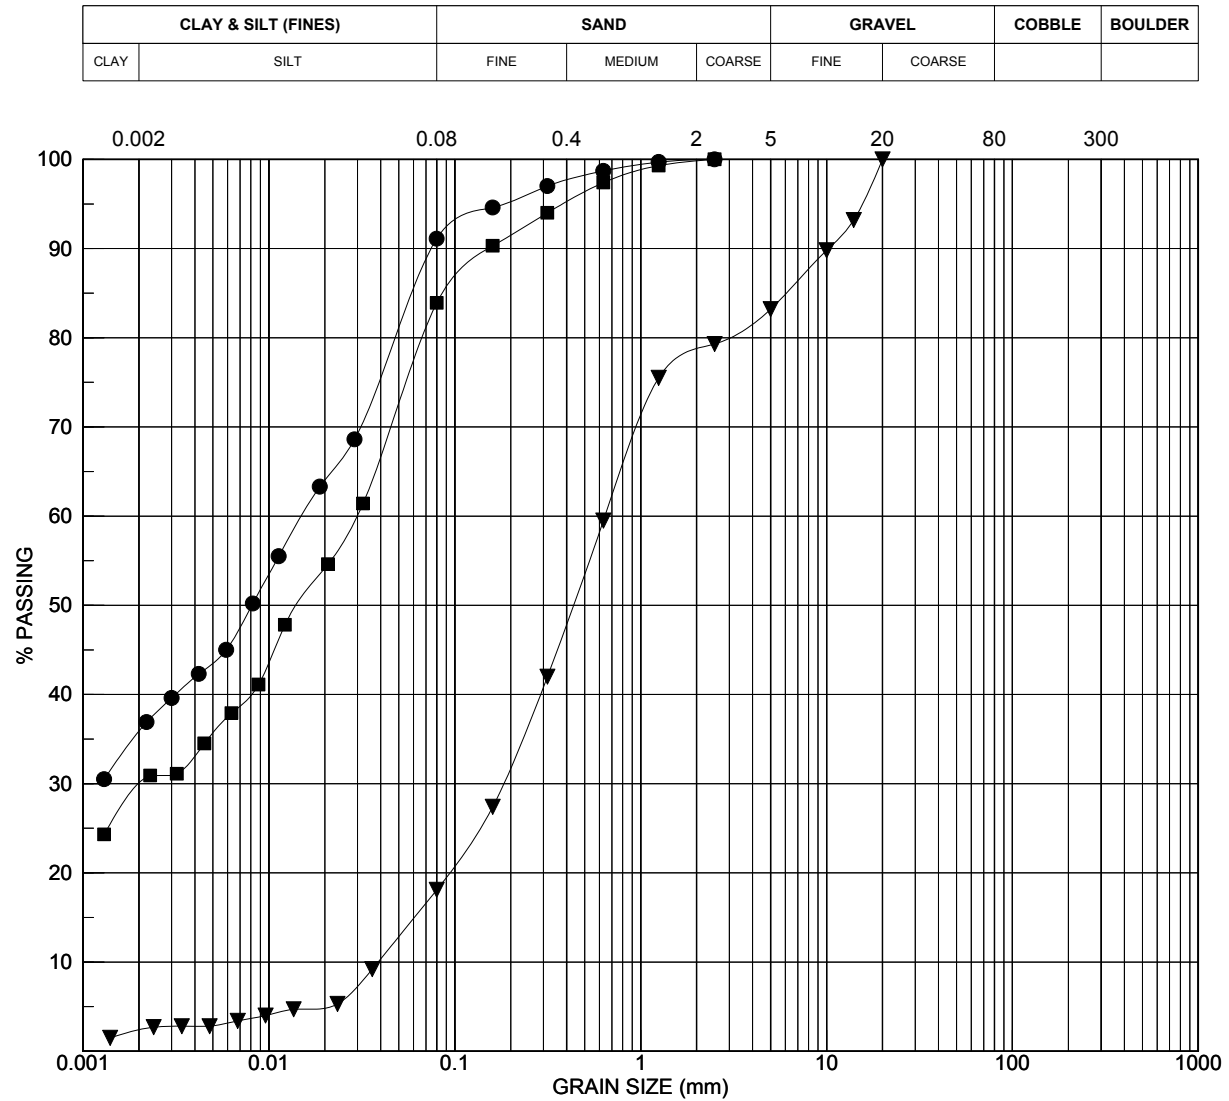
FIGURE 2.1

Borehole	Sample	Depth (m)	Description	Gravel (%)	Sand (%)	Silt (%)	Clay (%)
●	BH15-TMF-02	CF-3	1,22 - 1,83	Silt and clay, traces of sand.	0	9	55	36
■	TP15-TMF-17	MA-6	2,50 - 3,00	Clayey silt, some sand.	0	16	54	30
▼	TP15-TMF-18	MA-3	0,80 - 1,20	Sand, some gravel and silt, traces of clay.	17	65	16	2

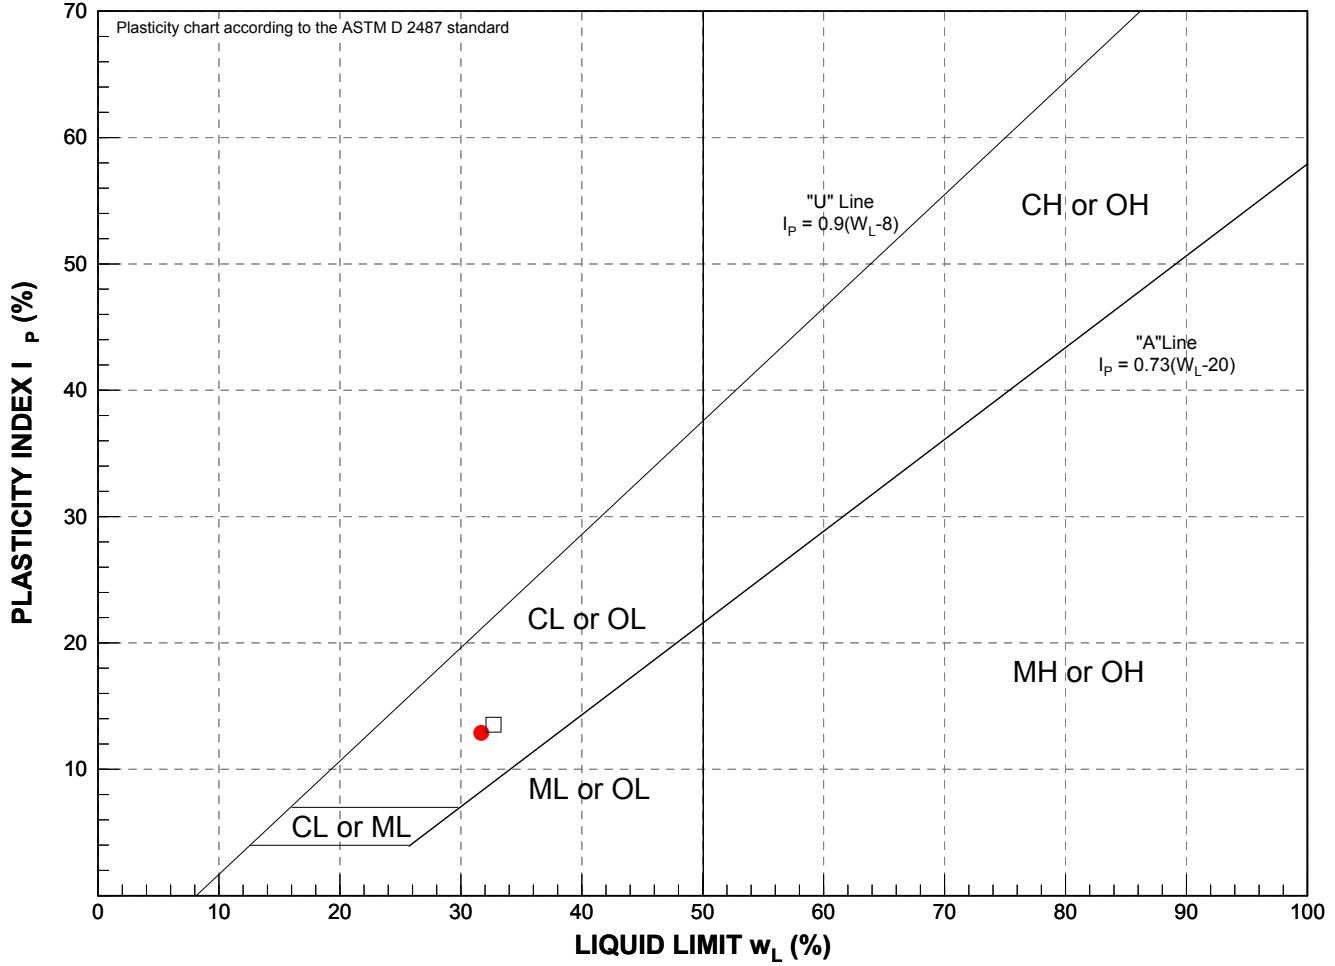
Figure 2.2

Symbol	Borehole	Type	Sample	Depth		w	w _L	w _p	I _L	I _p	USCS	Description
				from	to							
●	BH15-TMF-02	CF	3	1.22	1.83	31	32	19	0.9	13	CL	-
□	TP15-TMF-17	MA	6	2.50	3.00	25	33	19	0.4	14	CL	-
