APPENDIX 2

SITE PHOTOS

Phase 2 and 3 – Cacouna Energy, Gros Cacouna, Quebec

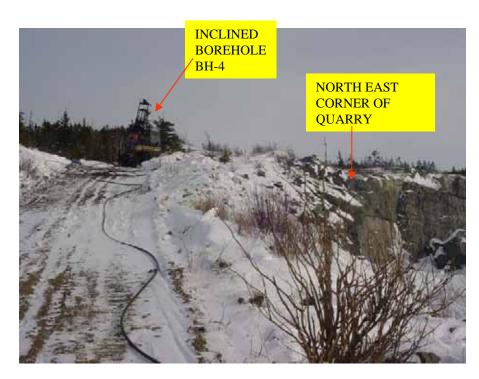
Photo 4. Location of inclined borehole BH-4 (during drilling). Drill is directed perpendicular to the fracture plane in order to intercept a continuation of the plane below tank T-100. Other than minor deformation features caused by folding of the rock in the geological past, no indications of the fracture plane were observed in the core of borehole BH-4. Borehole BH-4 revealed solid sandstone below the elevation of tank T-100.

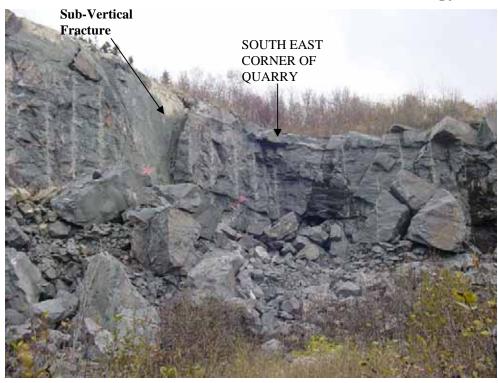
Photo 6. Area view of a sub-vertical fracture (photo looking south-east). The projection of the fracture plane separating the two massive sandstone beds continues through tank T-101 80m to the north. However, inclined borehole BH-4 and evidence from the north-east corner of the quarry cliff face (i.e., no vertical offset of the shale beds) shows proves that this fracture does not exist in the vicinity of tank T-100.

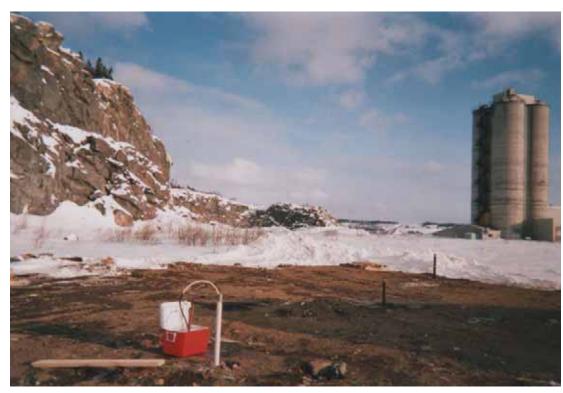
Photo 8. View of three in-line boreholes (8m apart) used for conducting the cross-hole seismic survey in the footprint of tank T-101. Borehole BH-7 (HQ-75mm) was drilled to a depth of 30m and showed the rock to be solid (strong) below the intial 0.5 metres of blast rock on the surface and 2m of fractured, blast affected rock.

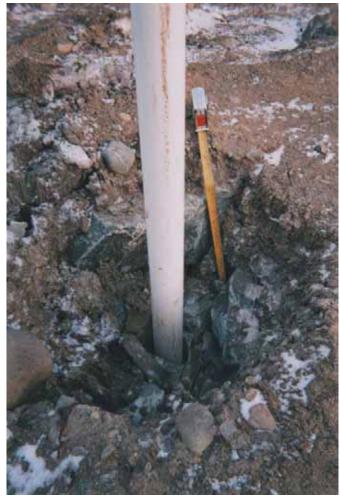
Photo 9. Close-up of borehole BH-5. Note fill placed around blasted rock layer that covers the foot print of tank T-101. Borehole was drilled through blasted rock and continued to a depth of 15m for boreholes BH-5 and BH-6 and 30m for HQ (75mm) borehole BH-7.
