HDPE geomembrane after 20 years of service

Testing reveals that most physical properties of 20-year-old pond liner pass today's requirements.

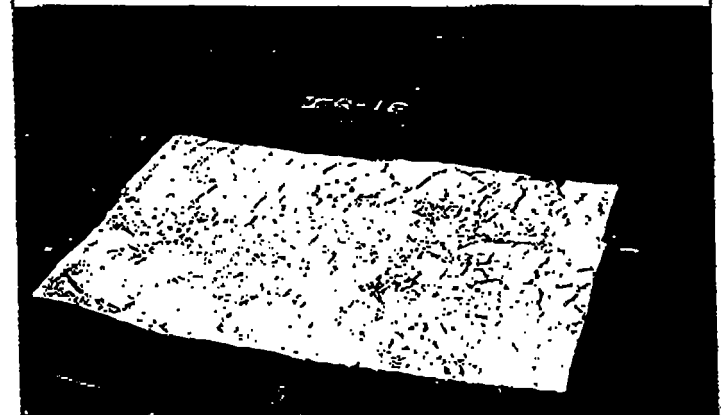
Photo 2: Desiccated soil can be seen beneath a liner sample taken above the water line (an exposed sample).
