Parachèvement de l'autoroute 35 entre la
frontière américaine et Saint-Jean-sur-Richelieu

Observations sur la tolérance aux embruns salins d'espèces ligneuses
en plantation aux abords des autoroutes

Effects of Deicing Salt on Eastern White Pine: Foliar Injury, Growth Suppression and Seasonal Changes in Foliar Concentrations of Sodium and Chloride

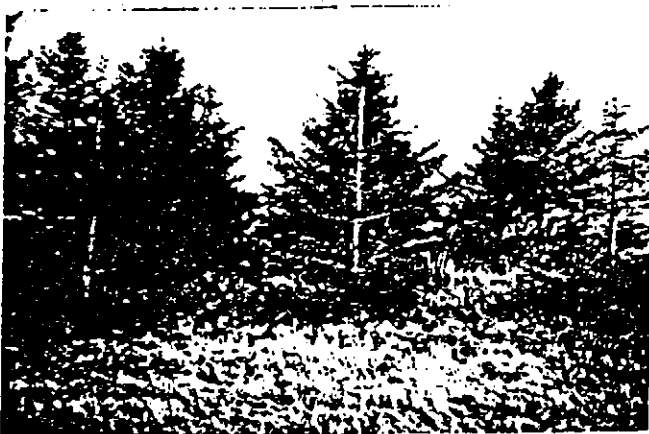
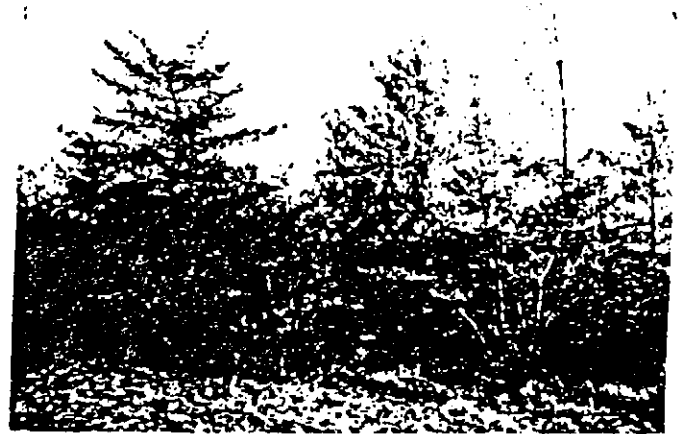
Abies balsamea

Pinus banksiana

Figure 2. Aperçu des dommages causés par les embruns salins, pour deux espèces âgées de 16 ans, situées dans la partie CC', aux abords de l'auto-route à environ 17 m du revêtement. Photos prises en novembre 1990.
