Janvier 2013

MISE À JOUR D'ÉVALUATION ENVIRONNEMENTALE DE SITE PHASE I D'UNE PROPRIÉTÉ INCLUANT DEUX TERRAINS VACANTS - NO 3 806 513 ET 4 186 802 - AU 3600, RUE F.X. TESSIER, VAUDREUIL-DORION, QUÉBEC

N° de référence : 001-12-1122-0143-3000 Rev0

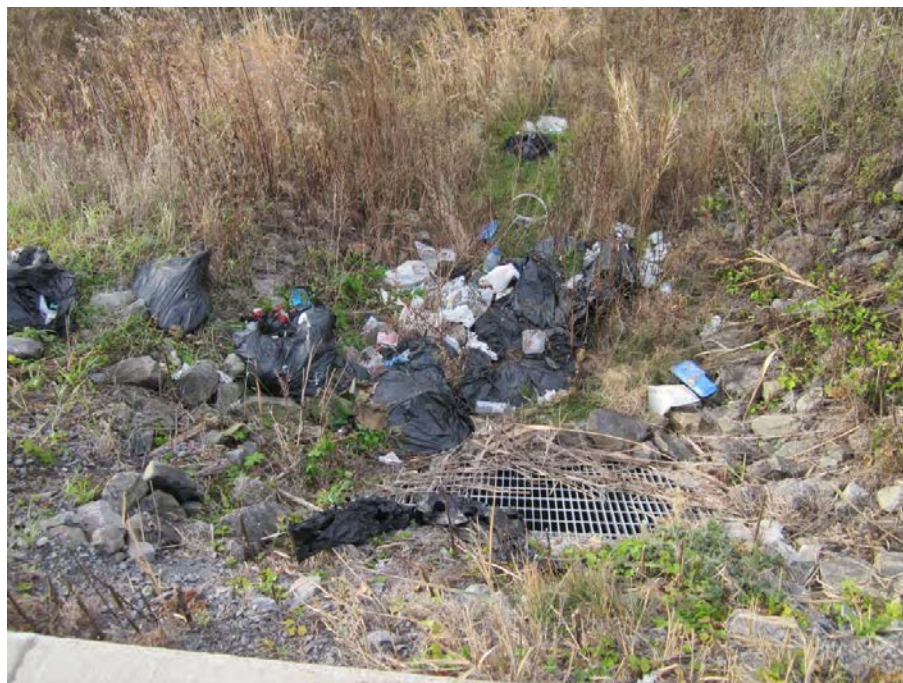
Figure 2 : Détritus observés sur le Site, près d'une grille du système d'égout pluvial, le long de la rue F.X. Tessier.

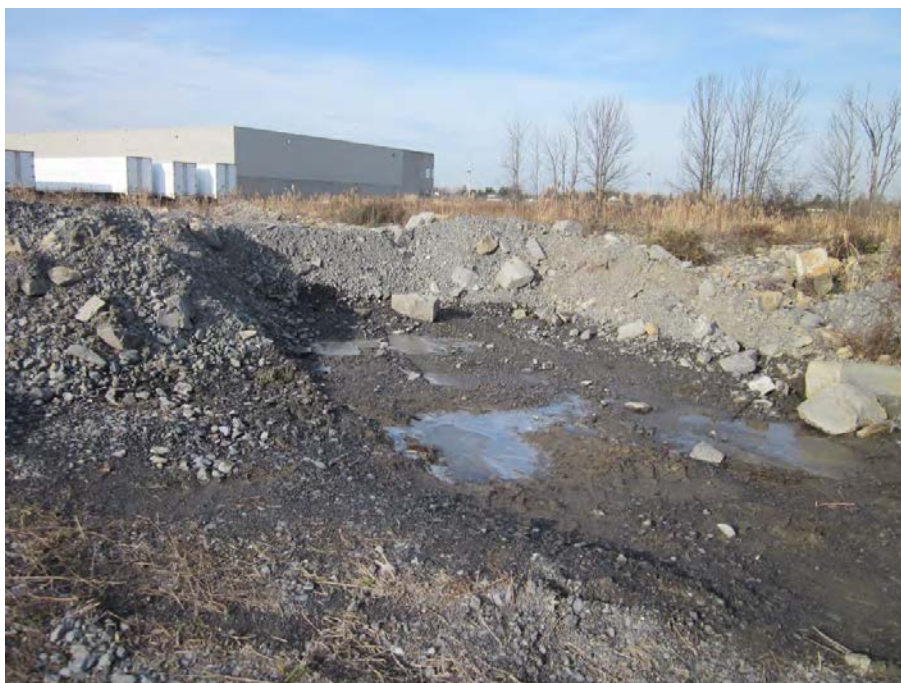
Figure 3 : Pile de remblai observée sur le Site (regardant vers l'ouest).

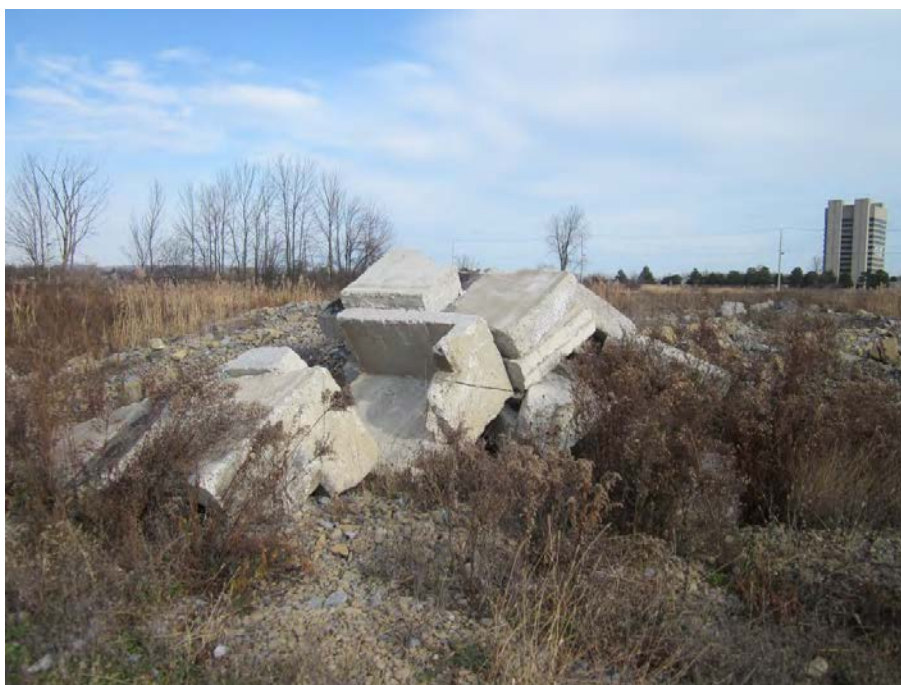
Figure 4 : Débris de béton observés sur le Site (regardant vers le nord-est).

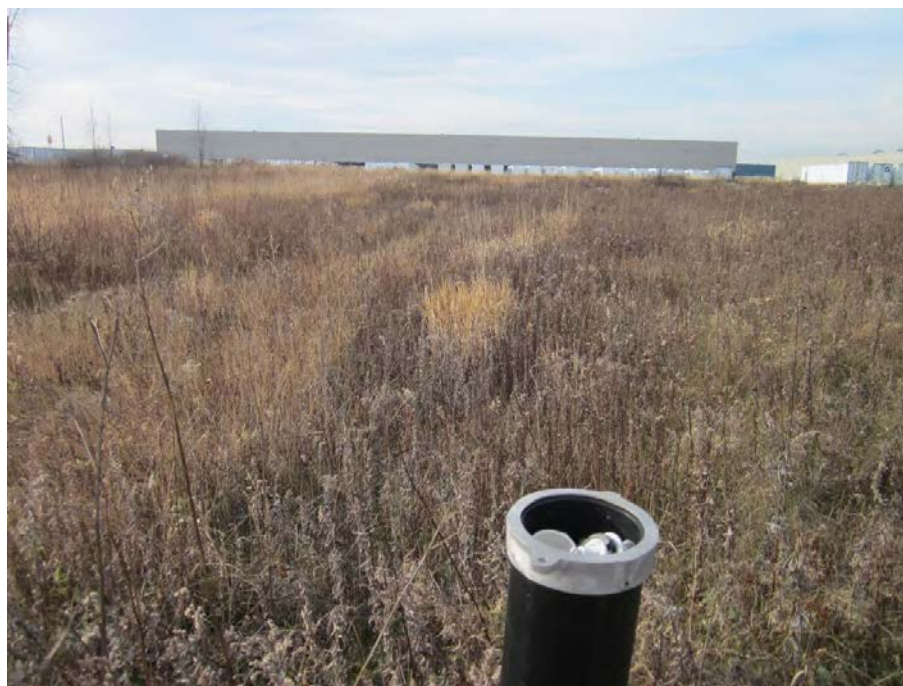
Figure 6 : Puits d'observation observés sur le Site, présumé d'avoir été installé dans le contexte de l'ÉES Phase II Limitée de Golder en 2006 (MW-06-1) (regardant vers le sud-ouest).

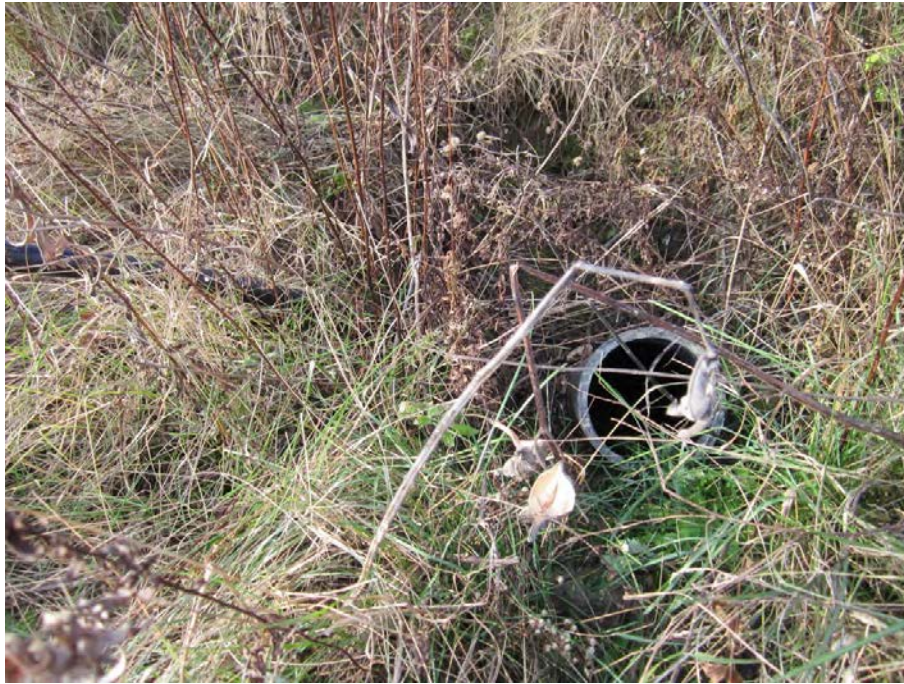
Figure 7 : Forage ouvert observé sur le Site, présumé d'avoir été installé en 2006 par Golder dans le contexte d'une étude géotechnique (BH-6).

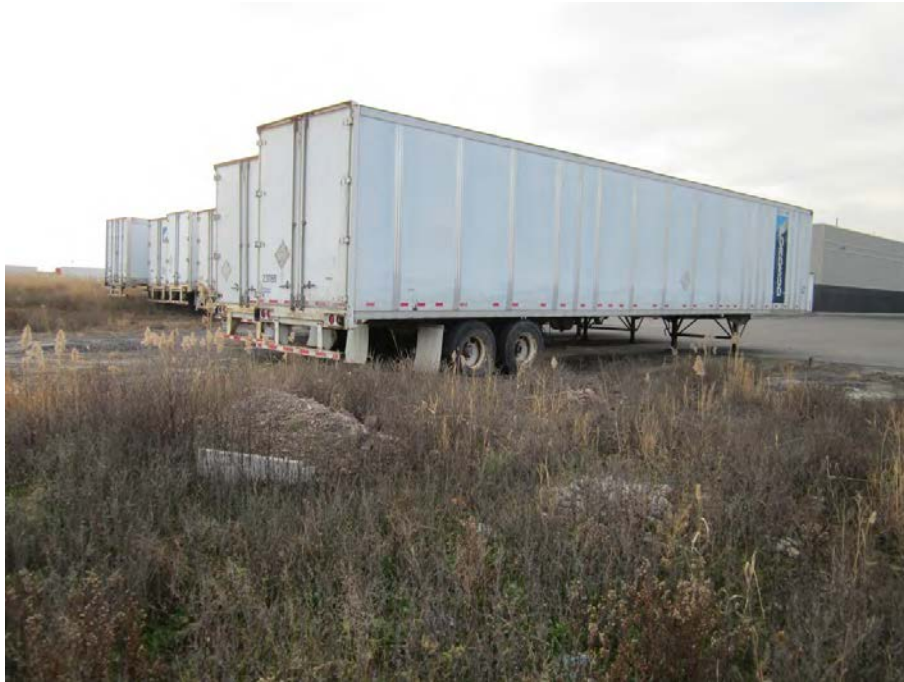
Figure 9 : Limite sud-ouest du Site et propriété voisine située à l'ouest occupée par un bâtiment commercial vacant sis au 400, rue Marie-Curie; une portion de cette propriété est occupée par un stationnement (regardant vers le sud-ouest).

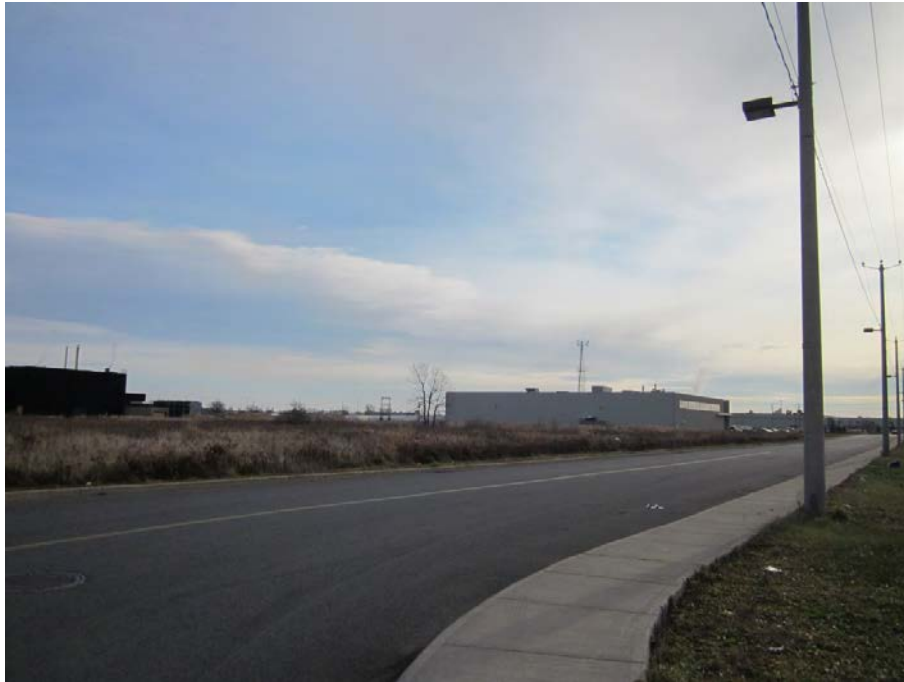
Figure 13 : Limite nord-est du Site, et propriétés voisines situées au nord-est et à l'est, occupées par des lots vacants et par un bâtiment commercial sis au 3405, rue F.X. Tessier (regardant vers le sud-est).

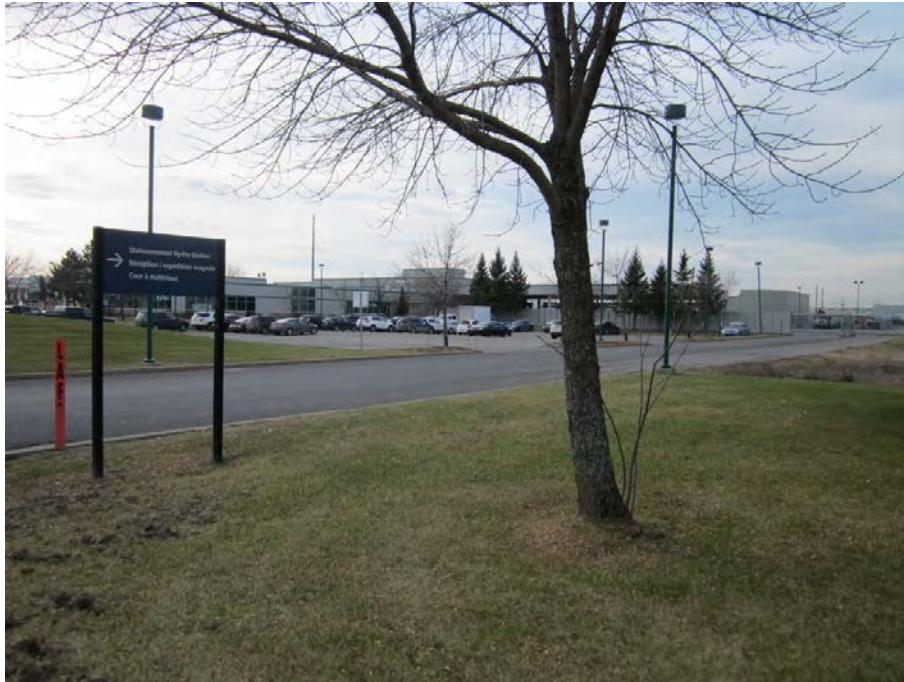
Figure 15 : Propriété voisine située au sud du Site, occupée par Hydro-Québec (regardant vers le sud-ouest).

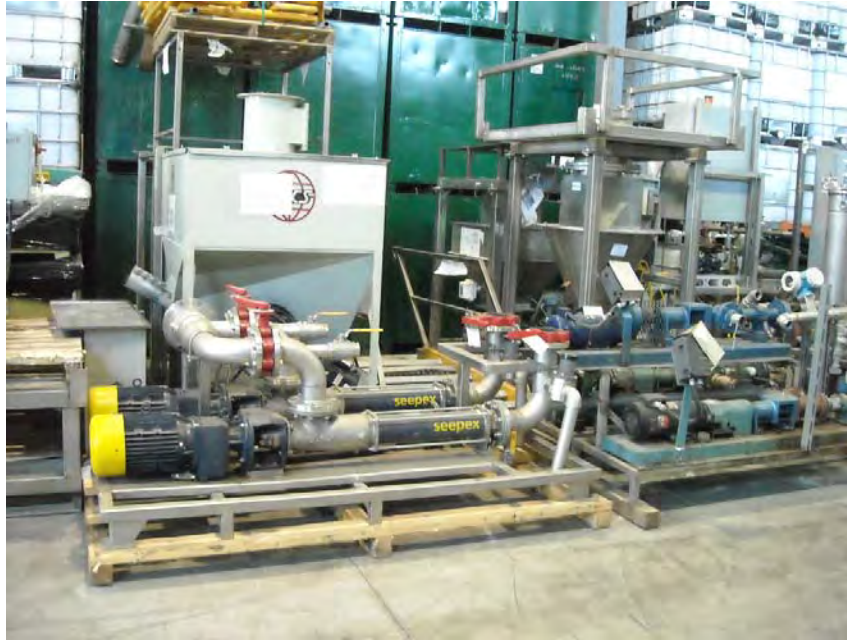
Figure 3: General view of the storage observed inside the suite occupied by Buckman Laboratories of Canada (3600 F.X. Tessier Street).

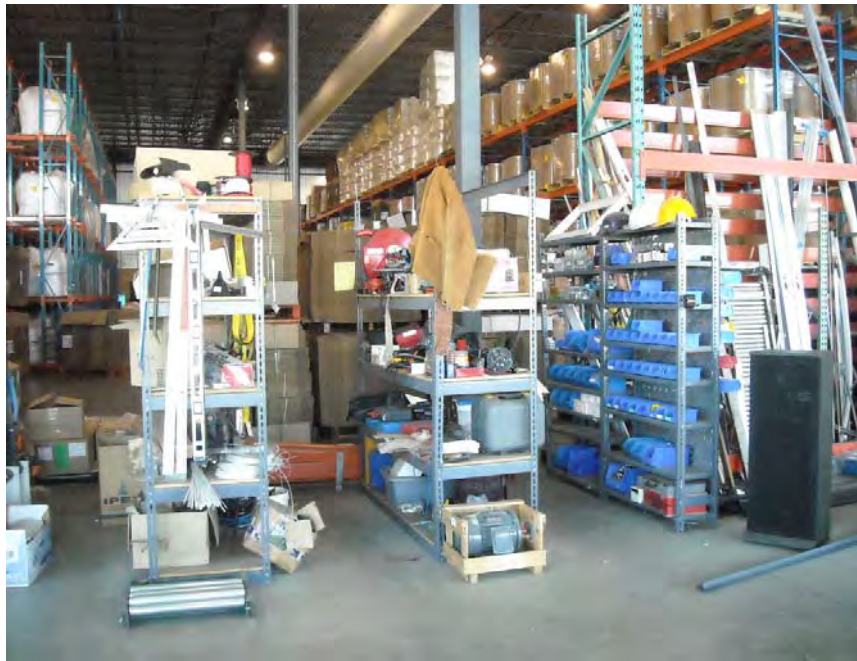
Figure 5: Partial view of storage observed inside the suite occupied by Frenesius (3600 F.X. Tessier Street).

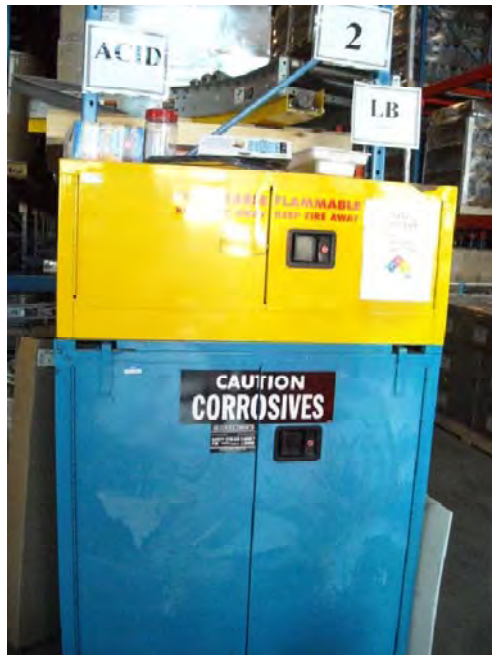
Figure 6: Partial view of flammable/corrosive products storage cabinet observed inside the suite occupied by Frenesius (3600 F.X. Tessier Street).

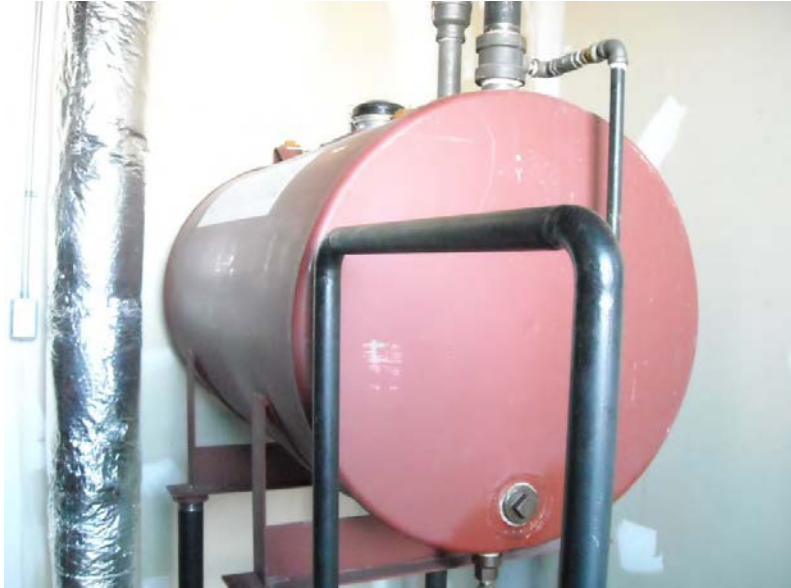
Figure 7: Partial view of the double-wall diesel AST associated with the sprinkler system, 3600 F.X. Tessier Street building.

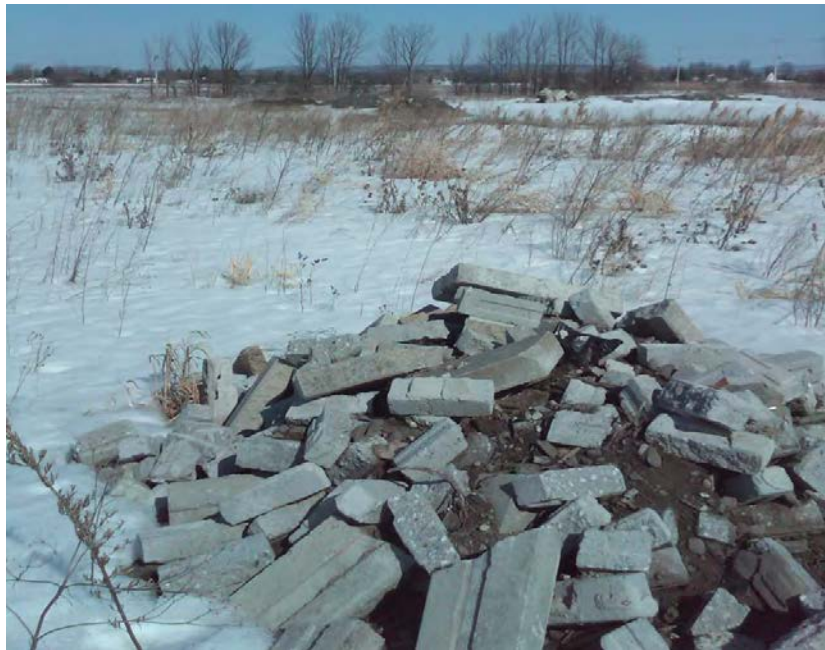
Figure 15: Partial view of the debris piles observed on the Site's vacant lots located east of the 400 Marie-Curie Street Site building.

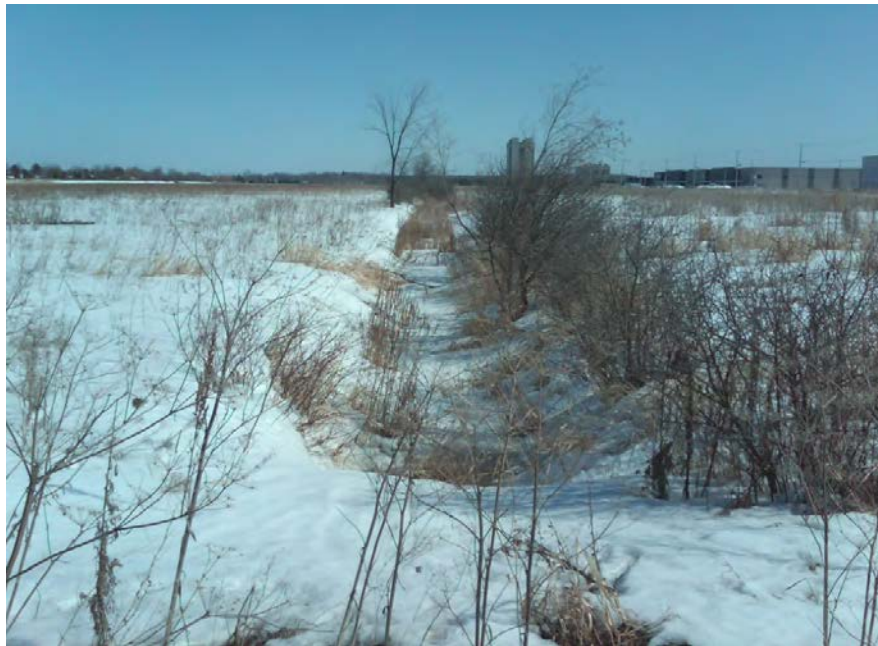
Figure 17: General view of a ditch observed in the portion of the Site consisting of vacant lots located on the north side of F.X. Tessier Street. View toward the east.

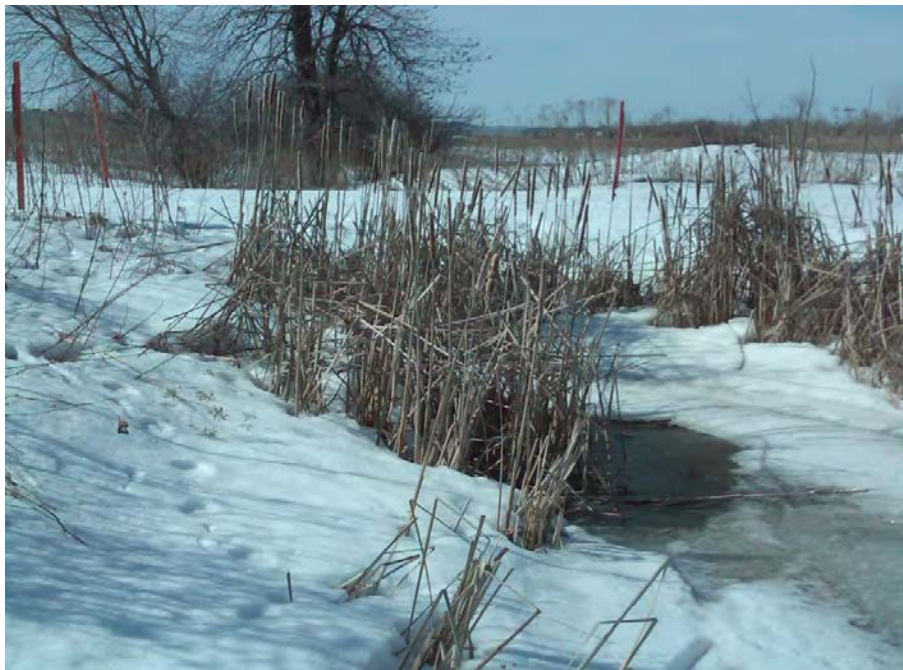
Figure 18: Partial view of a culvert and watercourse observed in the portion of the Site consisting of vacant lots located on the north side of F.X. Tessier Street. View toward the west.

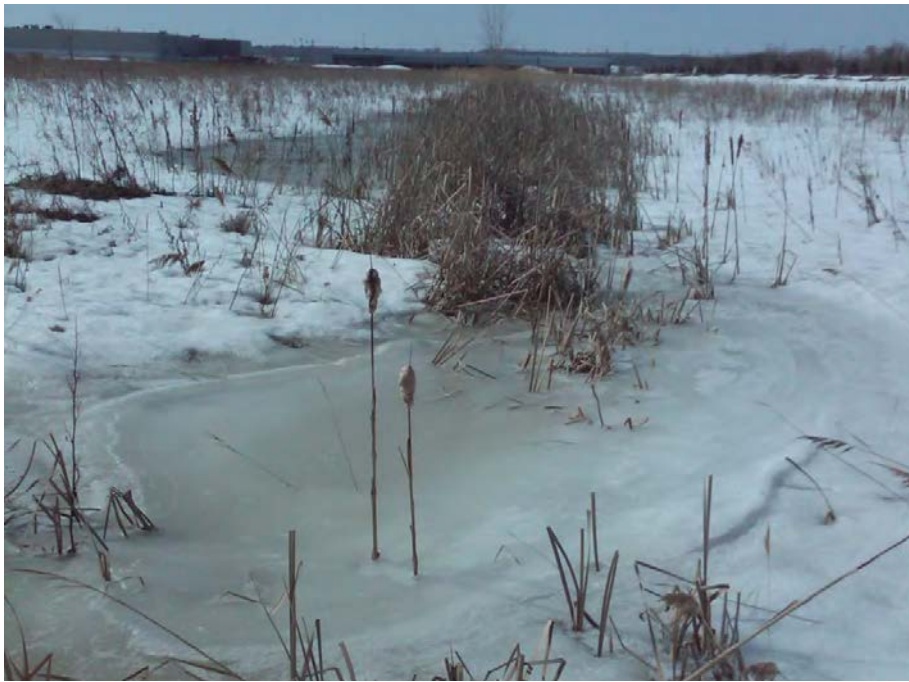
Figure 19: Partial view of a flooded area occupied by cattails observed in the portion of the Site consisting of vacant lots located on the north side of F.X. Tessier Street. View toward the east.

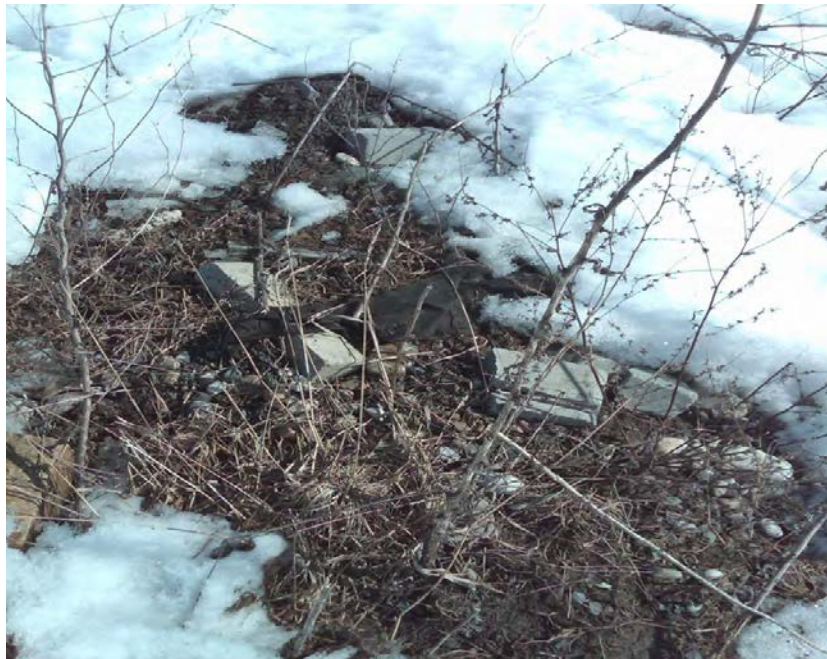
Figure 20: Partial view of debris observed in the portion of the Site consisting of vacant lots located on the north side of F.X. Tessier Street.

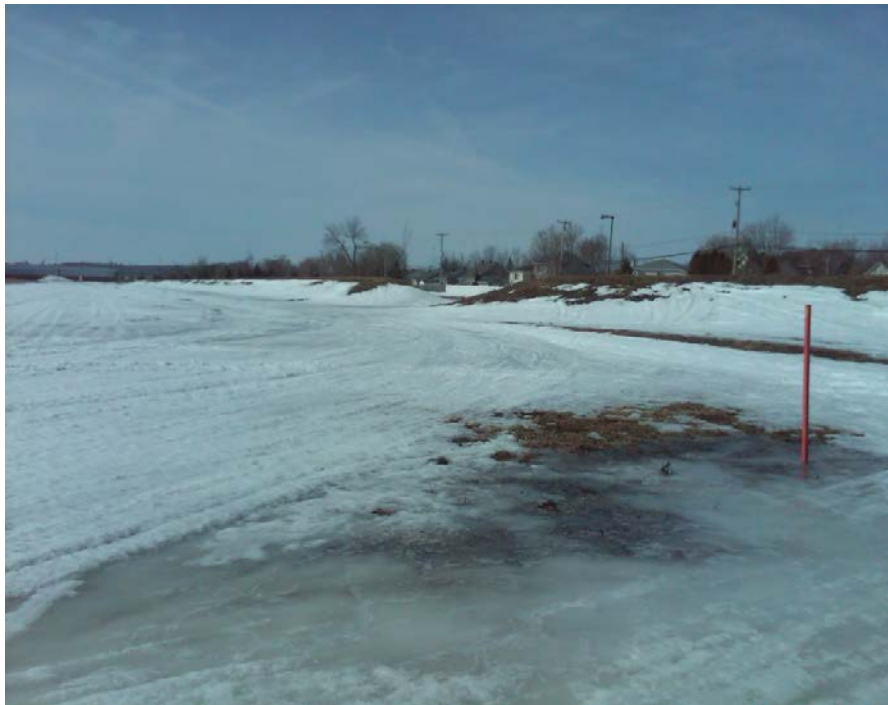
Figure 21: Partial view of a berm observed on the northwestern (adjacent to Montée Cadieux) portion of the Site consisting of vacant lots located on the north side of F.X. Tessier Street.
