# BOREHOLE RECORD

Projet Oléoduc Énergie Est de  
TransCanada – section québécoise  
6211-18-018

## BH-41

LOCATION Energy East Saint John Extension, Highway 2 Crossing, New Brunswick

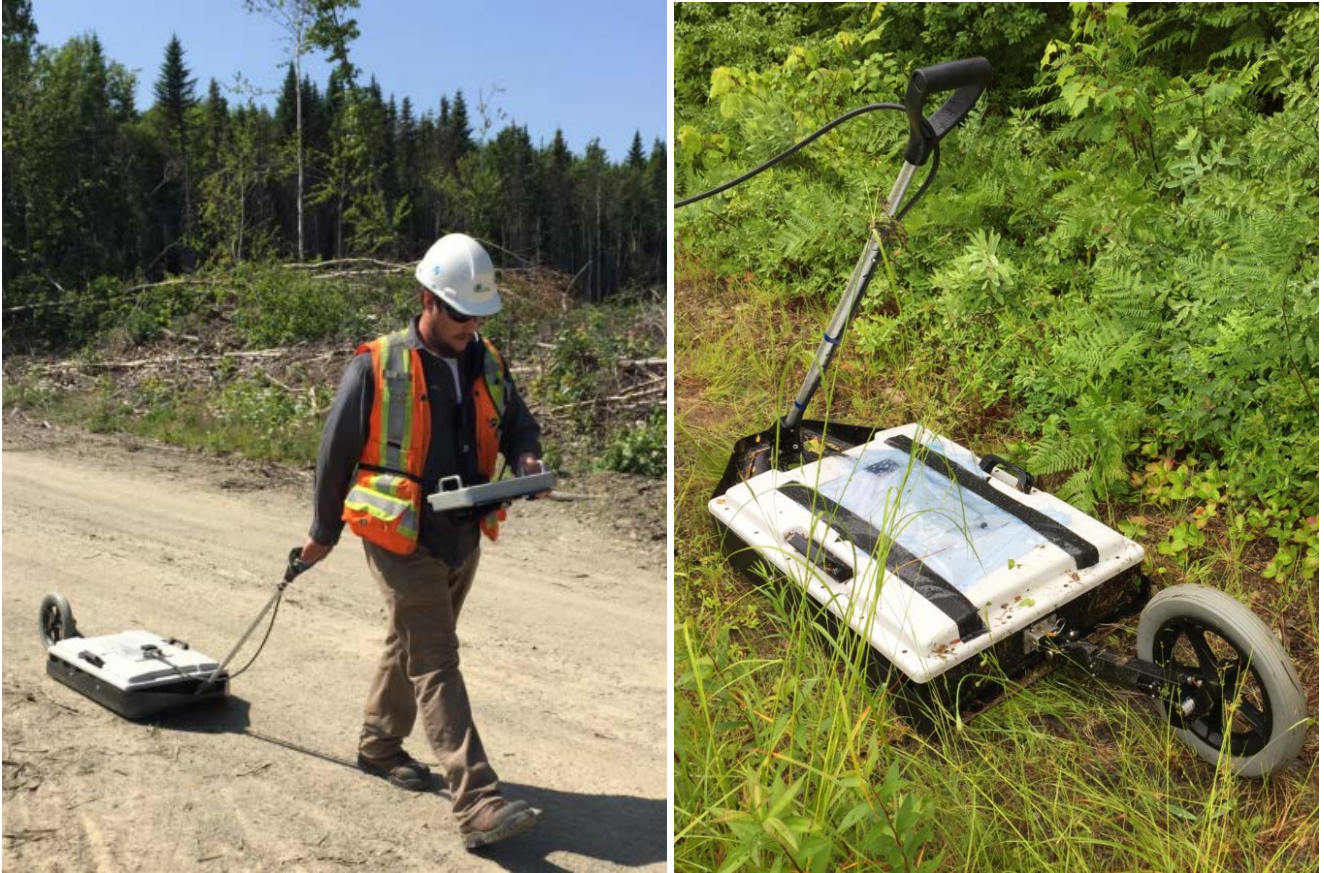
*Image 1 : Géoradar en fonction (photo de gauche); Démonstration de l'imperméabilité de l'équipement pour des conditions rigoureuses (photo de droite)*

Composantes	Mala GX
Fréquence de l'antenne	160 MHz
Distance entre les antennes	0,33
Intervalle de lecture	0,2 m
Nombre de données superposées	Jusqu'à 2048
Orientation de l'antenne	Perpendiculaire à la ligne du relevé

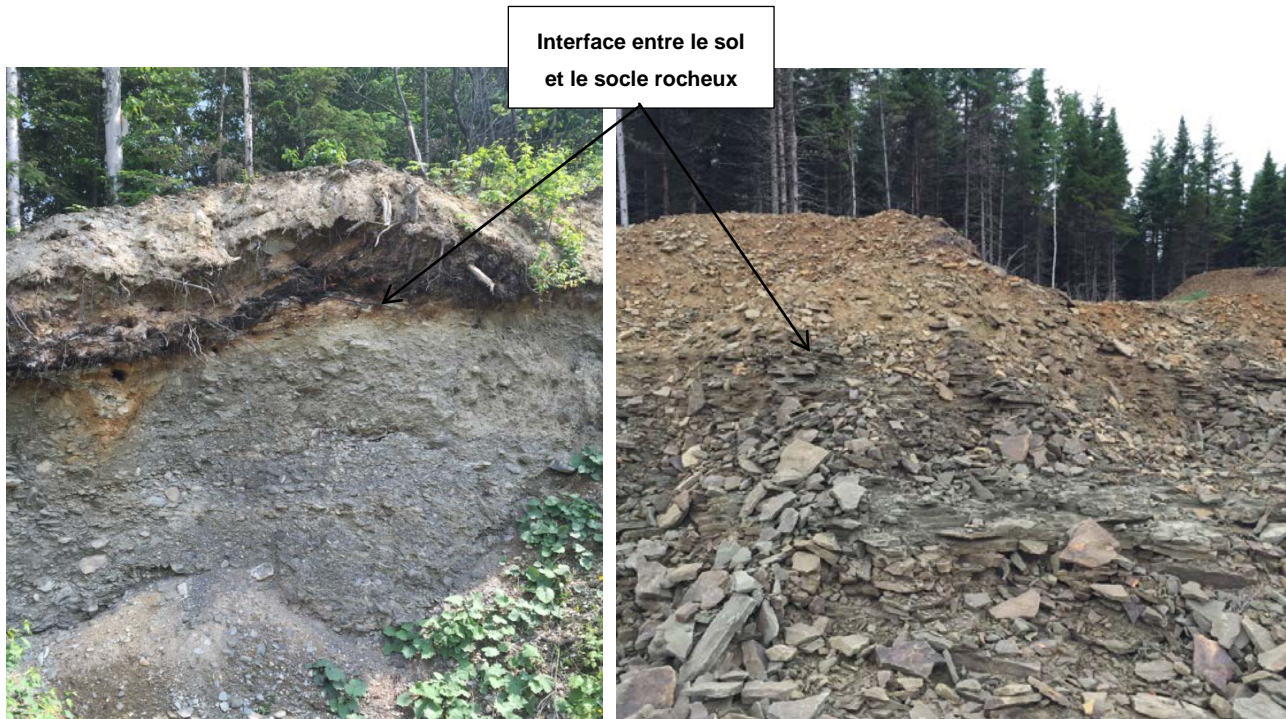
*Image 2 : L'interface entre le mort-terrain et le socle rocheux : Les racines et la couleur du matériau indiquent l'interface entre les deux couches (photo de gauche); La couleur des deux matériaux indique l'interface entre les deux couches (photo de droite)*

Des interfaces entre le sol et le socle rocheux se présentent dans les données du GPR sous la forme d'un réflecteur continu qui imite l'interface réelle. La réponse du GPR face à un roc altéré ou ayant été soumis à une action glaciaire est souvent constituée d'une série de réflexions hyperboliques continues, compte tenu de la nature fracturée et polyédrique du roc près de la surface. En raison de l'âge très avancé de l'interface du substratum rocheux au Nouveau-Brunswick, l'interface entre le mort-terrain et le roc est souvent « floue », au mieux (voir les photos de l'image 3). En conséquence, le contraste des propriétés diélectriques entre ces deux horizons est parfois très faible, ce qui crée une réflexion faible et / ou mauvaise du signal de l'émetteur GPR. Le résultat est une interface mal définie du substratum rocheux. Plusieurs sections le long du tracé ne pouvaient pas être interprétées avec confiance relativement à la présence d'un réflecteur (assise rocheuse), ce qui a amené une absence d'interprétation.

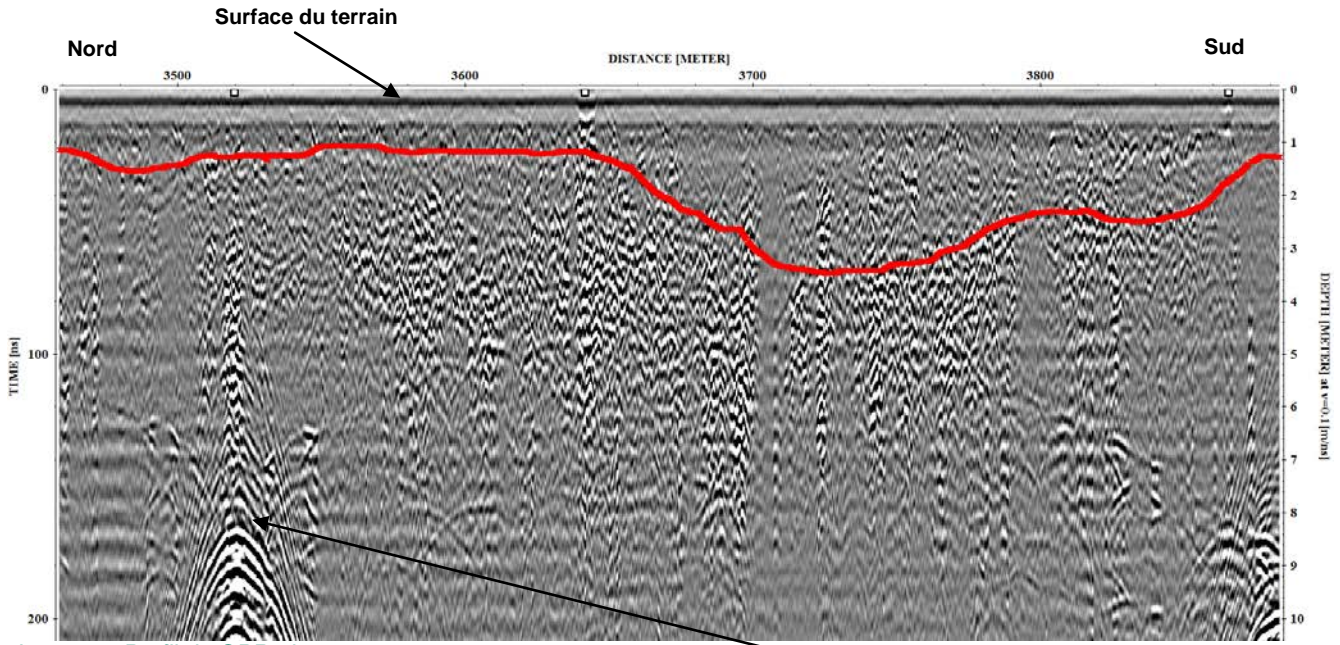
Image 3 : Profil de GPR obtenu au segment 16

Réflexion aérienne causée par des pylônes électriques

Les images 3 à 6 sont des exemples de profils obtenus à l'aide du géoradar lors de la présente investigation. Ces profils montrent certains éléments identifiés à partir des données. Ces différentes coupes illustrent la variété des réponses du GPR, rencontrées d'une extrémité à l'autre de la province. La ligne rouge correspond à l'interface interprétée du socle rocheux.

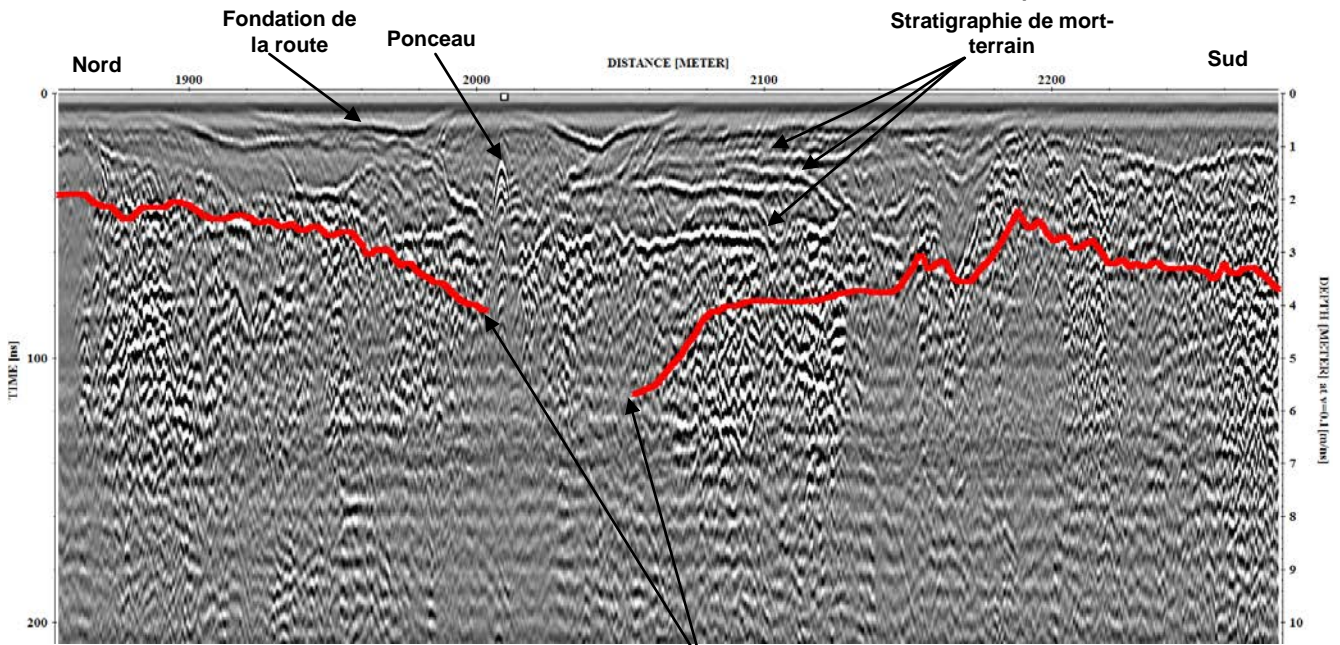
Image 4 : Profil de GPR obtenu au segment 25

Absence d'interprétation du socle rocheux. Aucun réflecteur n'a été défini.
