# NUNAVIK ABANDONED MINERAL EXPLORATION SITES REHABILITATION PROJECT

## 2013-2014 ACTIVITY REPORT

**Kativik Regional Government**

**April 2014**

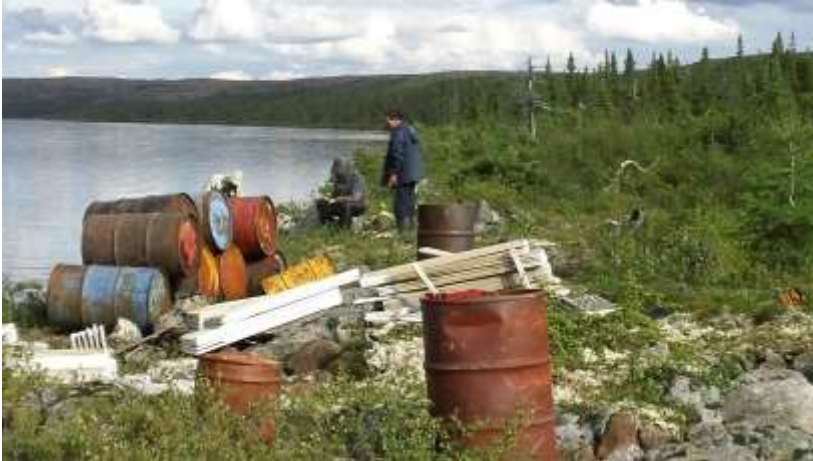
Figure 1: Workers on site KAW-36, August 2013

In collaboration with the Naskapi Nation of Kawawachikamach and the Innu Nation of Matimekush-Lac John, an initial inspection of the site was undertaken in June and a cleanup session was carried out in August 2013. 40 barrels, drill rods, core boxes, and various metal waste were removed from site. Photographs of the material transported from the site are found in Appendix 2.

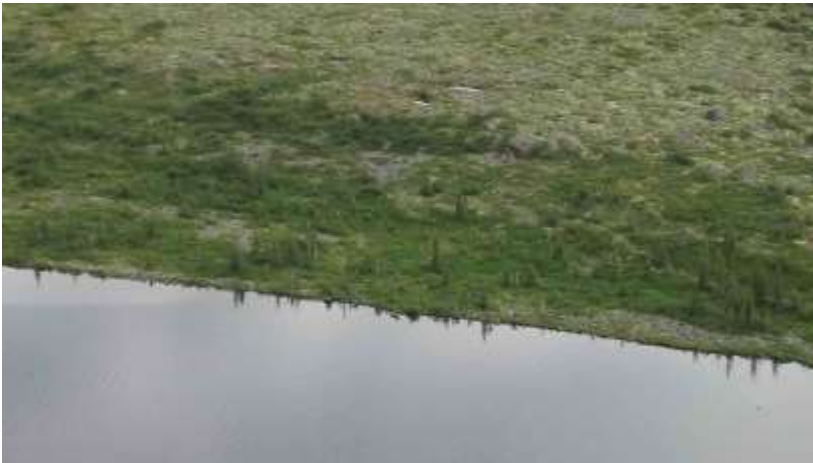
Figure 2: Aerial view of site KAW-36 after cleanup, August 2013

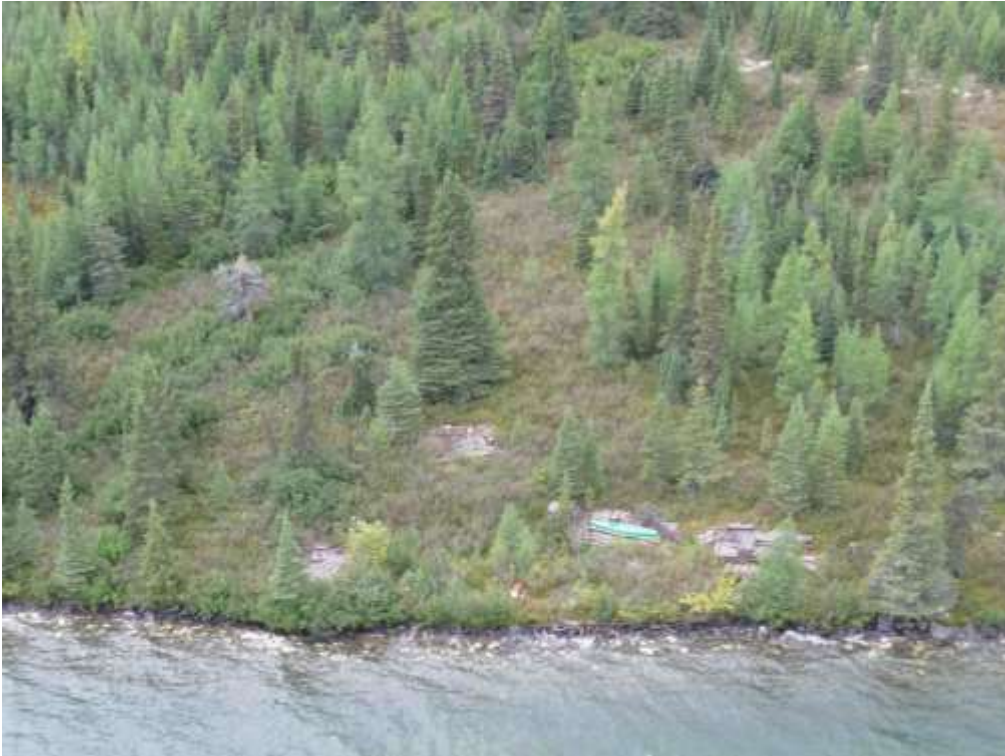
Figure 3: Site KAW-59 during 2011 inspections

stoves and metal pipes were removed. Some wooden debris was left on site. Photographs of the site before cleanup are found in Appendix 2.

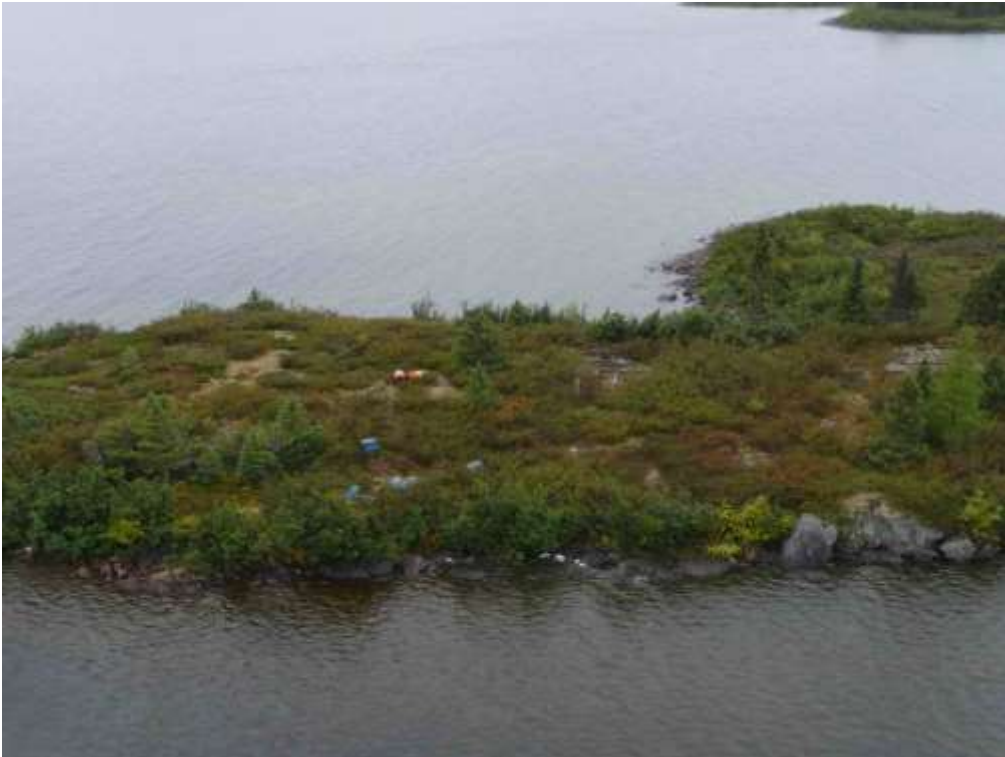
Figure 4: Site KAW-119, during 2011 inspections

An initial inspection of the site was undertaken in June and the cleanup was completed in September 2013. Mostly metal debris was removed from the site and included 60 barrels, 30 propane tanks, stove and small metal cans. This material was transported to Kuujuaq by helicopter where it was stored in marine containers and shipped to a recycling facility by ship in October. Wooden debris was either burned or left to rot of site. The site is now considered as rehabilitated.

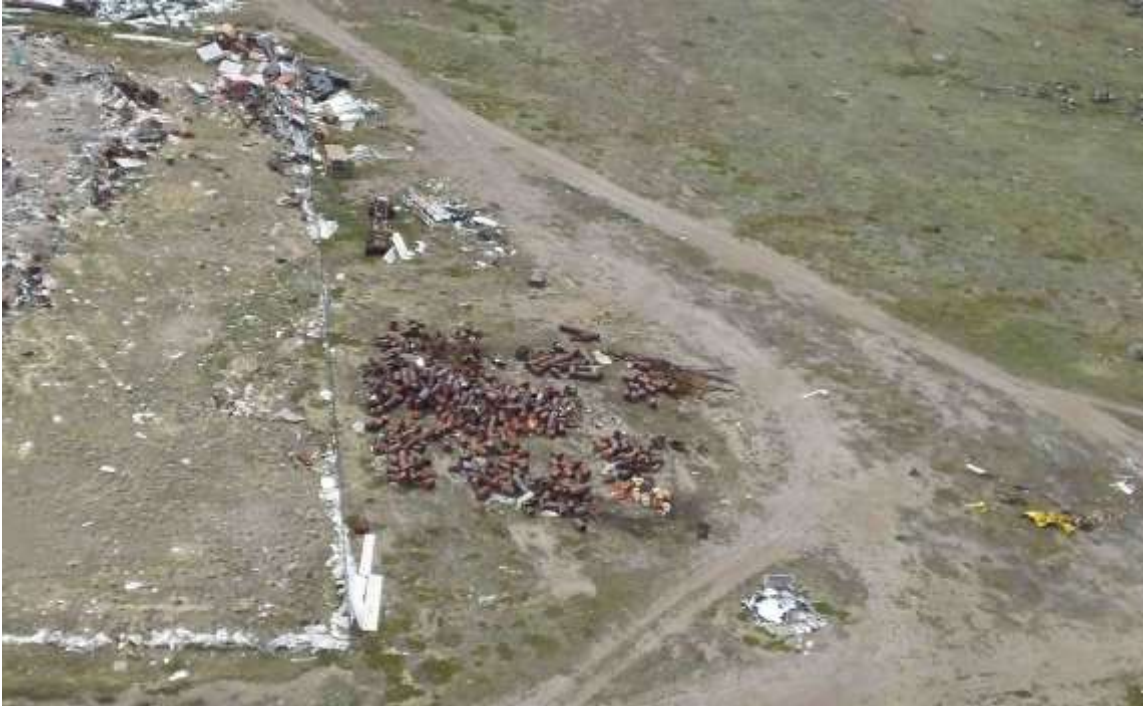
Figure 5: Barrels located at the Aupaluk disposal site, August 2013

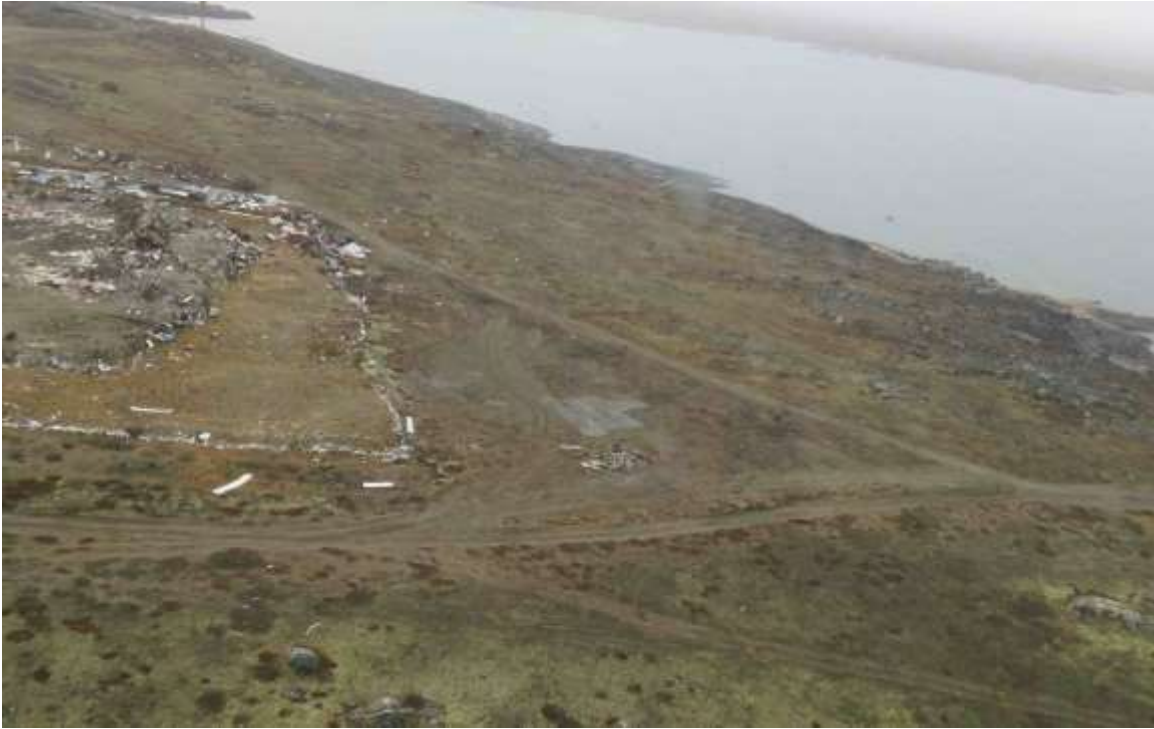
Figure 6: Aupaluk disposal site after removal of barrels, October 2013

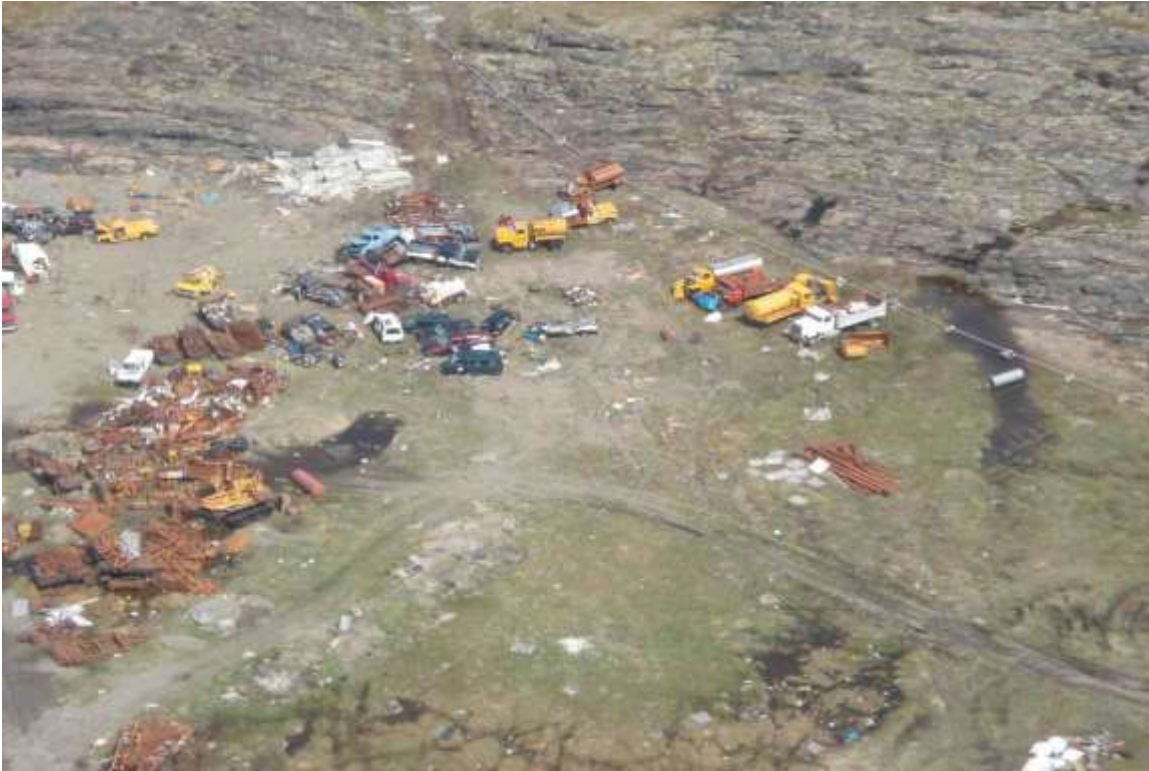
Figure 7: View of material stored next to municipal garage in Aupaluk, October 2012

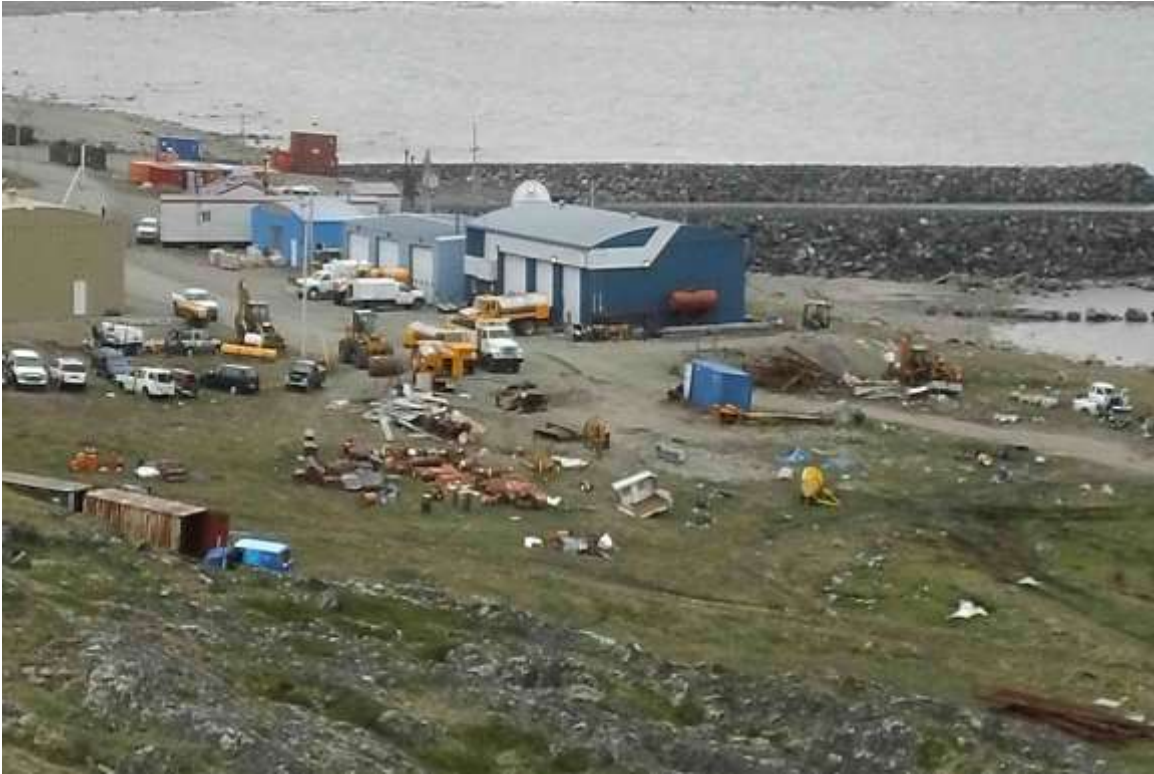
Figure 8: View of municipal garage area after material was removed, August 2013

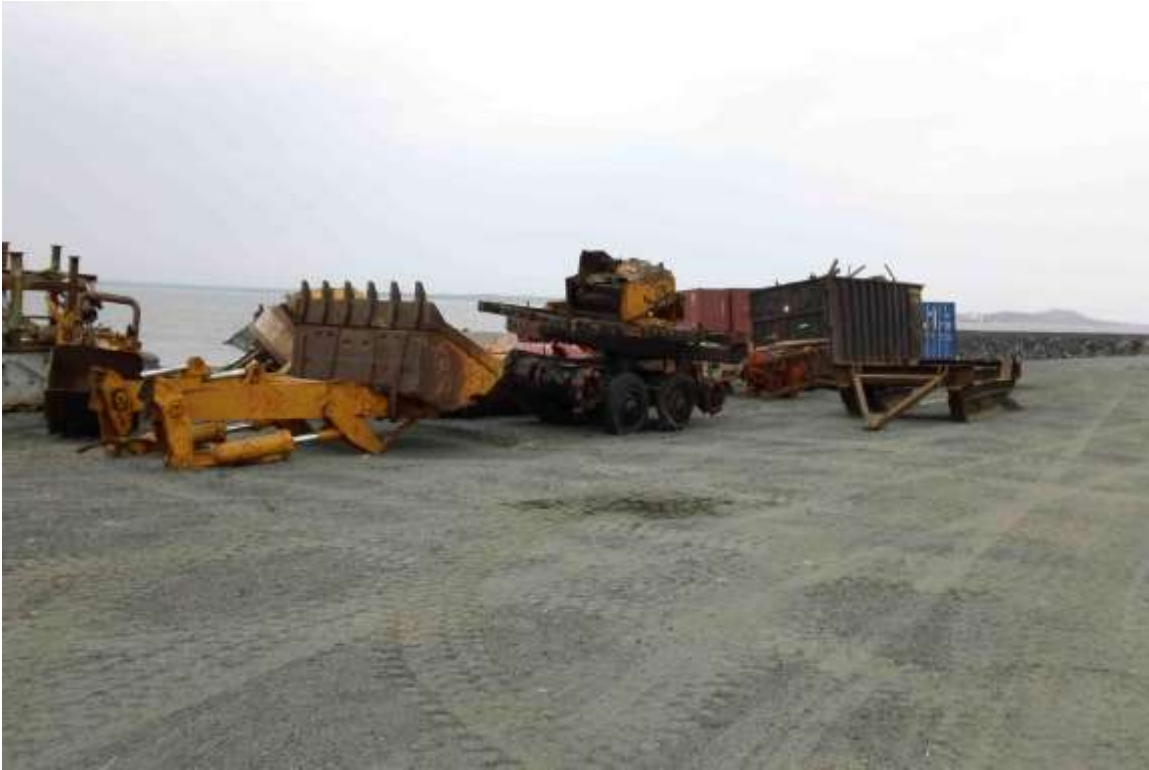
Figure 9: Material at dock in Aupaluk, October 2013

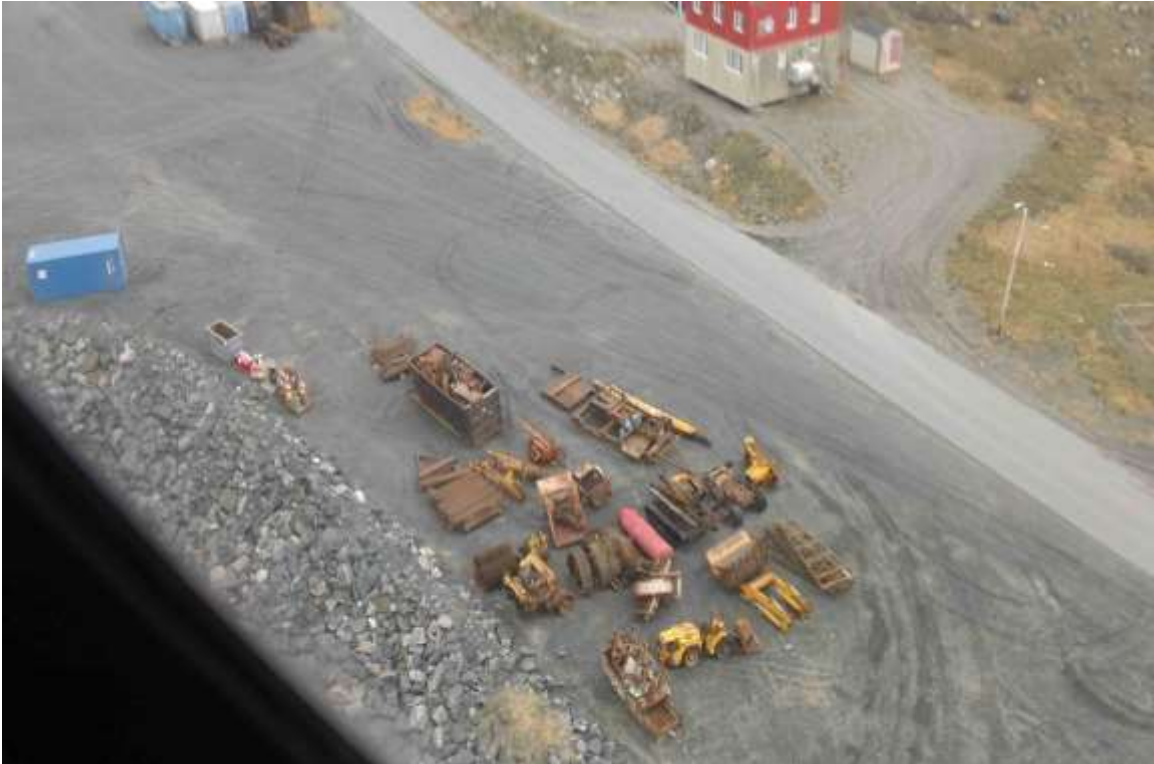
Figure 10: Aerial view of material at dock in Aupaluk, October 2013

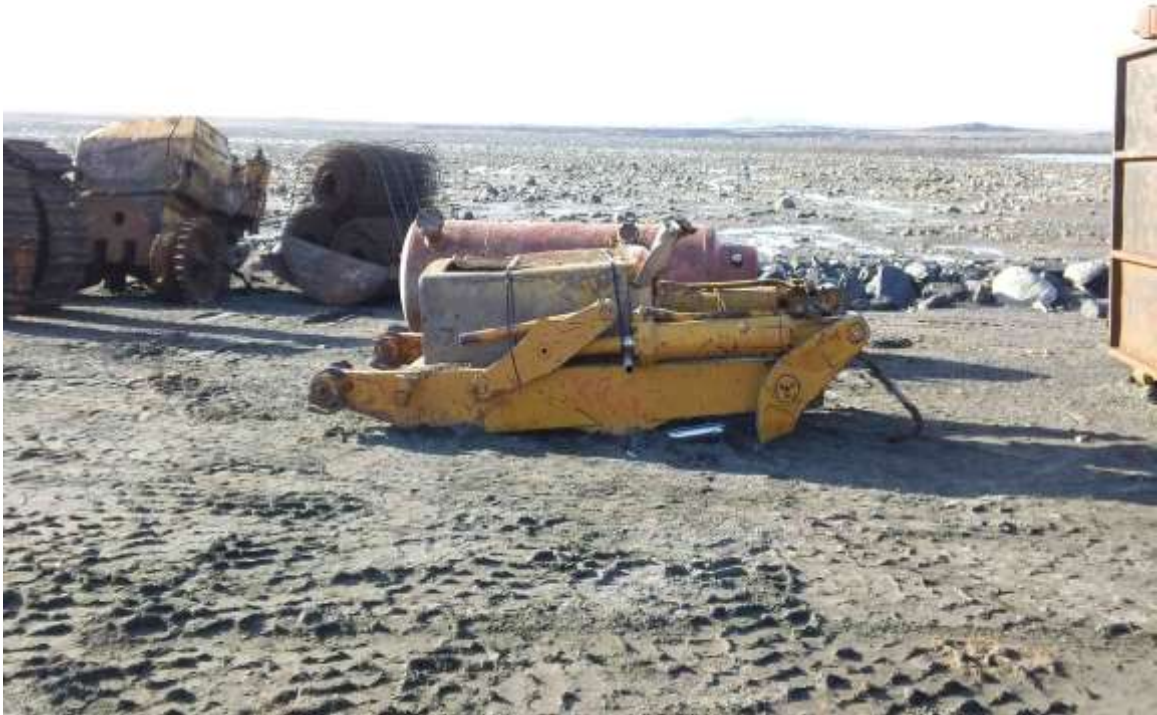
Figure 11: Example of remaining material in Aupaluk, October 2013

Metal waste, including the drums, as well as the miscellaneous debris, can be transported by helicopter to Kuujjuaq where it will be stored in marine containers and transported by ship. Wood debris can be burned on site.

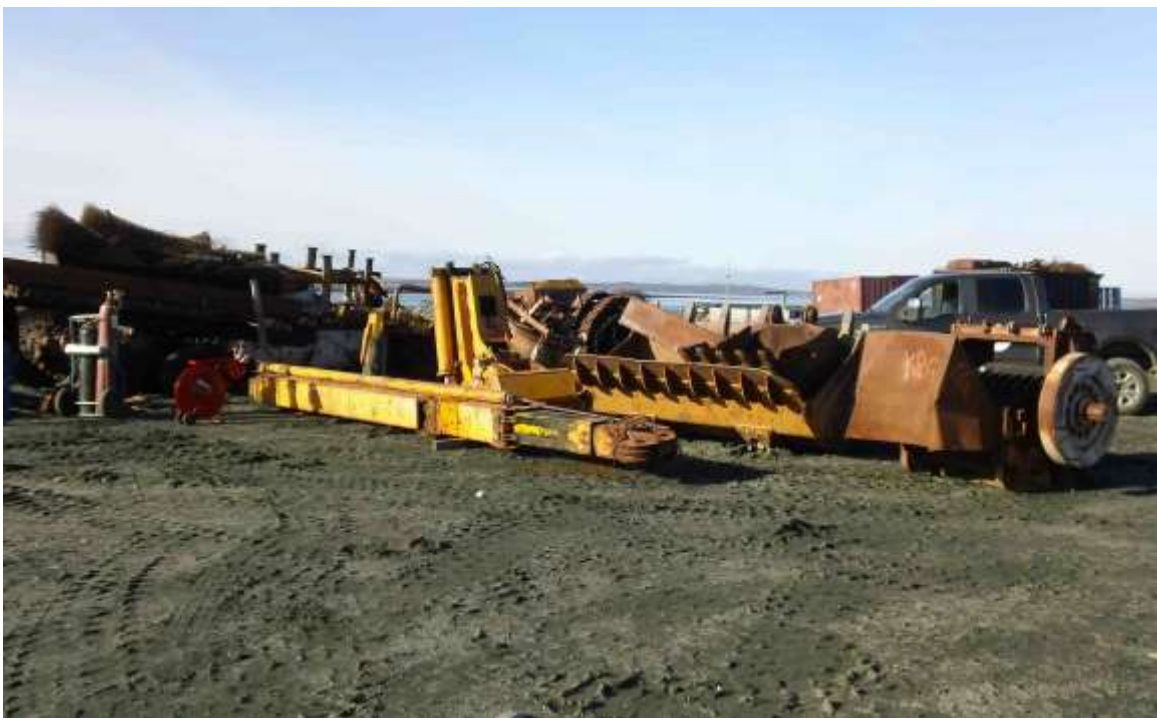
Figure 12: Example of remaining material in Aupaluk, October 2013

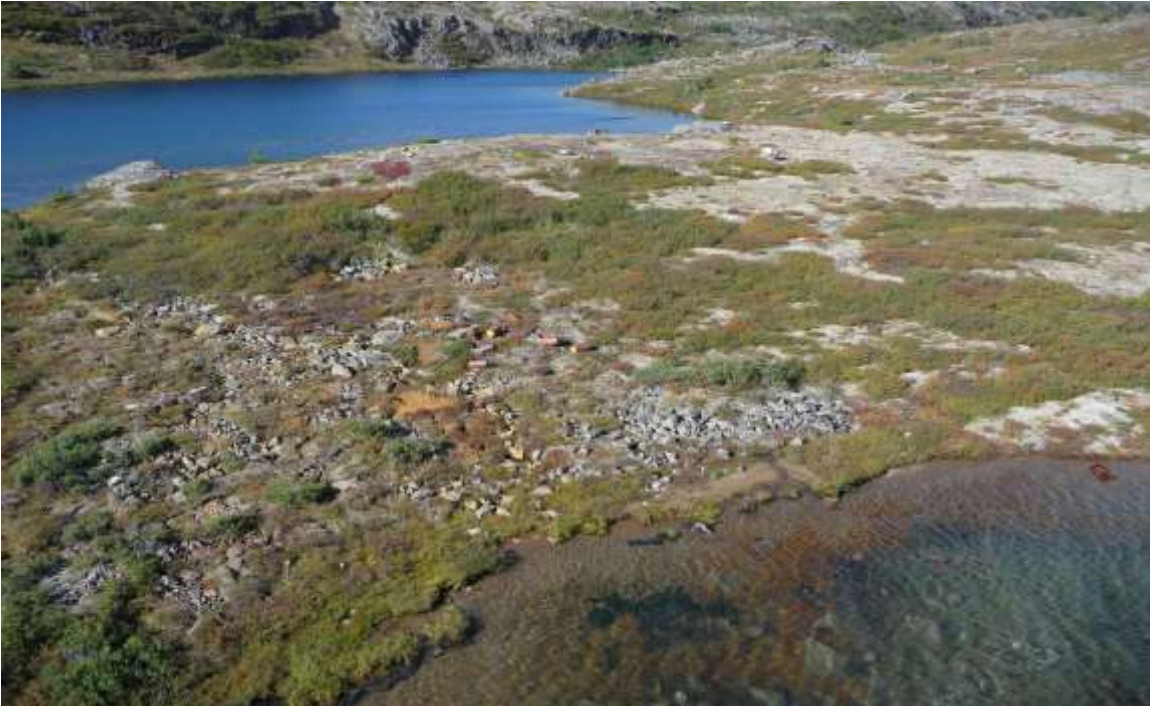
Figure 13: Aerial view of site TA-1, September 2011

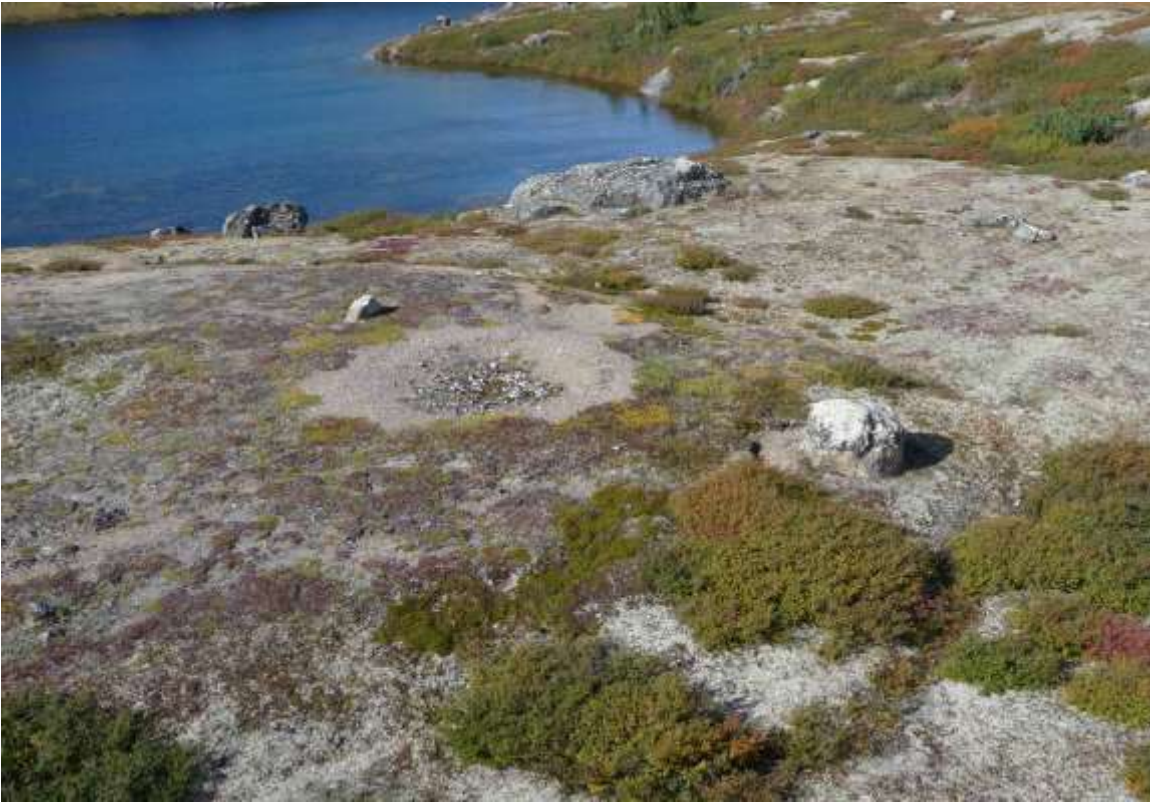
Figure 14: Small disposal site at site TA-1, September 2011

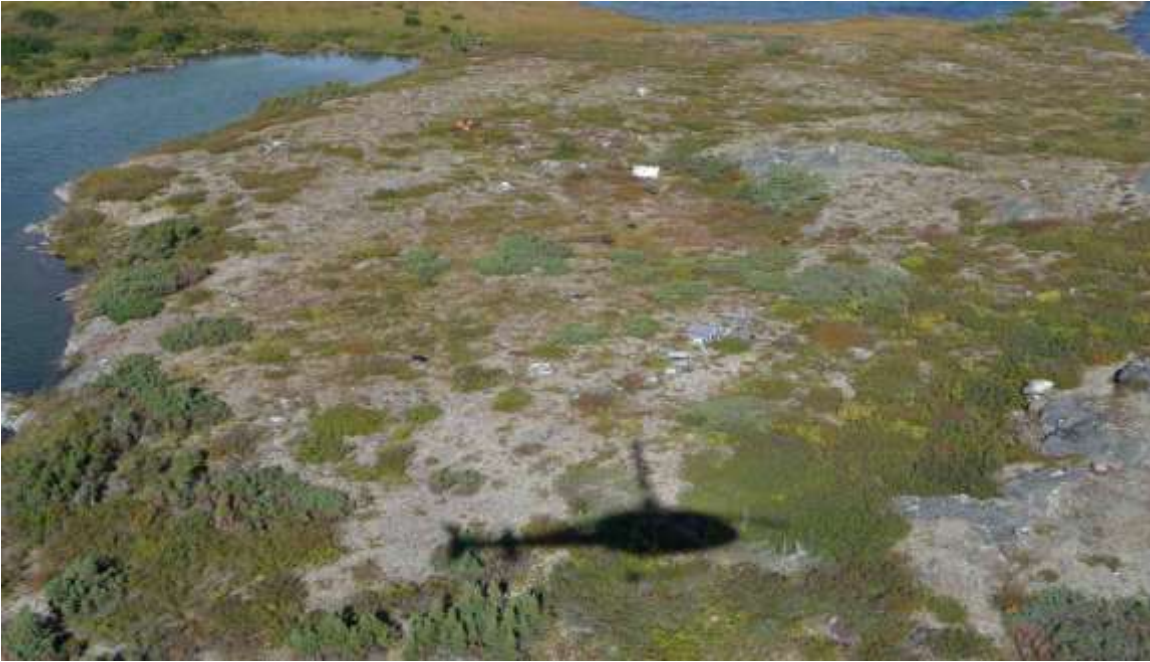
Figure 15: Aerial view of site TQ-6, September 2011

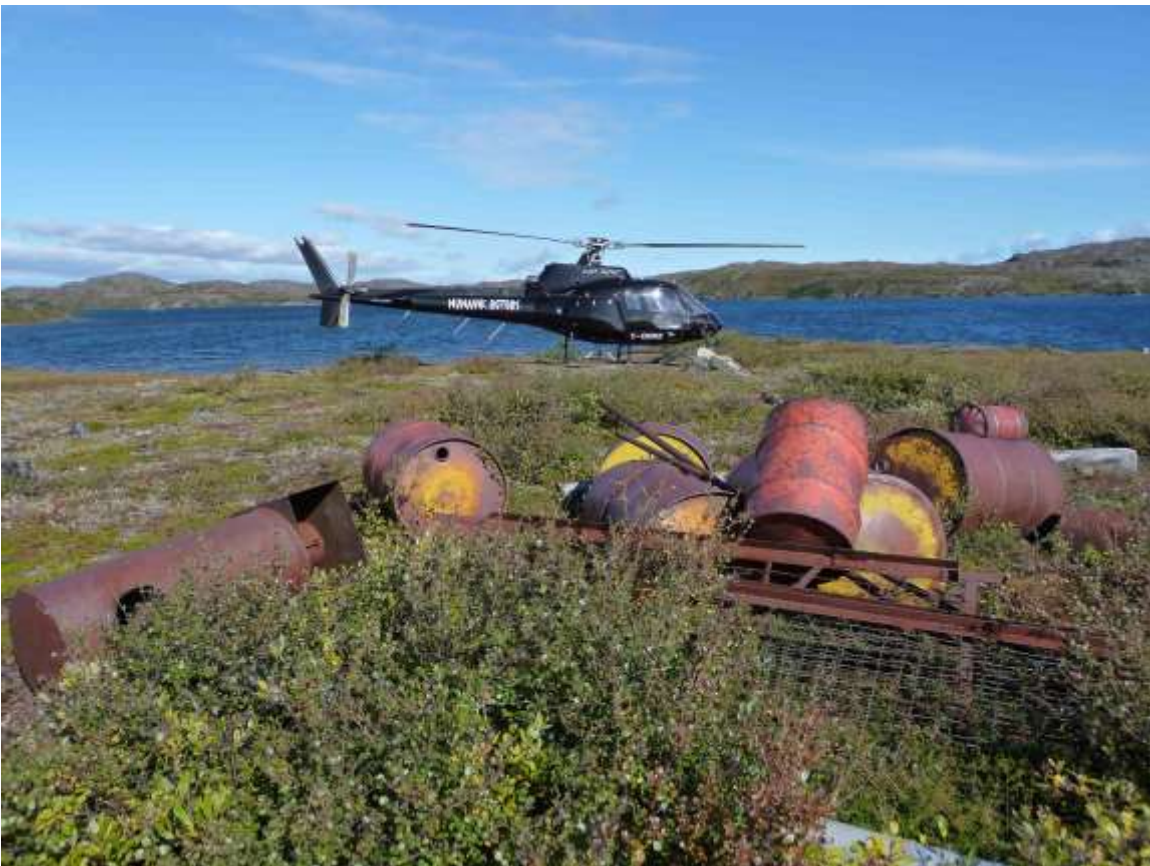
Figure 16: Material found on site TQ-6, September 2013

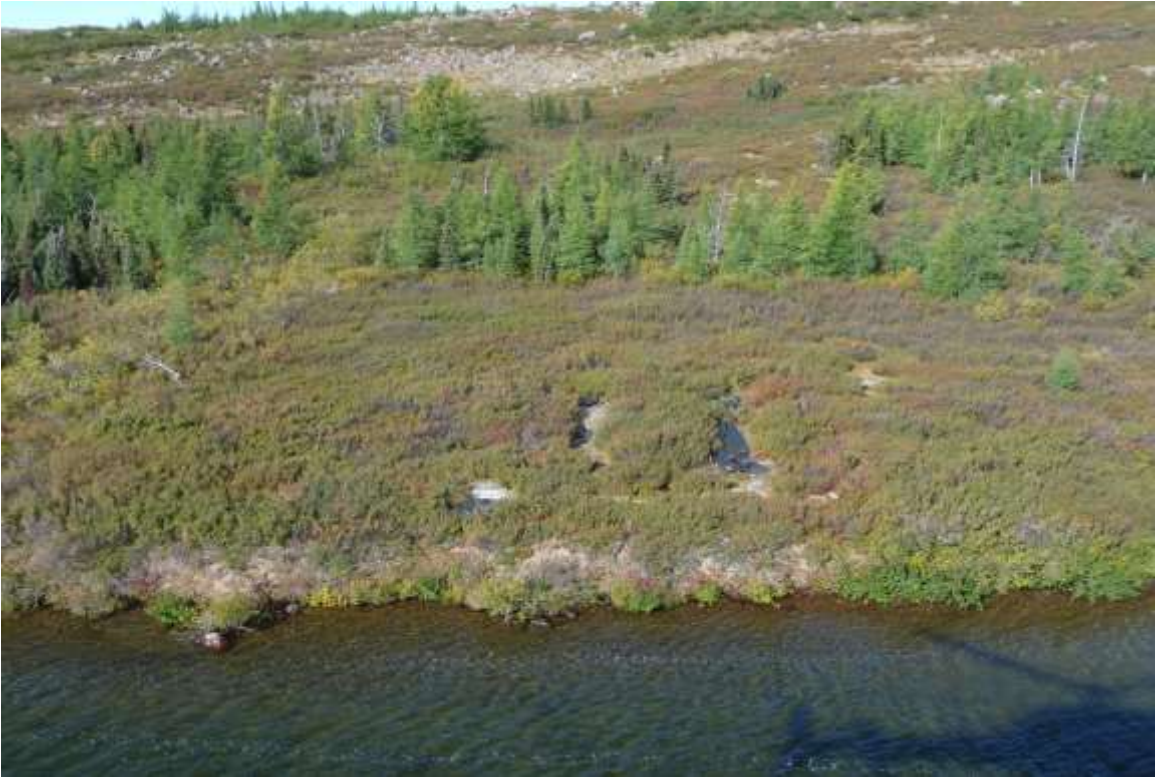
Figure 17: Aerial view of site TQ-10, September 2011

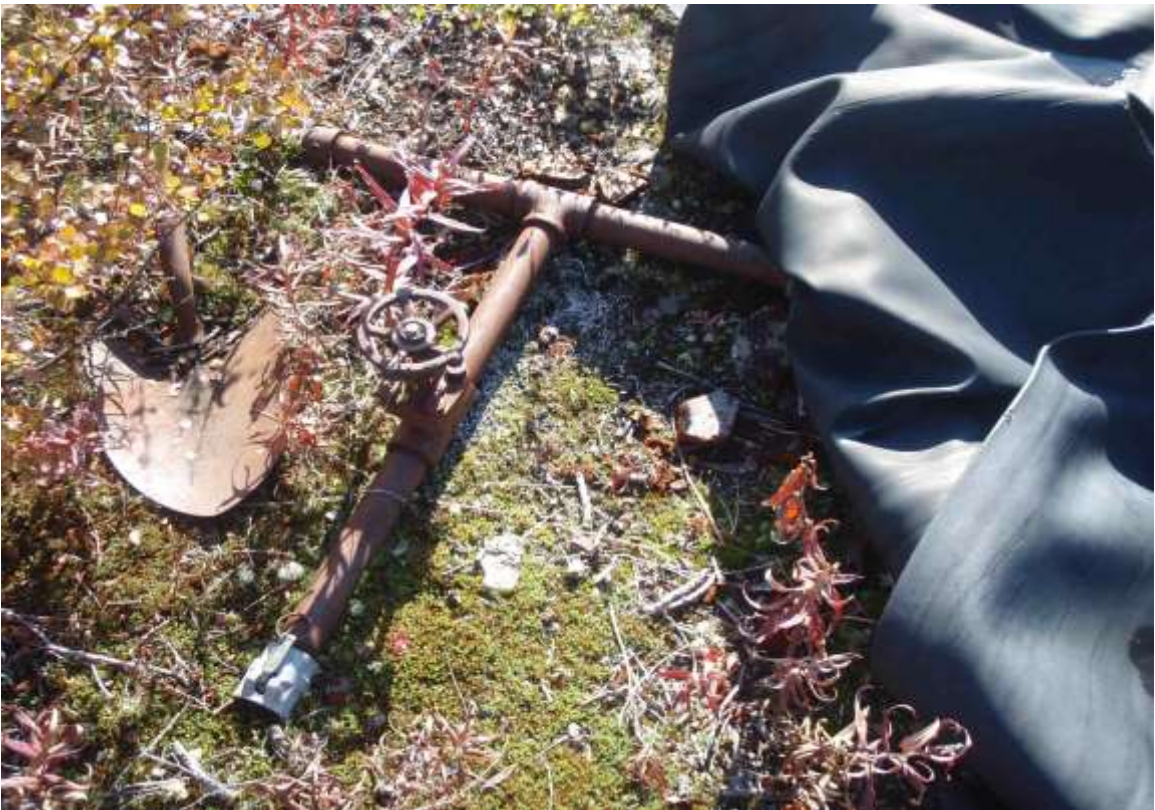
Figure 18: Material found on site TQ-10, September 2011

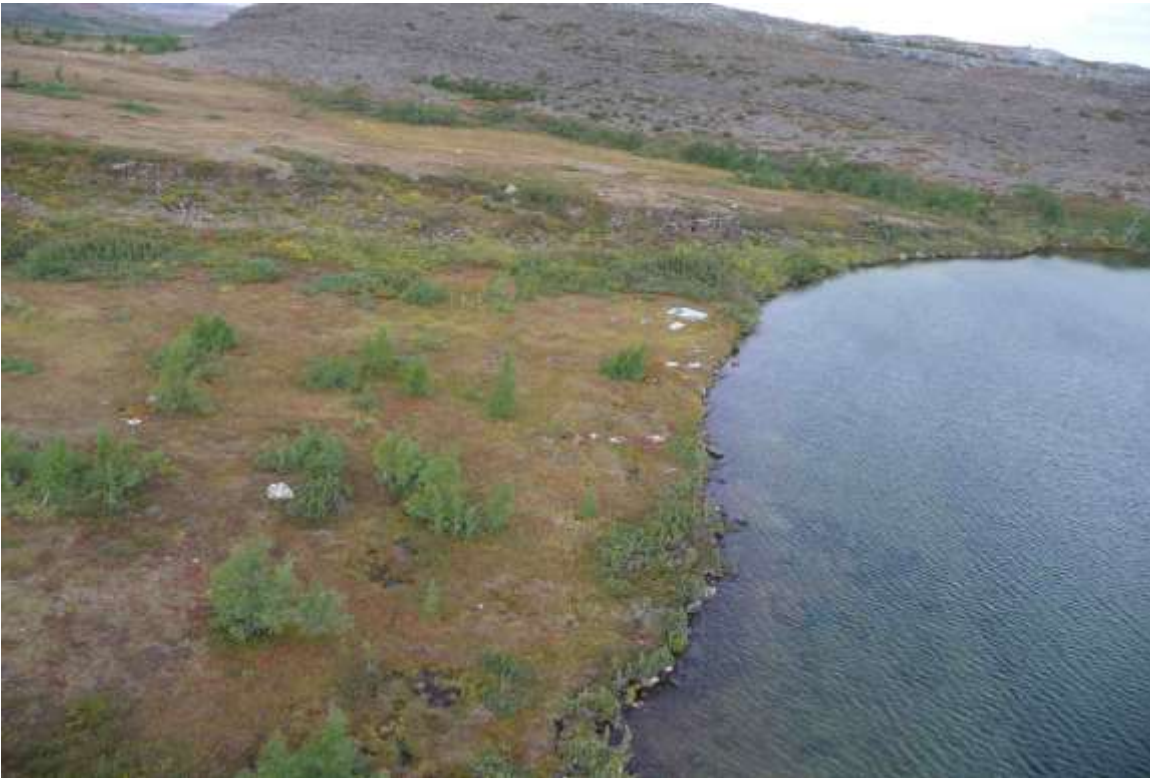
Figure 19: Aerial view of site TQ-14, September 2011

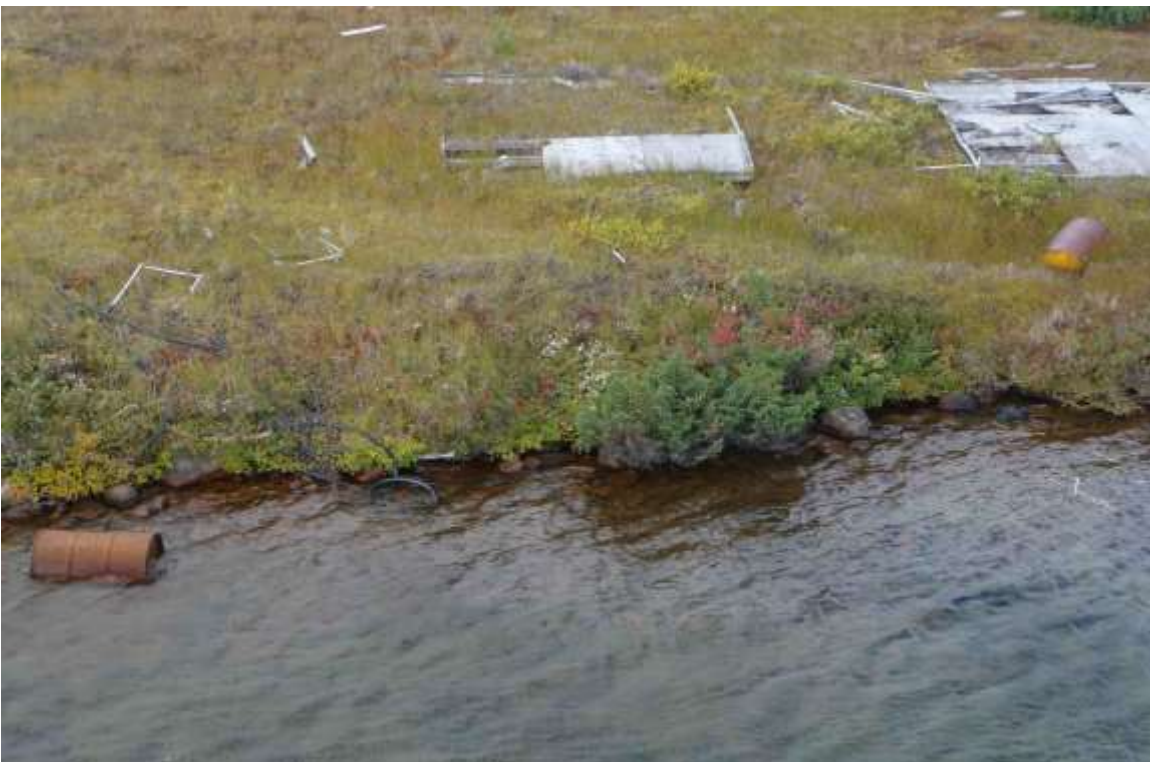
Figure 20: Material found on site TQ-14, September 2011

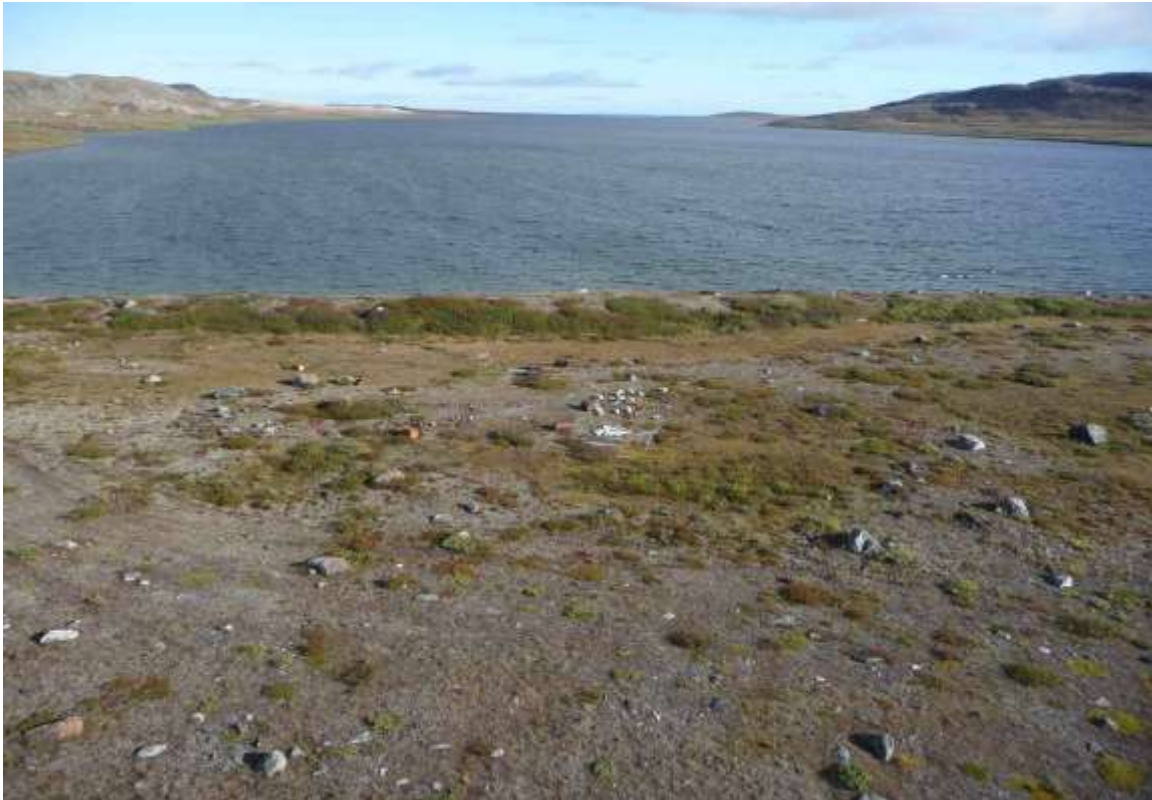
Figure 21: Aerial view of site G-24-N4-3, September 2011

In 2014, KRG will need to mobilize a team from Aupaluk to remove the material from these 2 sites. All metal debris can be transported to Aupaluk by helicopter were it can be stored in the marine containers already containing debris from other sites. It can then be transported by ship. Wood debris can be burned on site.

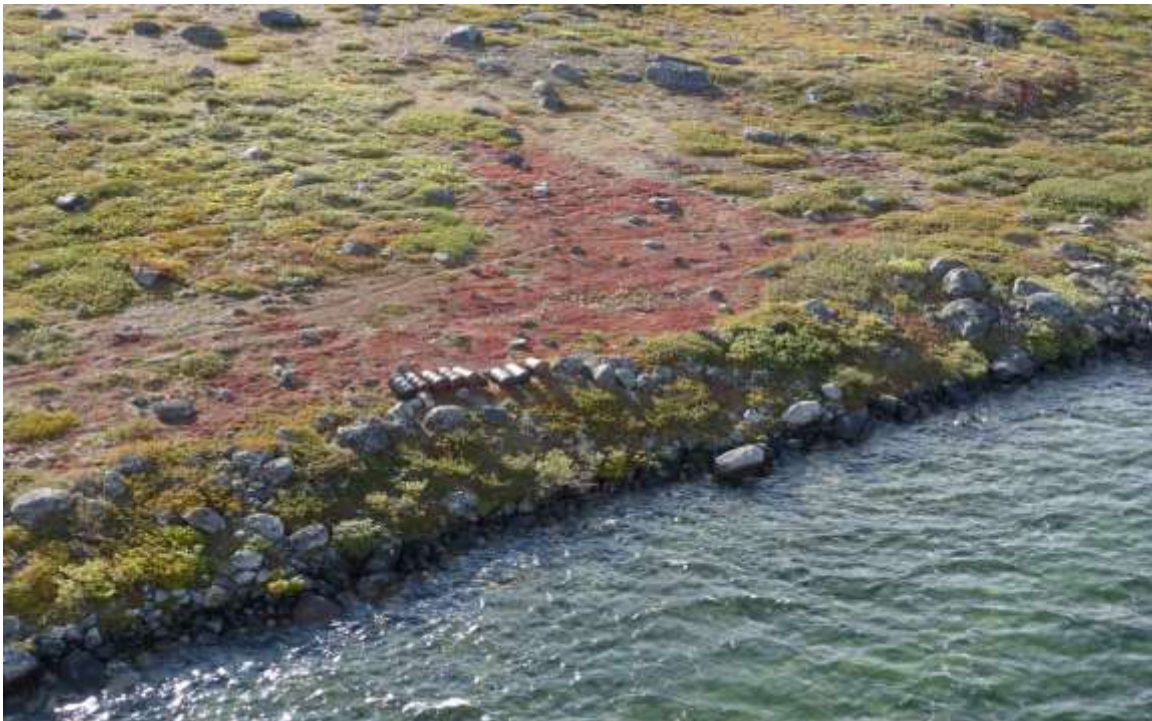
Figure 22: Aerial view of barrels found on site G-24-N4-3, September 2011

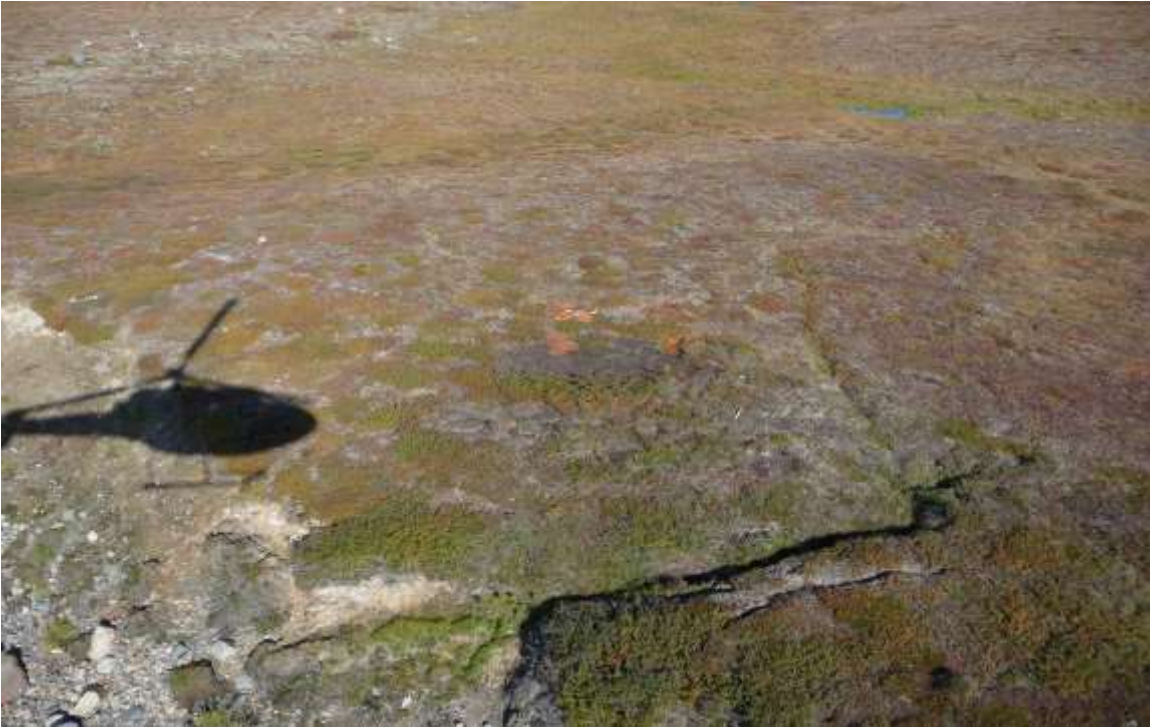
Figure 23: Aerial view of site PJ-19, September 2011

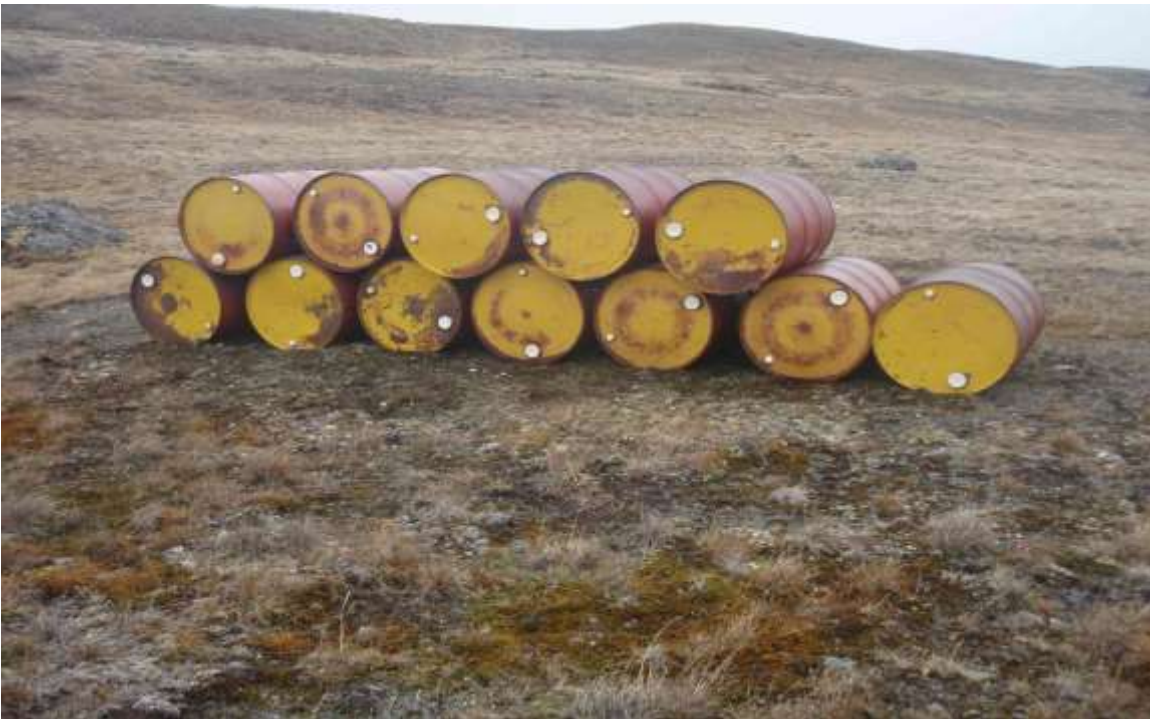
Figure 24: One group of barrels found at site WB-9, June 2012

A follow-up inspection was undertaken in June 2012. The site possesses 10 buildings and three small wooden cabins. The condition of the facilities has deteriorated since the original inventory. The site contains a large quantity of non-hazardous waste, such as bed frames, rotten mattresses, a stove-oven, a washing machine, refrigerators etc. Hazardous waste is nonetheless present on site and includes paint, motor oil, propane tanks, fire extinguishers, oil filters and a battery. Several thousand rock/core samples are still housed in a wooden structure on the site. There are approximately 20 barrels stacked close to the buildings, about half of which contain hydrocarbon residue. The soil contamination observed in 2001 underneath two barrels is still present. As well, within a one-kilometre radius of the camp, two groups of drums were observed. The first group, to the west of the site contain approximately 30 full and 10 empty barrels. The second group, located on a hill next to the site contains 18 empty drums. Photographs of the debris and buildings present at the site in 2012 are found in Appendix 4.

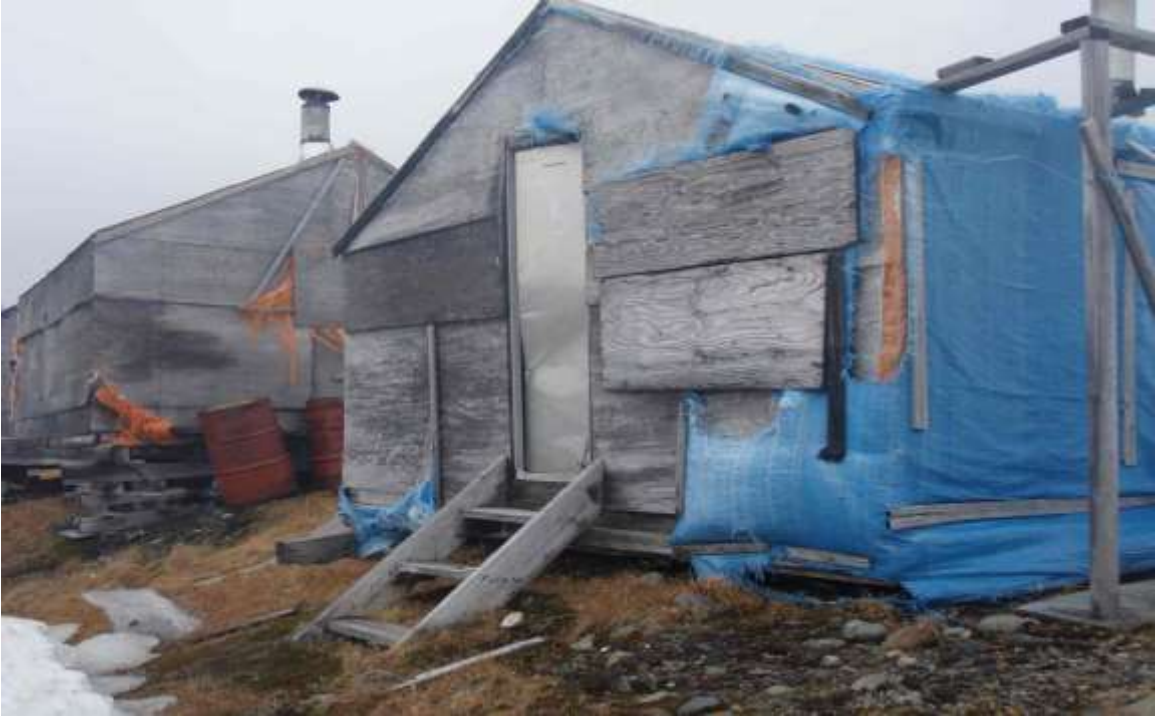
Figure 25: Two of thirteen buildings found on site WB-9, June 2012

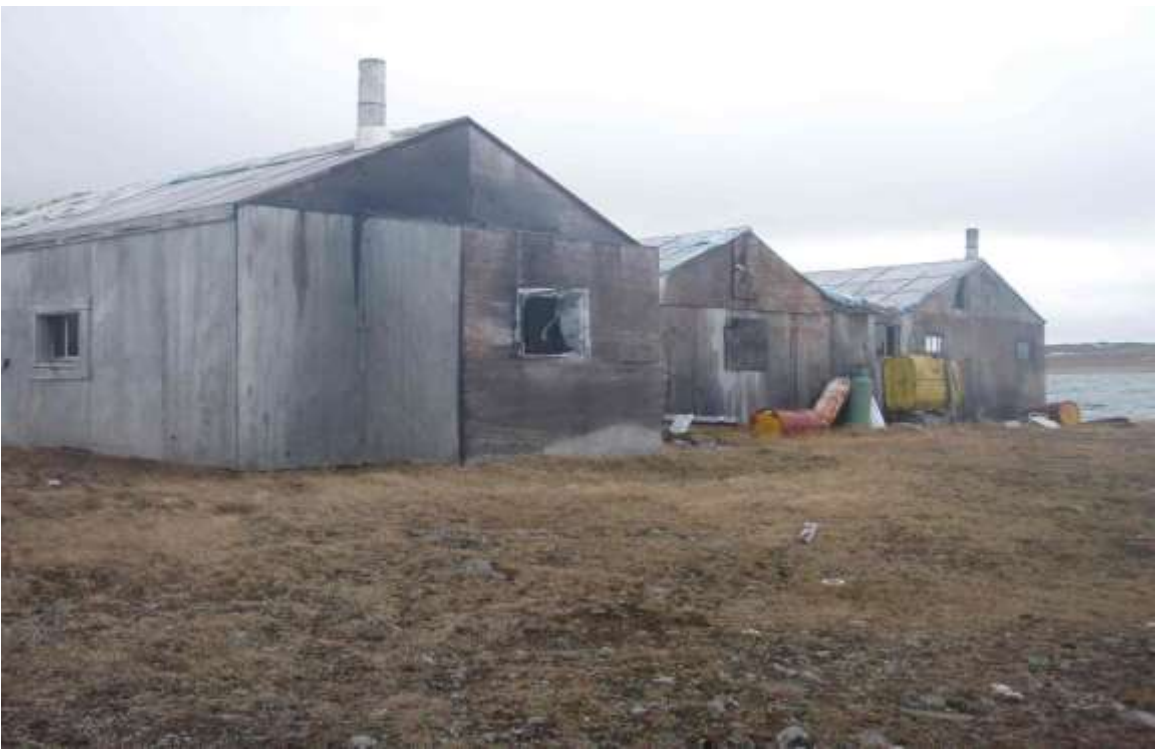
Figure 26: Example of wooden structures and debris found on site WB-9, June 2012
