# NUNAVIK ABANDONED MINERAL EXPLORATION SITES REHABILITATION PROJECT

## 2013-2014 ACTIVITY REPORT

**Kativik Regional Government**

**April 2014**

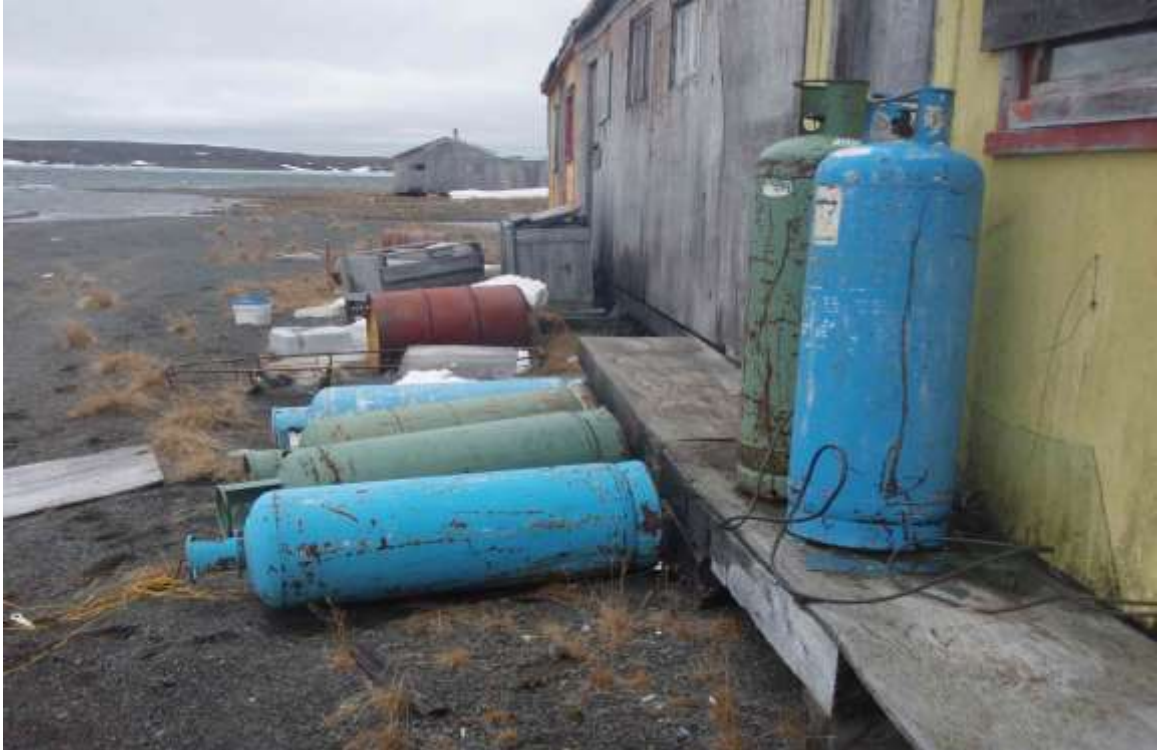
Figure 27: Propane tanks found at site WB-9, June 2012

A follow-up inspection was undertaken in June 2012. The site possesses 10 buildings and three small wooden cabins. The condition of the facilities has deteriorated since the original inventory. The site contains a large quantity of non-hazardous waste, such as bed frames, rotten mattresses, a stove-oven, a washing machine, refrigerators etc. Hazardous waste is nonetheless present on site and includes paint, motor oil, propane tanks, fire extinguishers, oil filters and a battery. Several thousand rock/core samples are still housed in a wooden structure on the site. There are approximately 20 barrels stacked close to the buildings, about half of which contain hydrocarbon residue. The soil contamination observed in 2001 underneath two barrels is still present. As well, within a one-kilometre radius of the camp, two groups of drums were observed. The first group, to the west of the site contain approximately 30 full and 10 empty barrels. The second group, located on a hill next to the site contains 18 empty drums. Photographs of the debris and buildings present at the site in 2012 are found in Appendix 4.

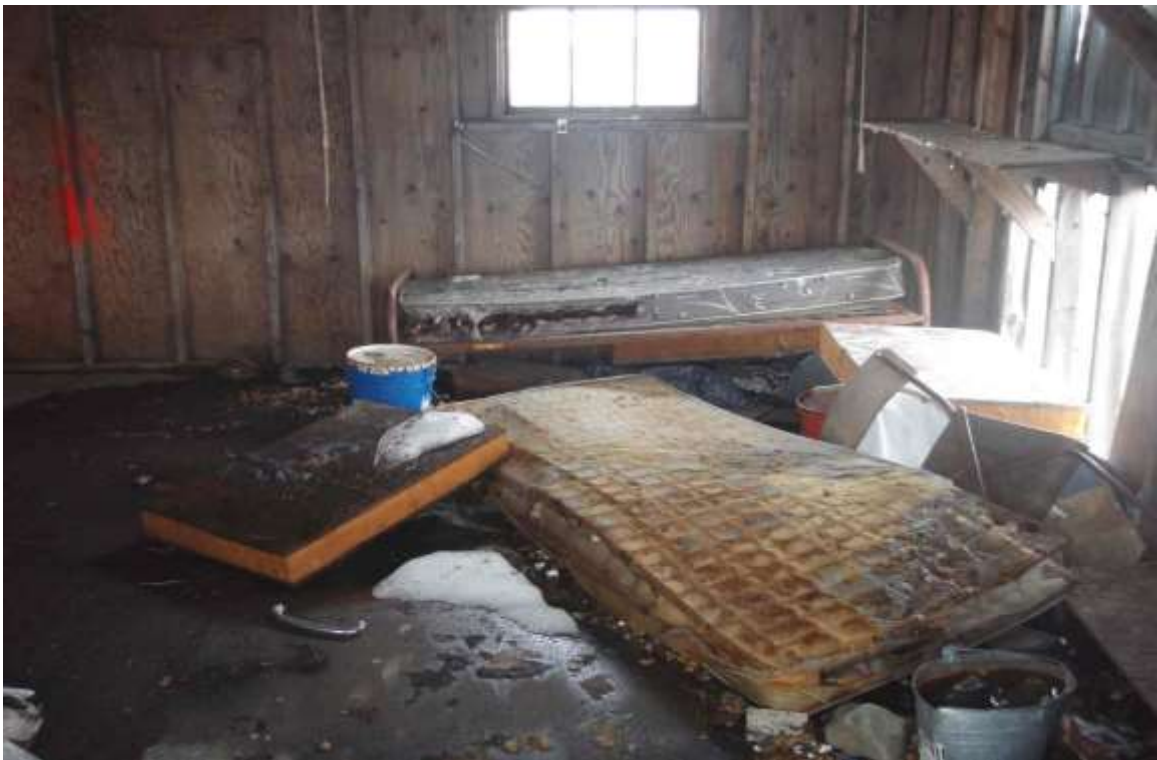
Figure 28: General debris and waste found inside buildings on site WB-9, June 2012

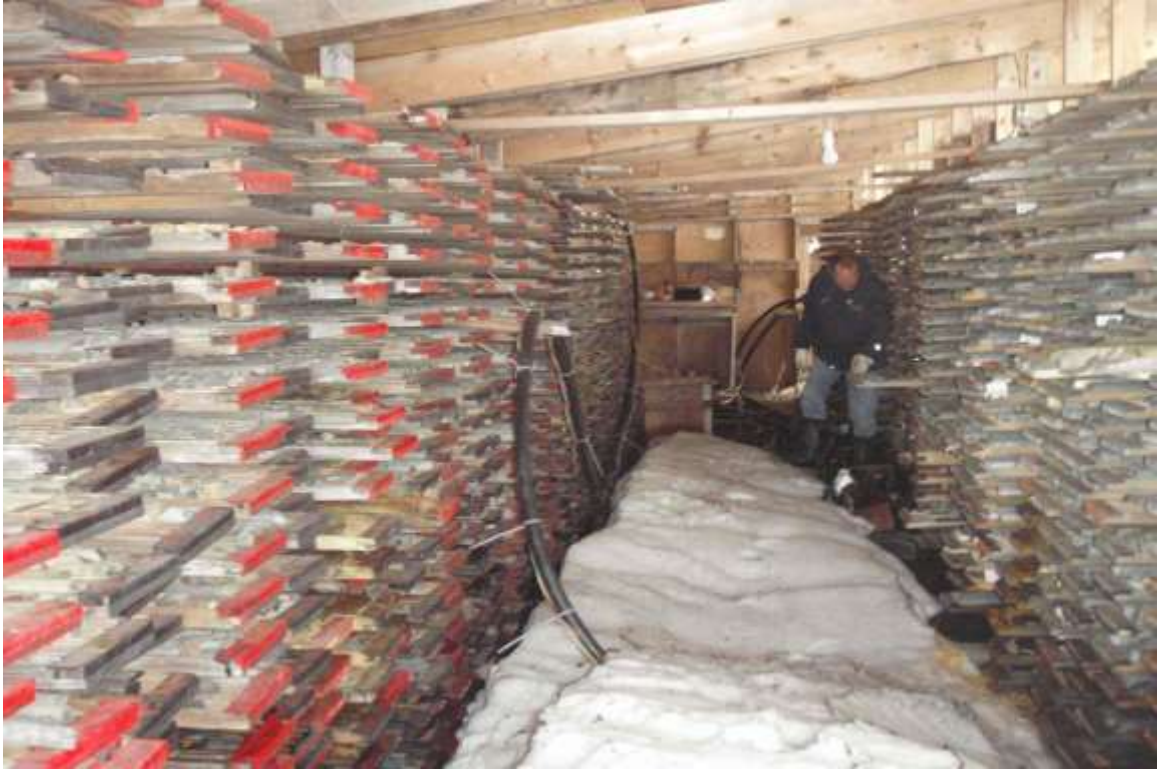
Figure 29: Core sample from previous mining exploration activities found at site WB-9, June 2012

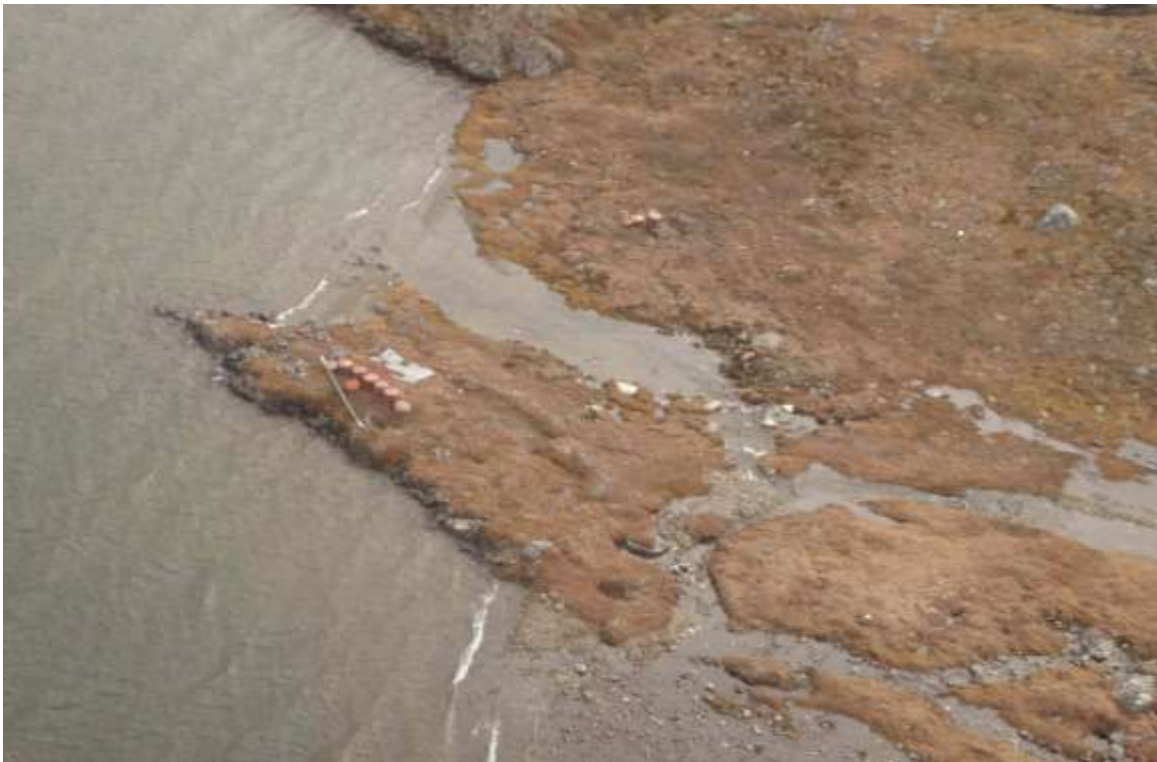
Figure 30: Sector 2 of site KV-1 containing crushed drum and wood, September 2012

Work will consist of gathering barrels and other debris to be removed from the site by helicopter. The combustible material can be burned on location. The site was inspected in September 2012 and photographs are found in Appendix 4.

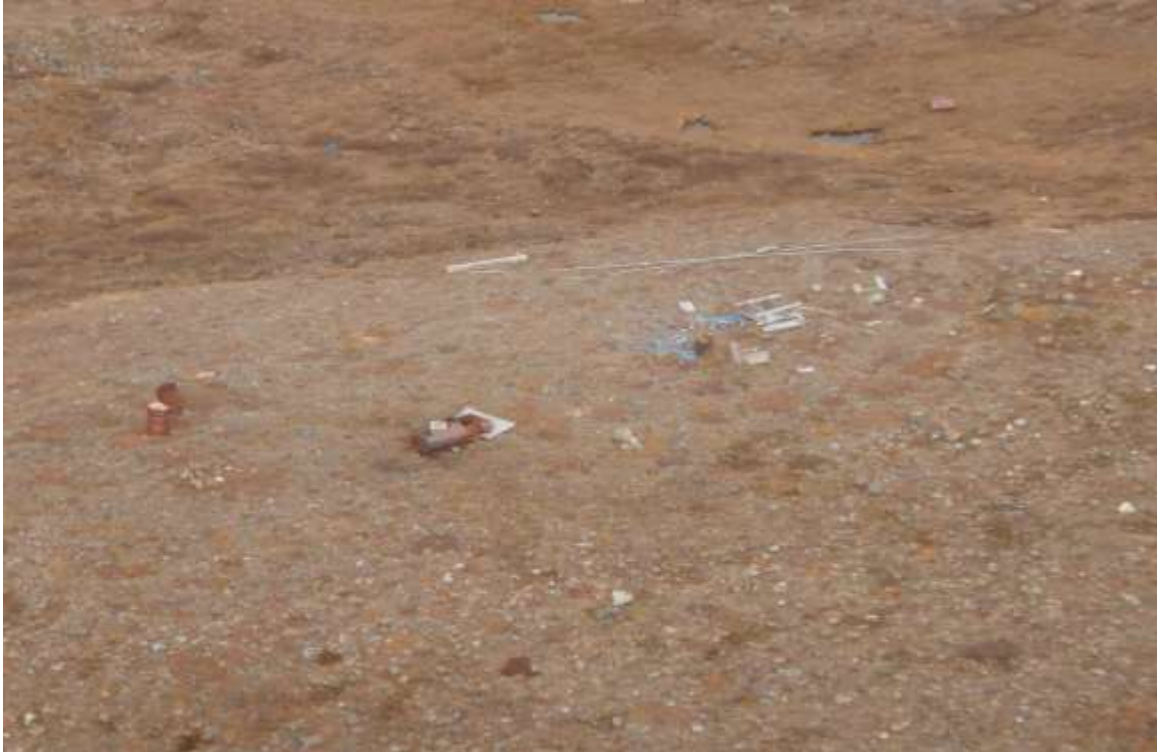
Figure 31: Sector 1 of site KV-1 containing various debris and wood, September 2012

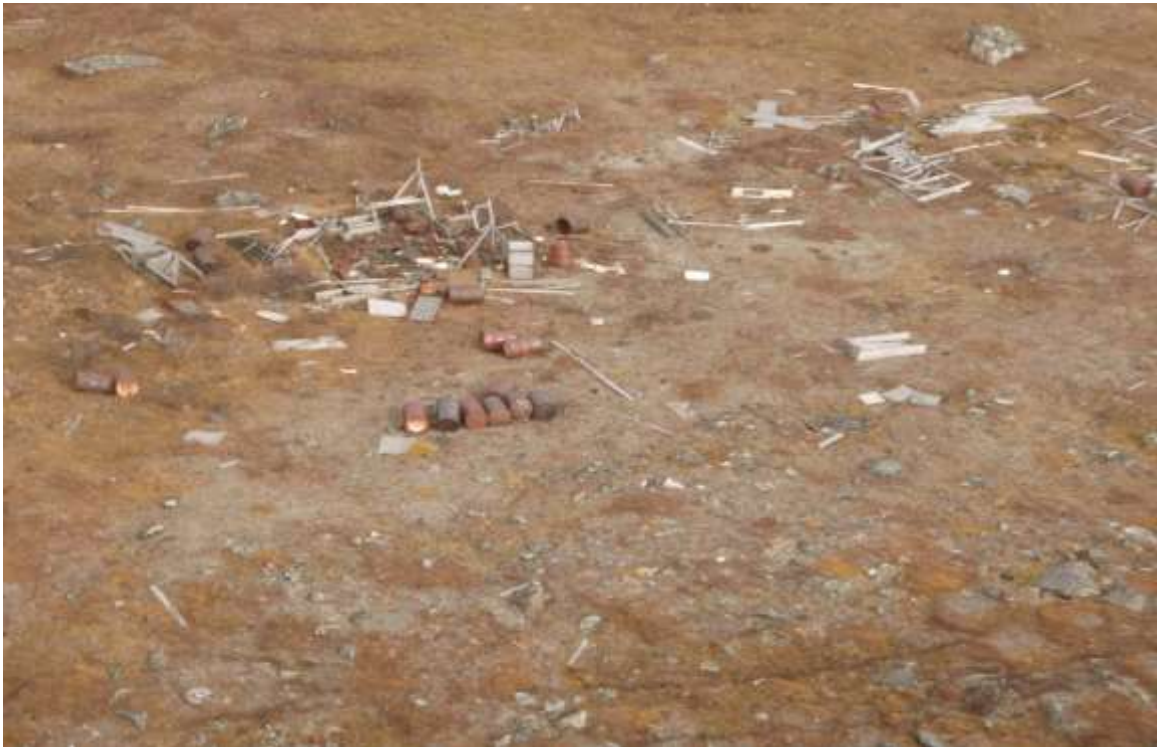
Figure 32: Sector 1 of site SW-27, containing wood debris, barrels, propane tanks and hazardous waste, September 2012

Of all the abandoned mineral exploration sites still requiring clean-up, site SW-27 contains the greatest quantities of residual material and hydrocarbons residue: roughly 1650 L of diesel, 260 L of grease and 26 L of oil. Although covering only 2.5 m<sup>2</sup>, hydrocarbon soil contamination is still very evident. Open or damaged barrels of grease were also observed. The site was inspected in September 2012 and photographs are found in Appendix 4.

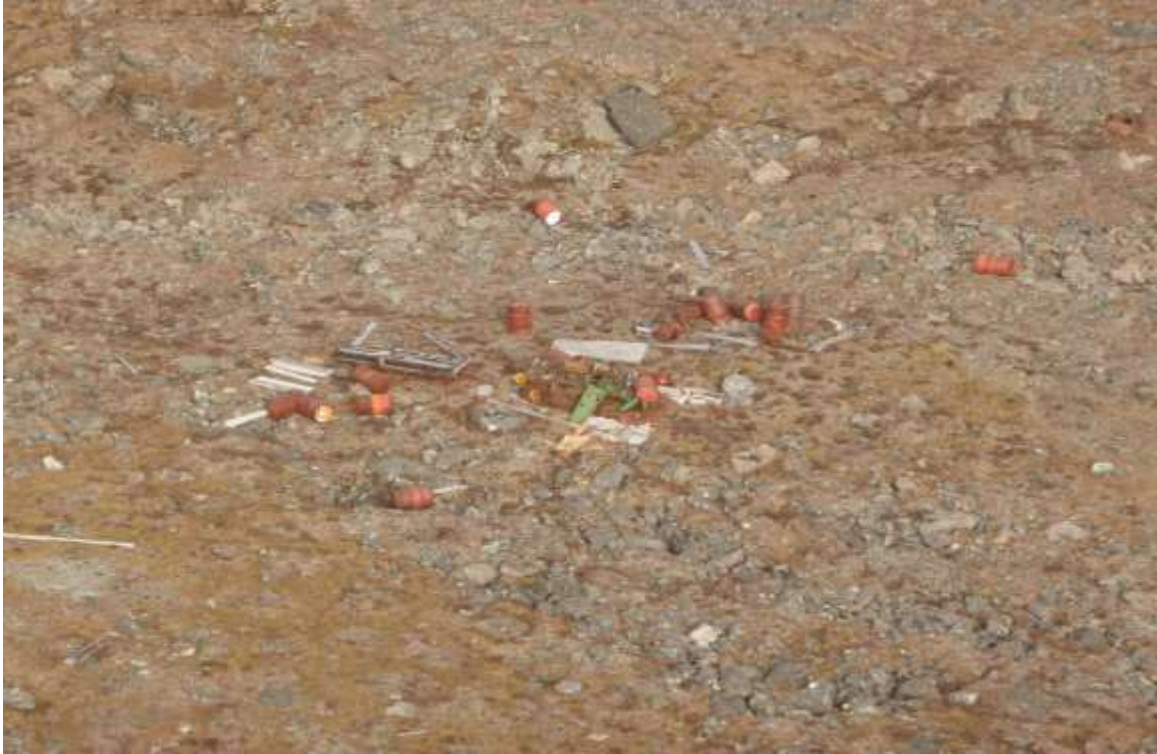
Figure 33: Sector 2 of site SW-27, containing barrels, muskeg, trailer, debris and hazardous waste, September 2012

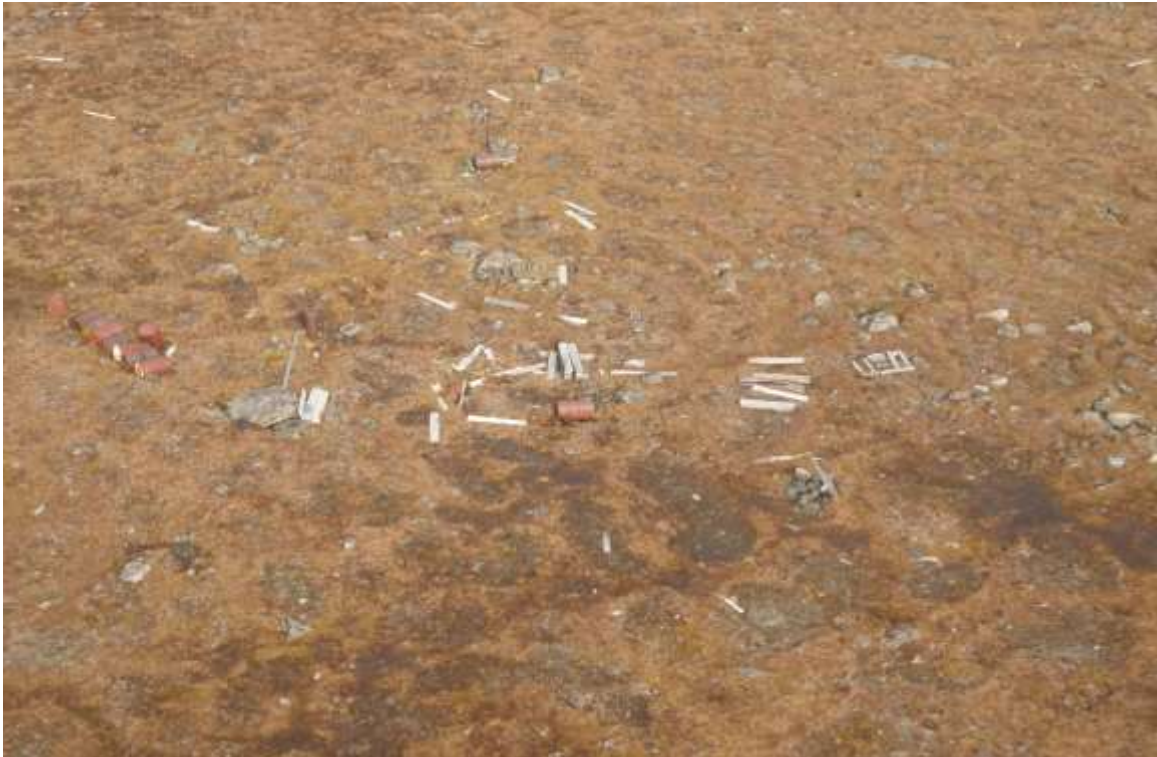
Figure 34: Sector 3 of site SW-27, containing barrels, wood and debris, September 2012

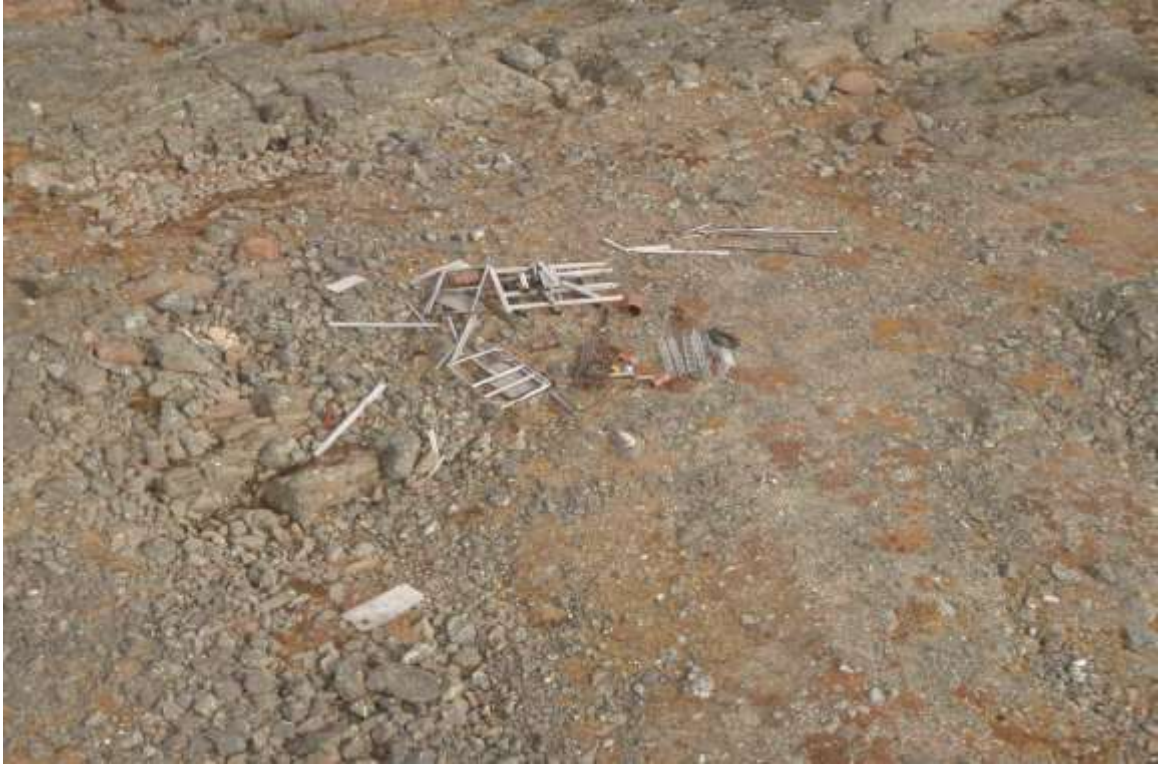
Figure 35: Sector 4 of site SW-27, containing barrels, debris and hazardous waste, September 2012
