Pipeline Accident Report

Natural Gas Pipeline Rupture and Fire Near Carlsbad, New Mexico August 19, 2000

**National
Transportation
Safety Board**
Washington, D.C.

**NTSB/PAR-03/01
PB2003-916501
Notation 7310B
Adopted February 11, 2003**

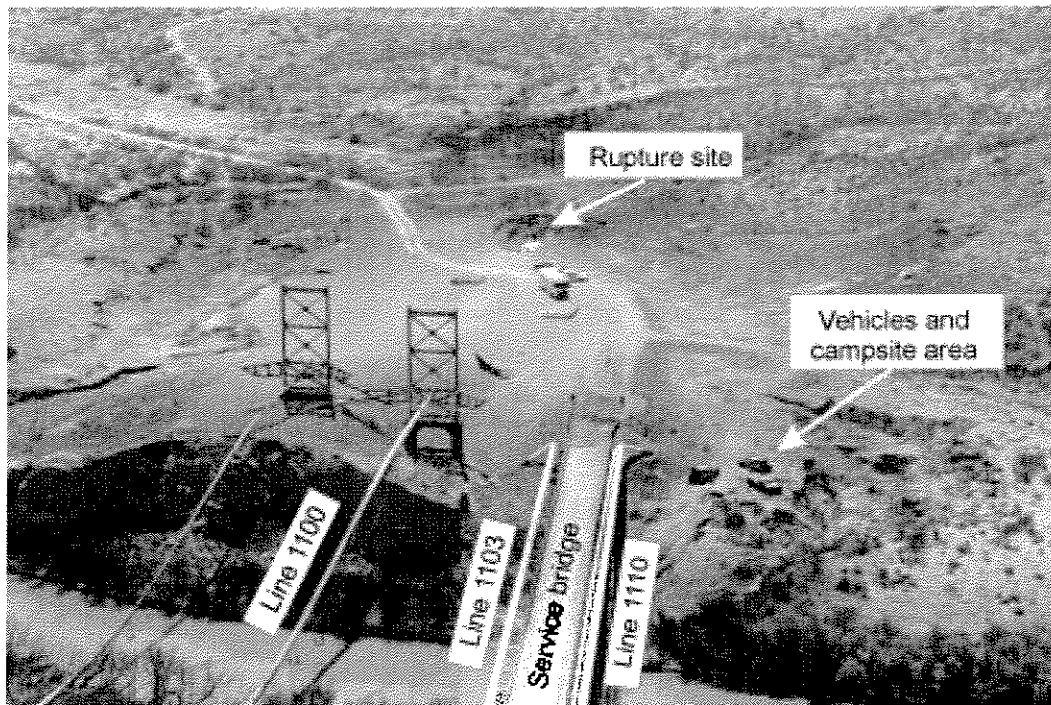
Figure 4. Aerial view of accident site looking east.

At the time of the accident, 12 members of an extended family were camping on the east bank of the Pecos River near the service bridge.¹ (See figure 4.) A locked wire rope and a “Private Right of Way—No Trespassing” sign at each entrance to the bridge restricted access to the bridge above the campsite. Two “Caution—High Pressure Gas Line” signs were posted near the east entrance to the service bridge. Also, a sign reading as follows:

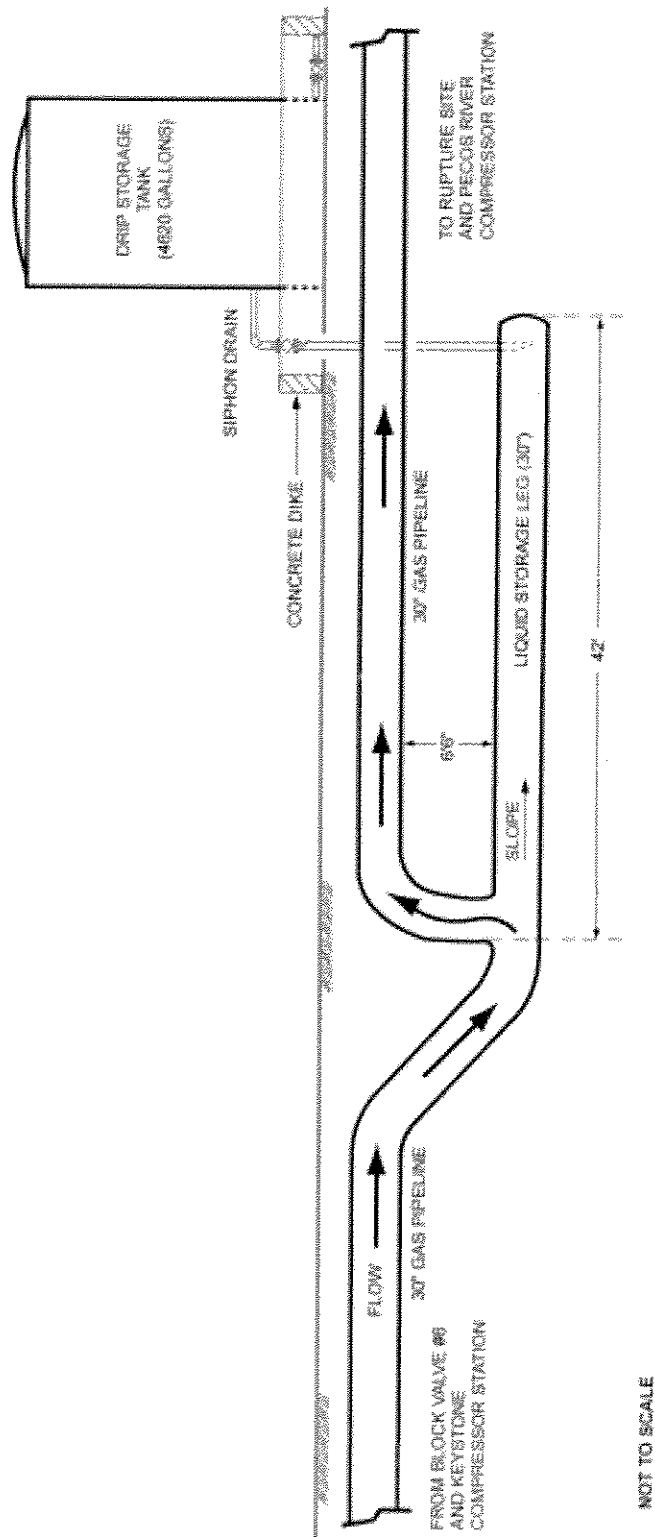
Figure 11. Diagram of line 1103 drip.

Line 1103 Drip Assembly. About 990 feet downstream/west of block valve No. 6 was a drip, a liquid collection leg buried beneath the pipeline that consisted of about 40 feet of 30-inch pipe. (See figure 10.) The leg was buried approximately 7 feet directly below the gas pipeline and sloped downward toward a dead end equipped with a siphon drain. The leg functioned to collect liquids and solids during normal transportation or after pigging operations. Also at this location was a liquid storage tank consisting of a 4,620-gallon aboveground steel tank installed within a concrete dike. The siphon drain in the liquid collection leg of the drip assembly emptied into this tank. (See figure 11.) The tank was fitted with piping and valves for loading the collected liquids into a truck for disposal. The drip assembly was installed during the original construction of the pipeline. Because of the location and design of this drip, cleaning pigs could not be run in the section of pipeline that ruptured. After the removal of the line 1100 drip in 1989, liquids and solids moving down line 1100 toward the Pecos River compressor station during both normal operations and pigging operations in line 1100 could enter line 1103 upstream of the drip.

There was no pig launcher at block valve No. 6 and no pig receiver at Pecos River compressor station. For that reason, and because of a reduced port valve²² and other pipeline features, including the drip, in the section of the pipeline between block valve No. 6 and the Pecos River compressor station, that portion of the pipeline (which included the rupture location) could not be pigged.
