Projet minier aurifère Canadian Malartic

Peer Review Report
Canadian Malartic Project
New Polishing Pond
Osisko Canadian Malartic Project

November 2008

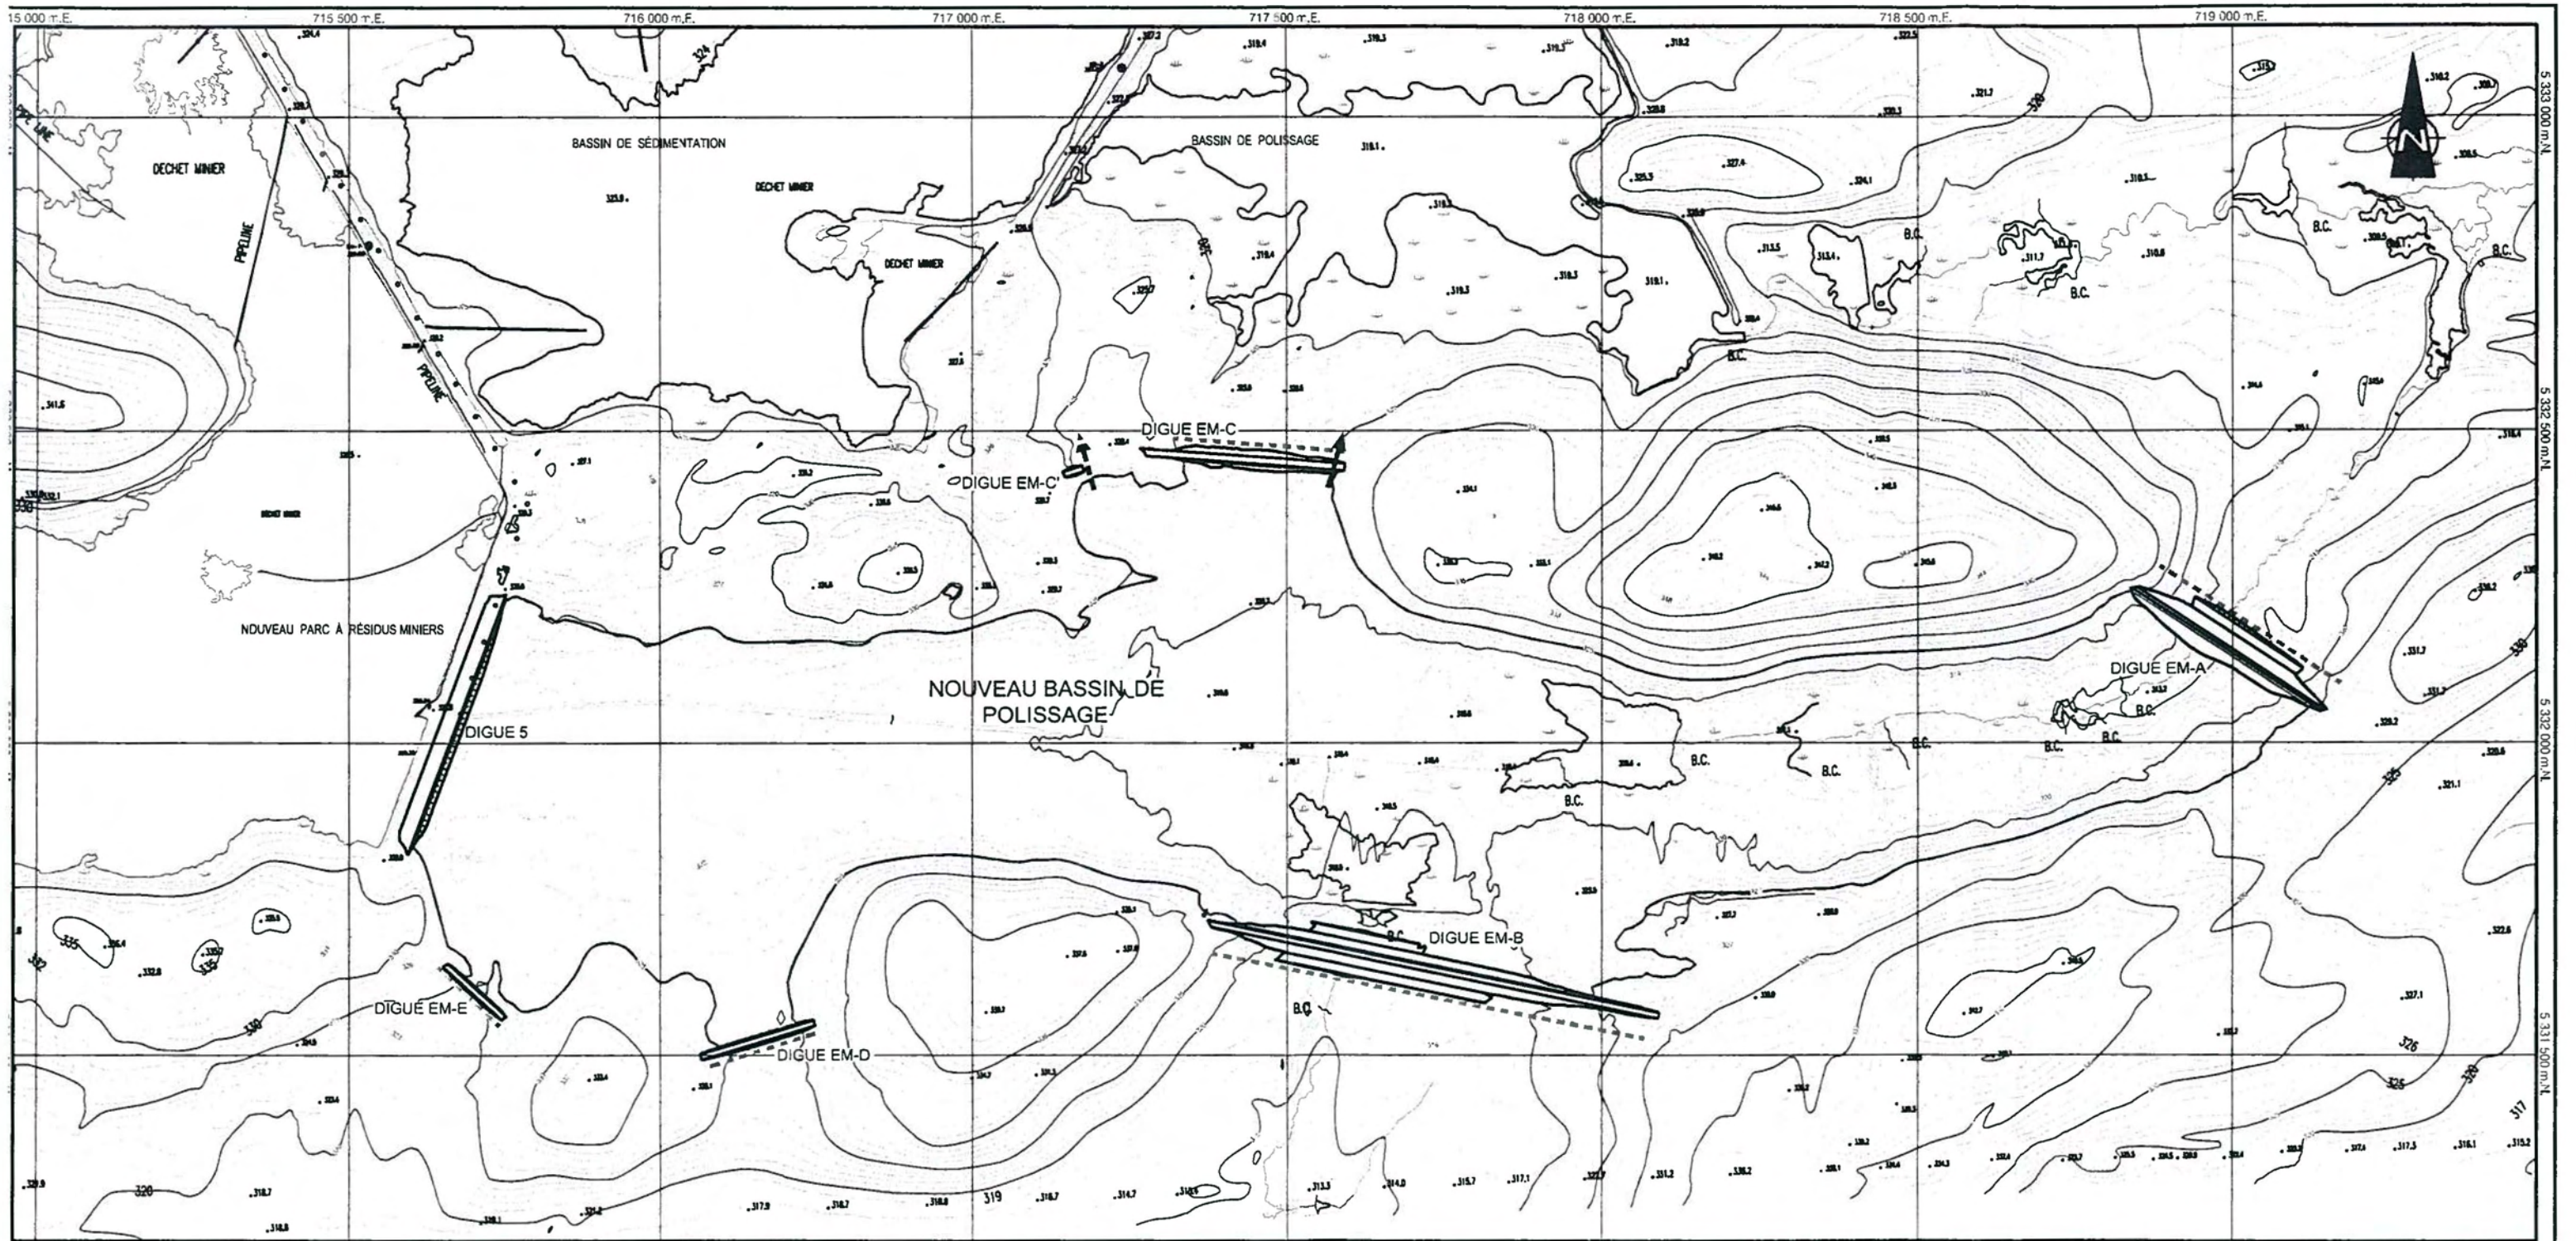
FIG. 1
 1

ÉTUDE DE CONCEPTION
 NOUVEAU BASSIN DE POLISSAGE,
 PROJET CANADIAN MALARTIC, MALARTIC, QUÉBEC

PLAN DU DÉVERSOIR D'URGENCE
 ET DES FOSSES PROPOSÉS

Figure 1 shows a plan of the proposed new polishing pond. It is adjacent to dike 5 of the old tailings pond and the proposed thickened tailings storage pile.

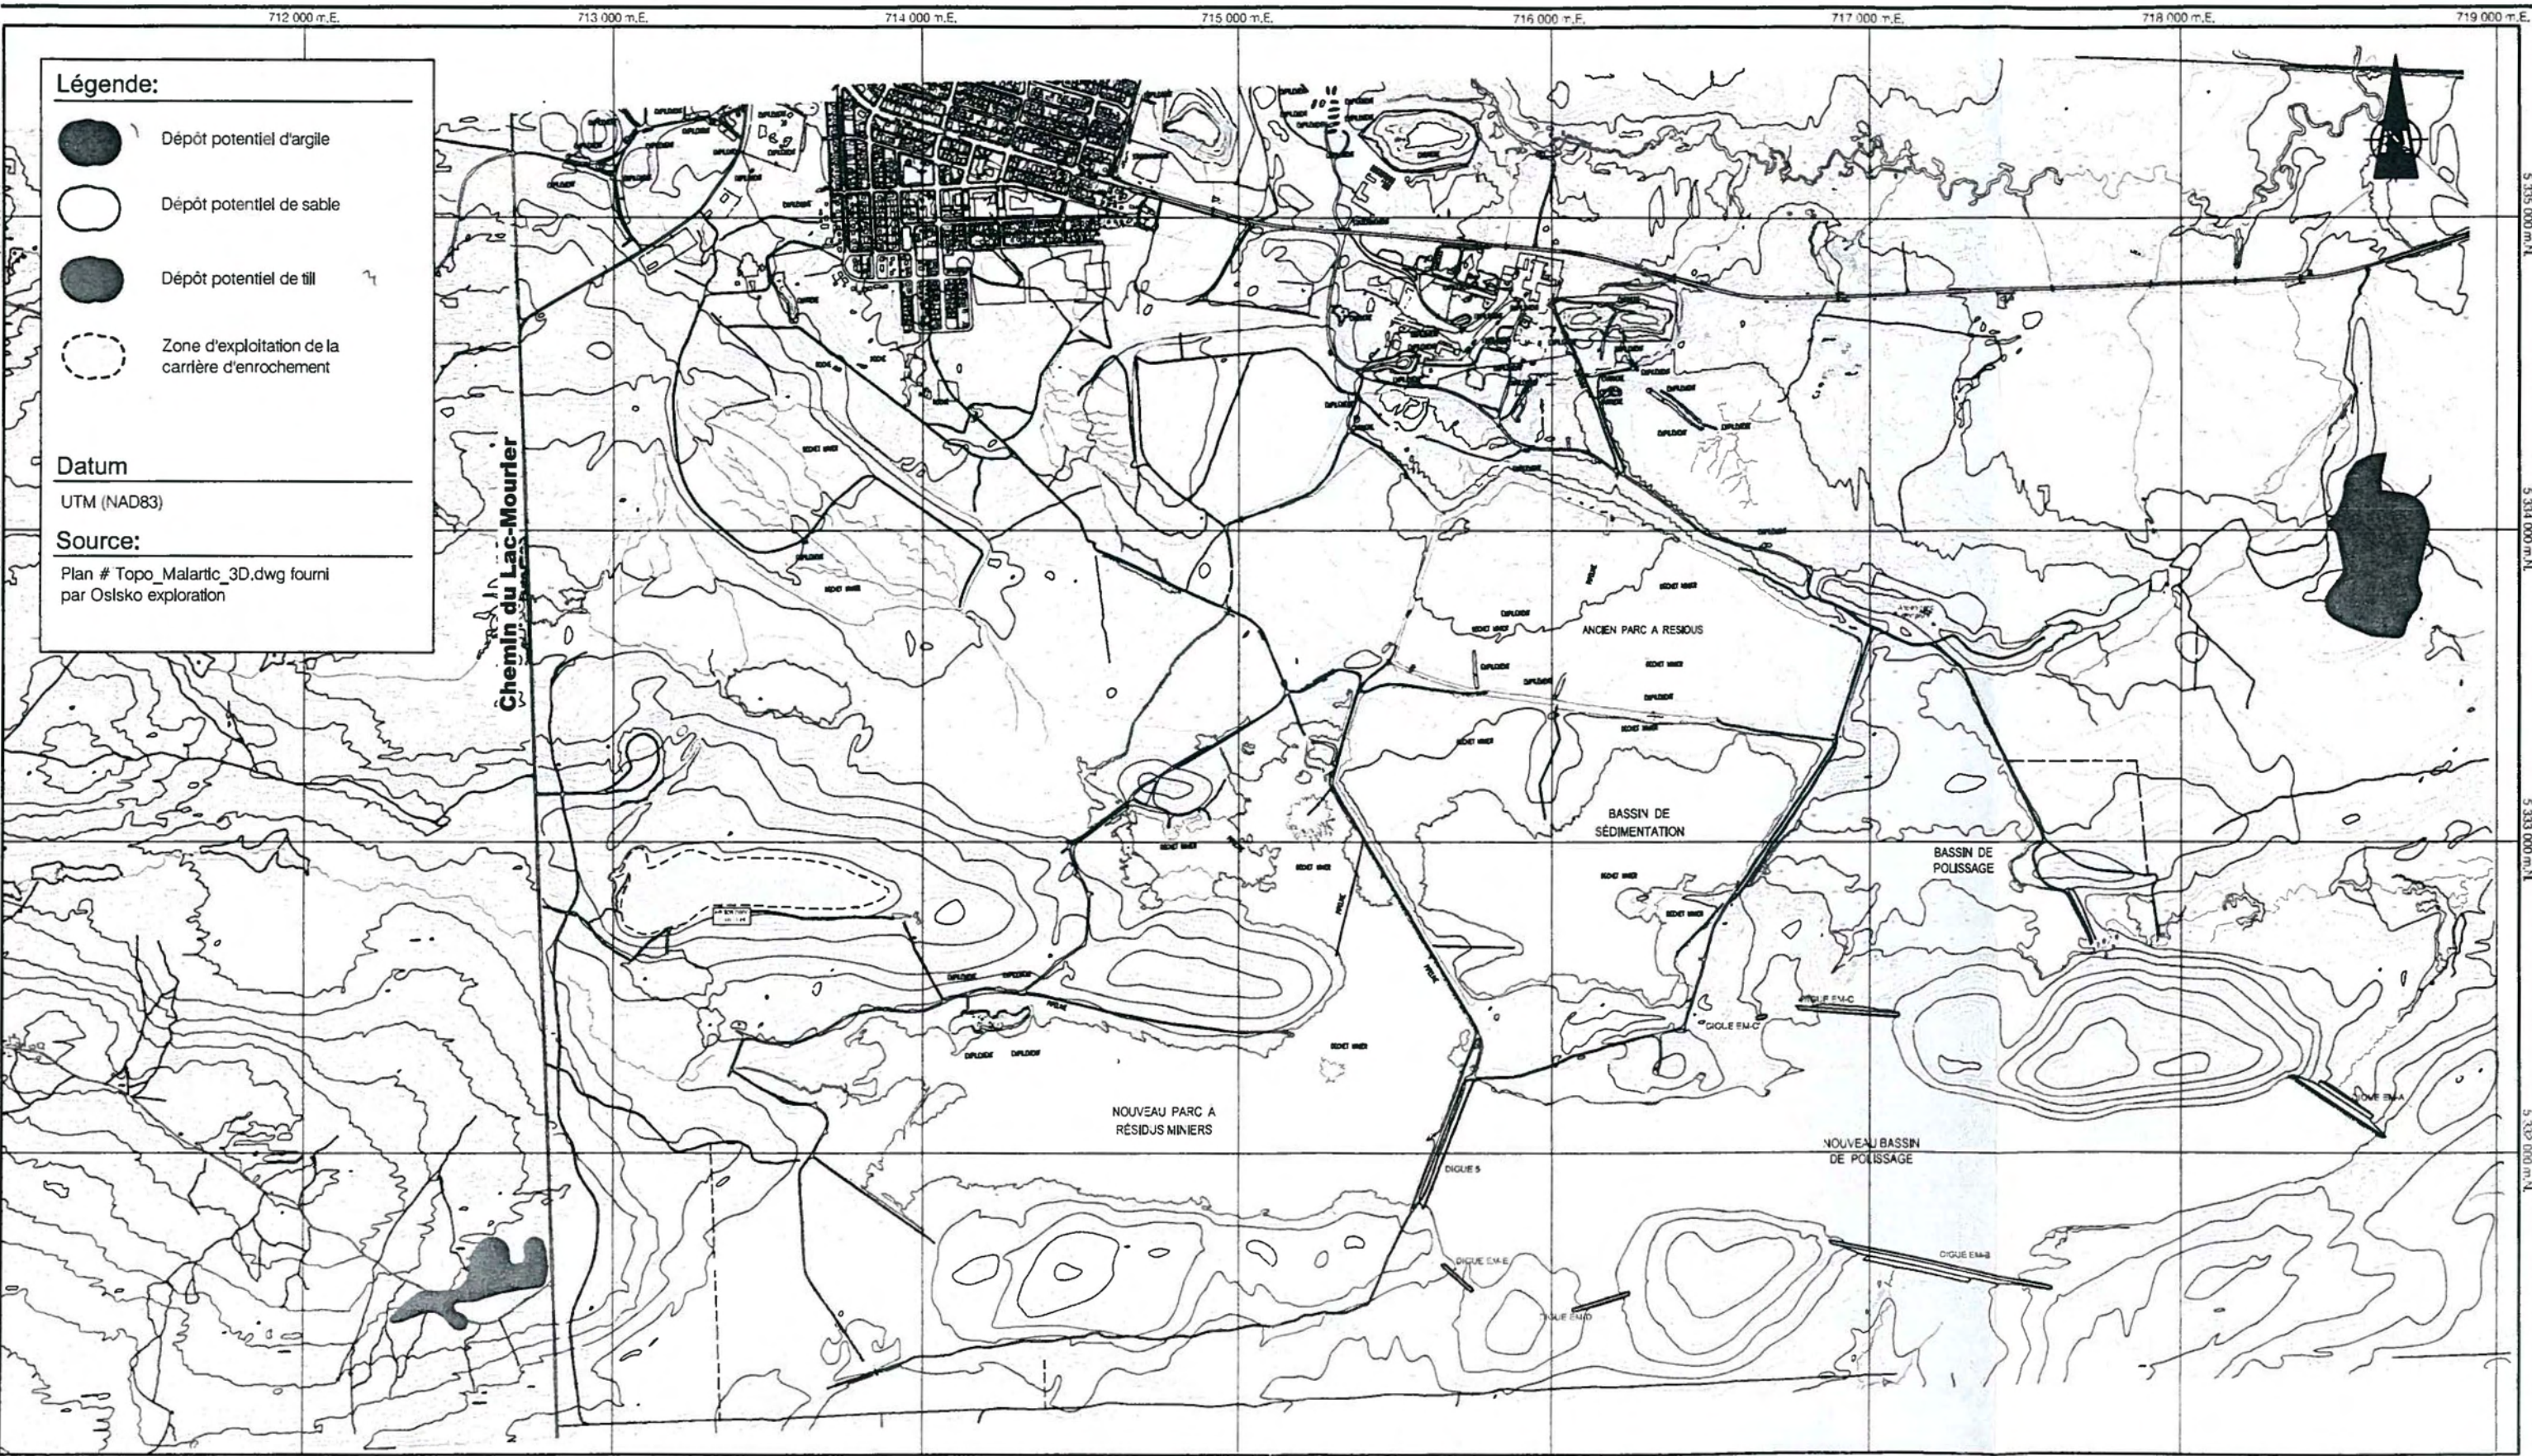
- Dépôt potentiel d'argile
- Dépôt potentiel de sable
- Dépôt potentiel de till
- Zone d'exploitation de la carrière d'enrochement

Figure 3 — Location of proposed borrow pits
