Bureau of Mines Report of Investigations/1984

Effects of Repeated Blasting on a Wood-Frame House

By Mark S. Stagg, David E. Siskind,
Michael G. Stevens, and Charles H. Dowding

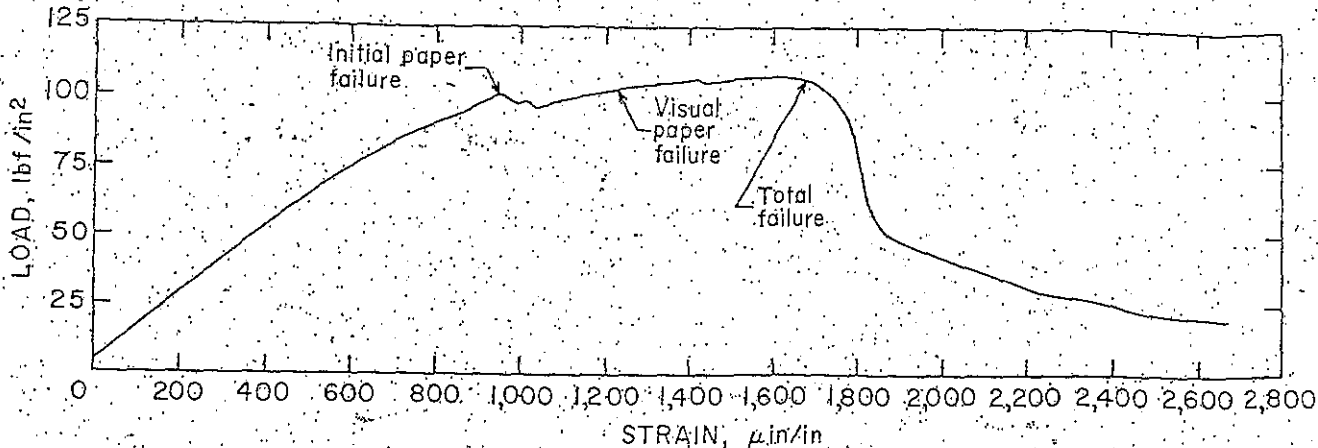
FIGURE 1. - Tensile stress strain-deformation curve for 1/2-in-thick wallboard.

- The gypsum core fails at ~ 350 $\mu\text{in}/\text{in}$ in tension and at ~ 1,000 $\mu\text{in}/\text{in}$ in bending, based on the nonlinear response points.
- For visual cracking, paper failure is the controlling factor. Its nonlinear response point occurs at ~ 1,000 to 1,200 $\mu\text{in}/\text{in}$ (fig. 1). However, visual observation of buckling or cracking is not possible until a slightly higher strain level is reached.
- Strain rate seems to affect ultimate or total failure, but the paper yield point is relatively constant. This allows comparison of various loading factors (e.g., blasting versus other activities and environmental factors).

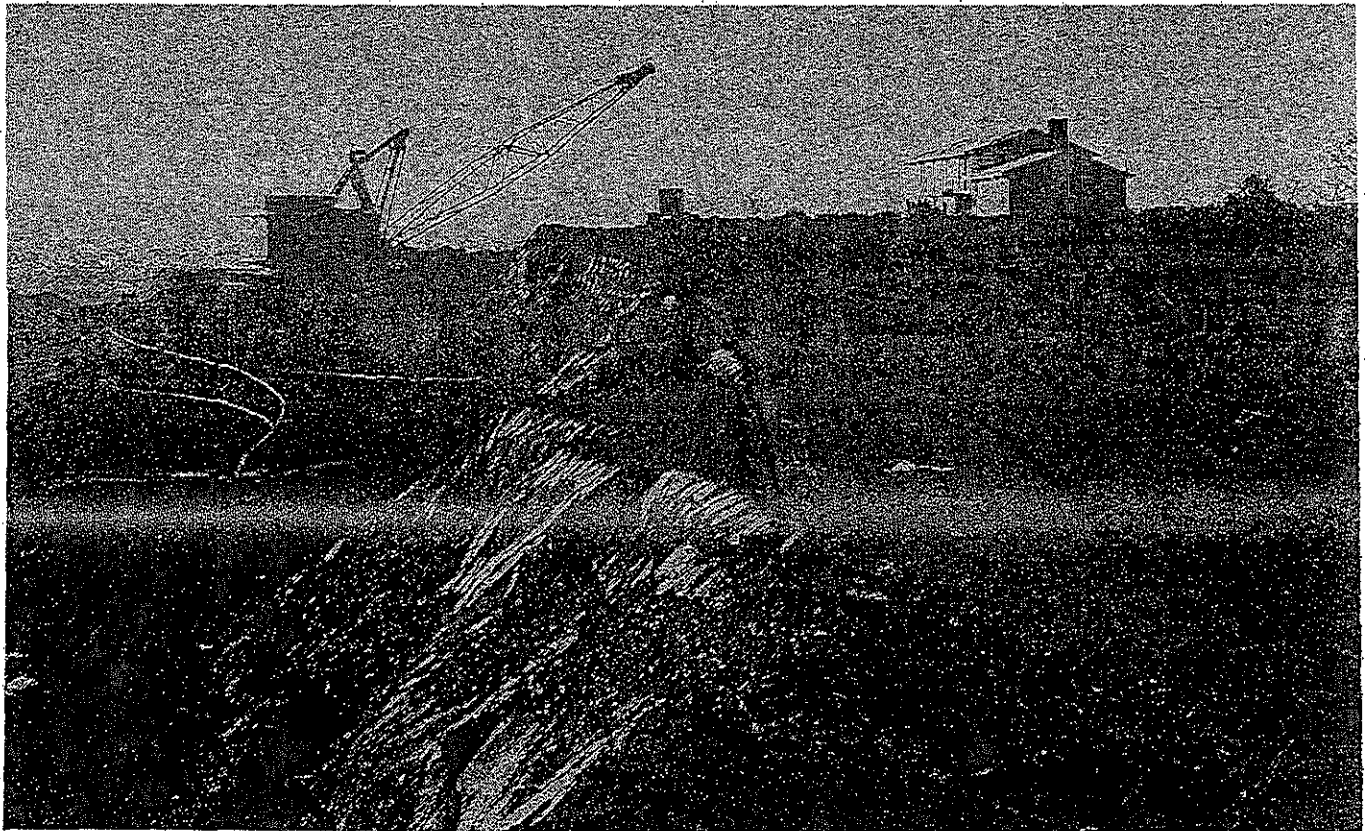
FIGURE 7. - House relationship to pit (south view).

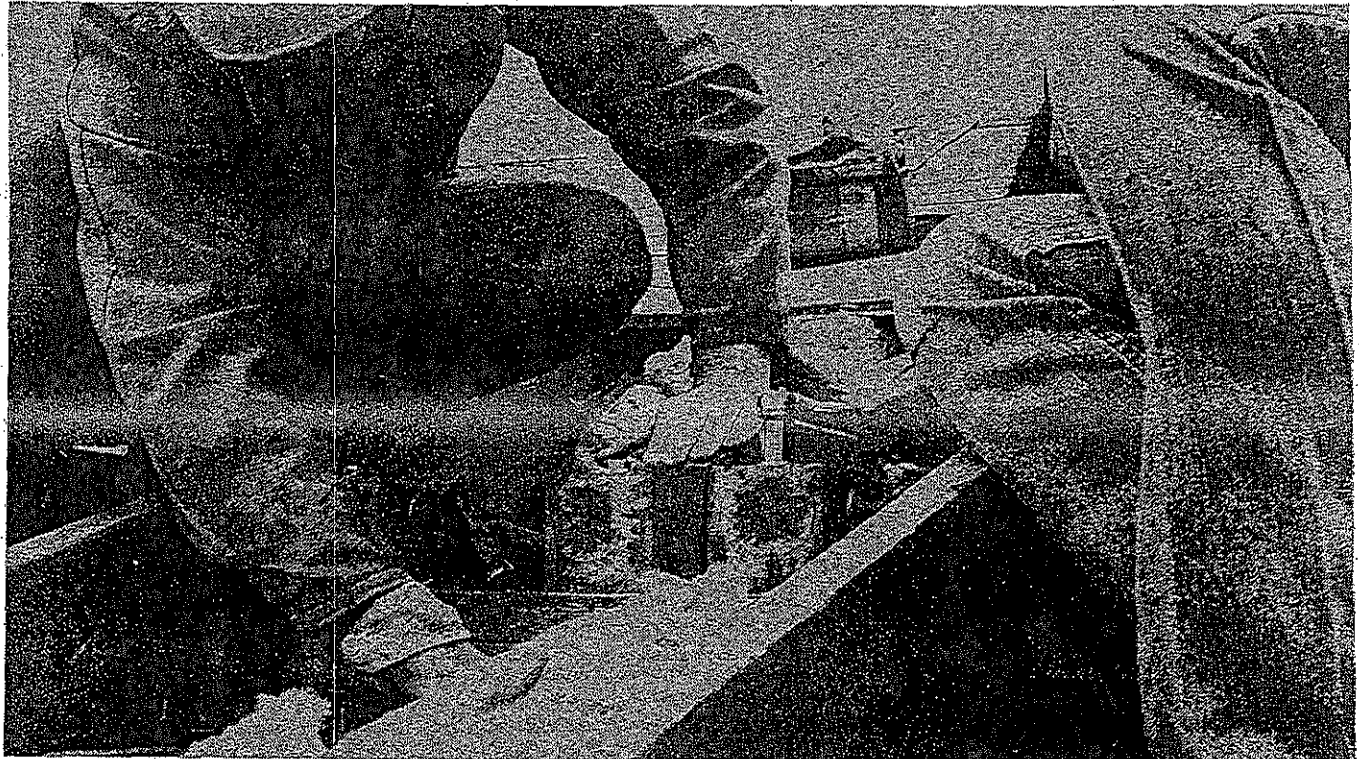
FIGURE 12. - Ceiling joists being bolted to wall studs.

were bolted (fig. 12) to ensure efficient horizontal load transmission during the more than 100,000 loading cycles. The tests involved inducing equivalent structure response until fatigue cracking was observed in the wallboard or until 100,000 cycles was reached at each level of vibration.

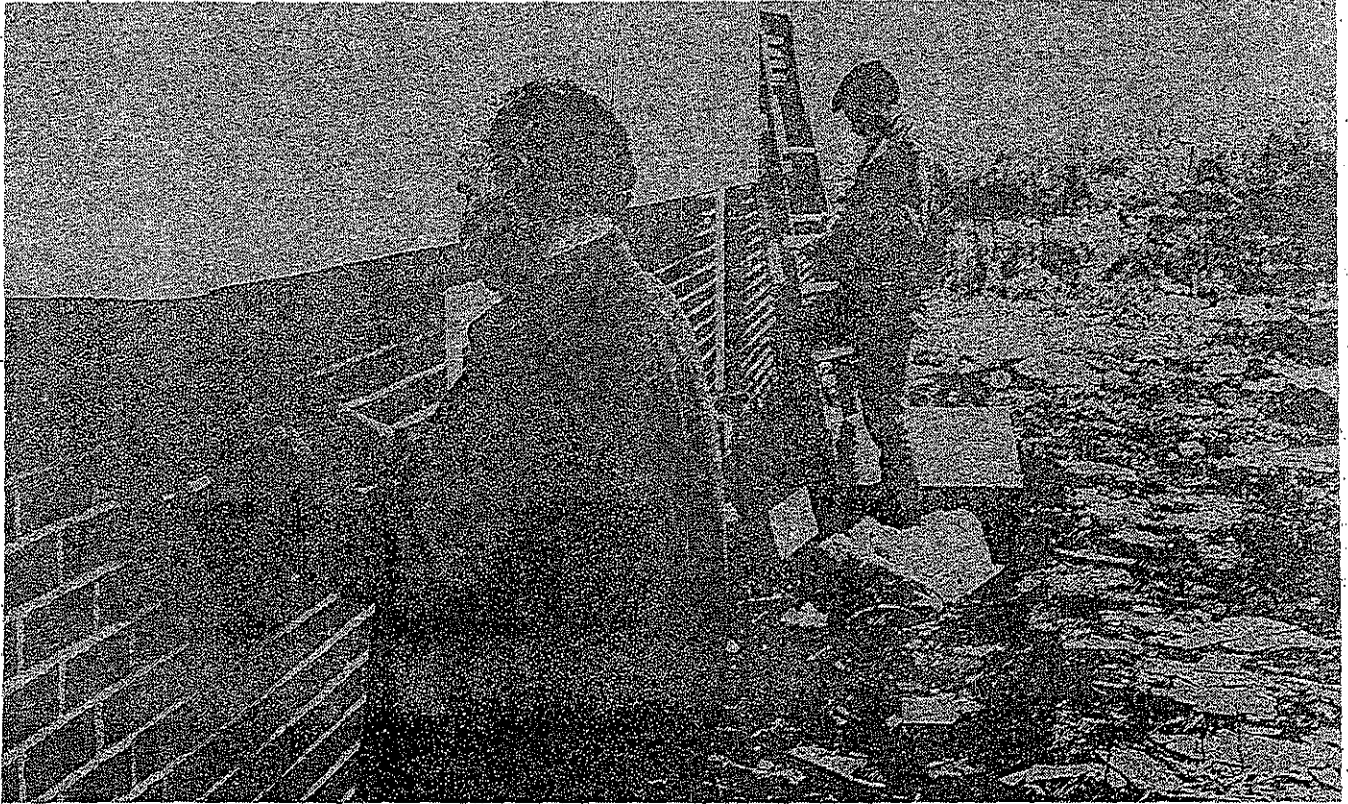
FIGURE 17. - Extensometer.

The extensometer (fig. 17) and groove comparator (fig. 18) measured the distance between set reference points ~ 10 to 30 ft apart and ~ 3 in apart, respectively. The reference points for these two devices were permanently mounted stainless steel spheres and dimpled steel blocks. They were installed over critical areas of interest as detailed in figures 15 and 16 (points G_1, G_2, G_3 , etc.). Differences in length, between that measured initially and at any later time, were divided by the initial length to obtain the strain values. A 45° rosette was employed at each groove comparator location on wallboard; and for masonry joints, both the vertical and horizontal axes of the block or brick were instrumented. (Sites $G_{13}-G_{16}$ (masonry locations) are not shown because the reference blocks dislodged after 2 months; however, these sites were promptly replaced by sites $G_{17}-G_{20}$. $G_{21}-G_{23}$ were additional sites instrumented during installation of the replacement sites.) In all, a total of 49 groove comparator measurements and 17 extensometer measurements were made each semimonthly data collection period. (Use of site E_{14} was discontinued after 3 months due to loosening of the reference sphere.) Readings were corrected for temperature differences as determined with Invar-bar standards.

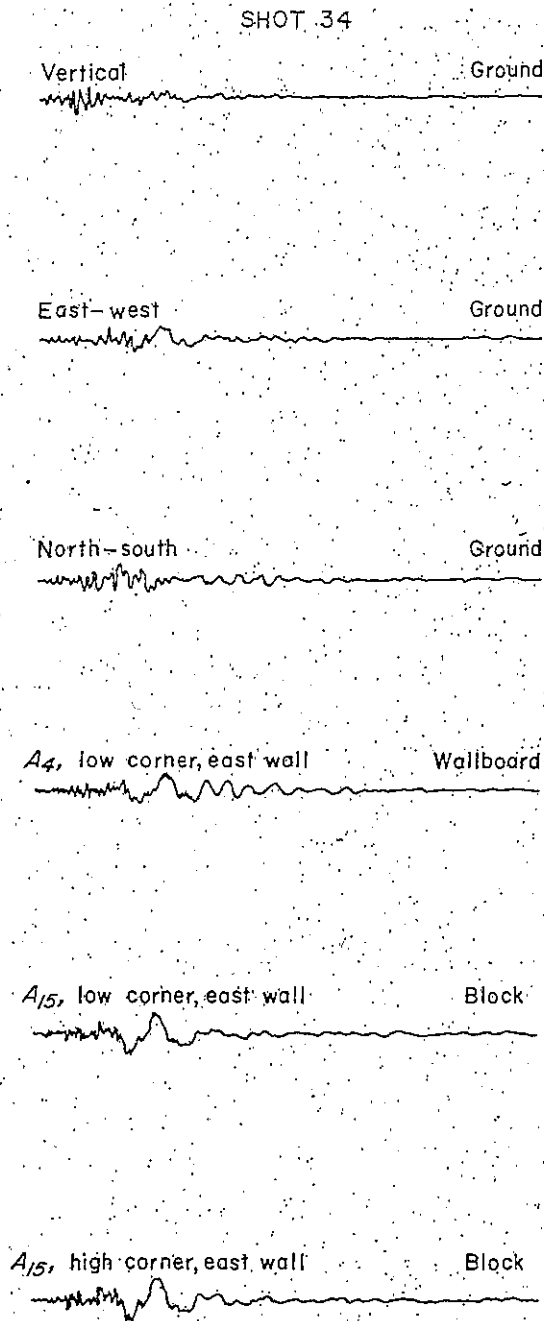
FIGURE 27. - Typical ground vibration and structure response waveforms for shot 34 with corresponding spectra. (Designations such as A_4 correspond to locations shown in figures 13 and 14.)

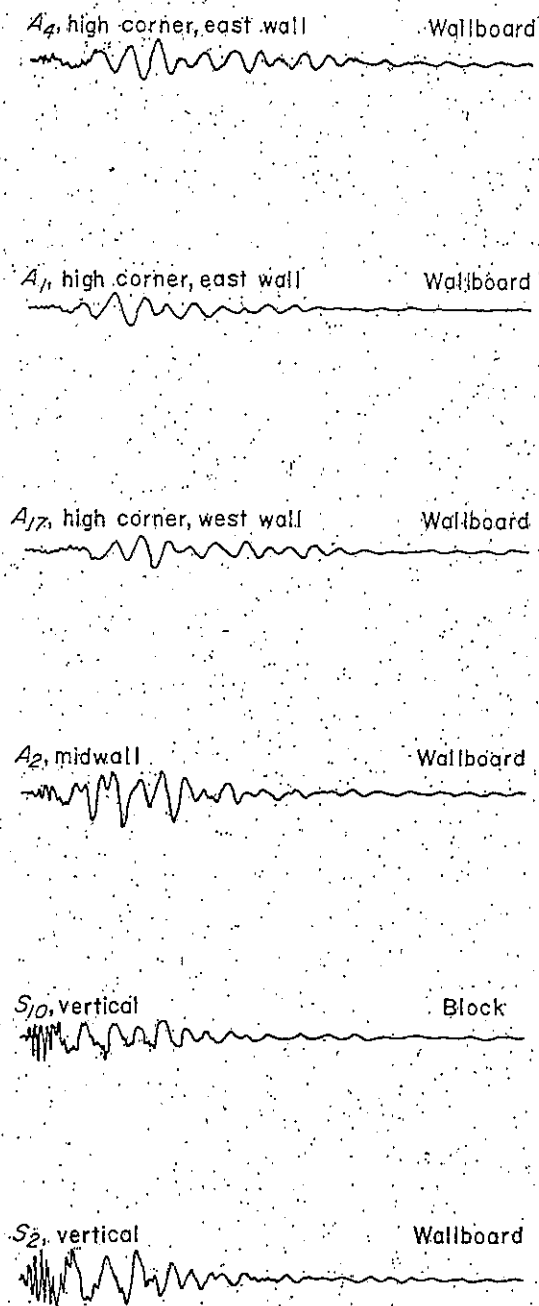
SHOT 123

FIGURE 28. - Typical ground vibration and structure response waveforms for shot 123 with corresponding spectra. (Designations such as A_4 correspond to locations shown in figures 13 and 14.)
